U.S. NUCLEAR REGULATORY COMMISSION

Report No. 50-344/85-26

Facility Name: Trojan Nuclear Plant

Management meeting on August 8, 1985, to examine the auxiliary feedwater system past history and reliability. The meeting was held pursuant to MC30702.

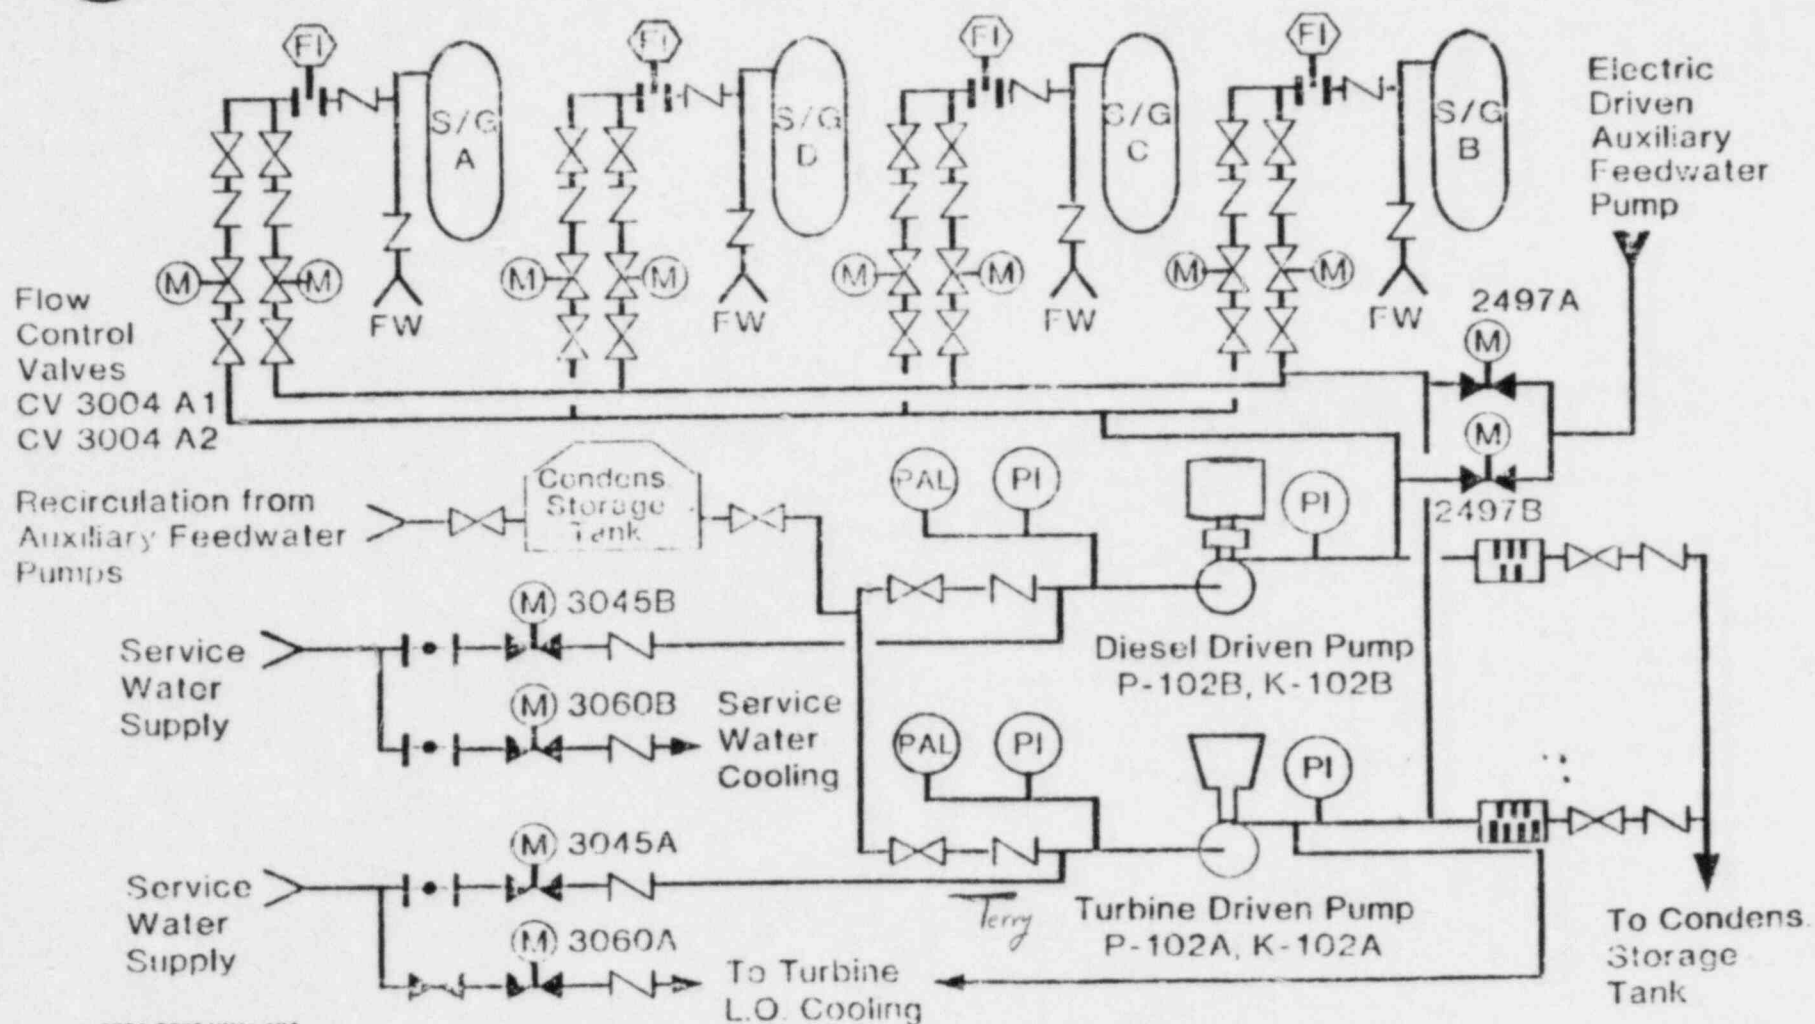
Figure 1

AUXILIARY FEEDWATER SYSTEM

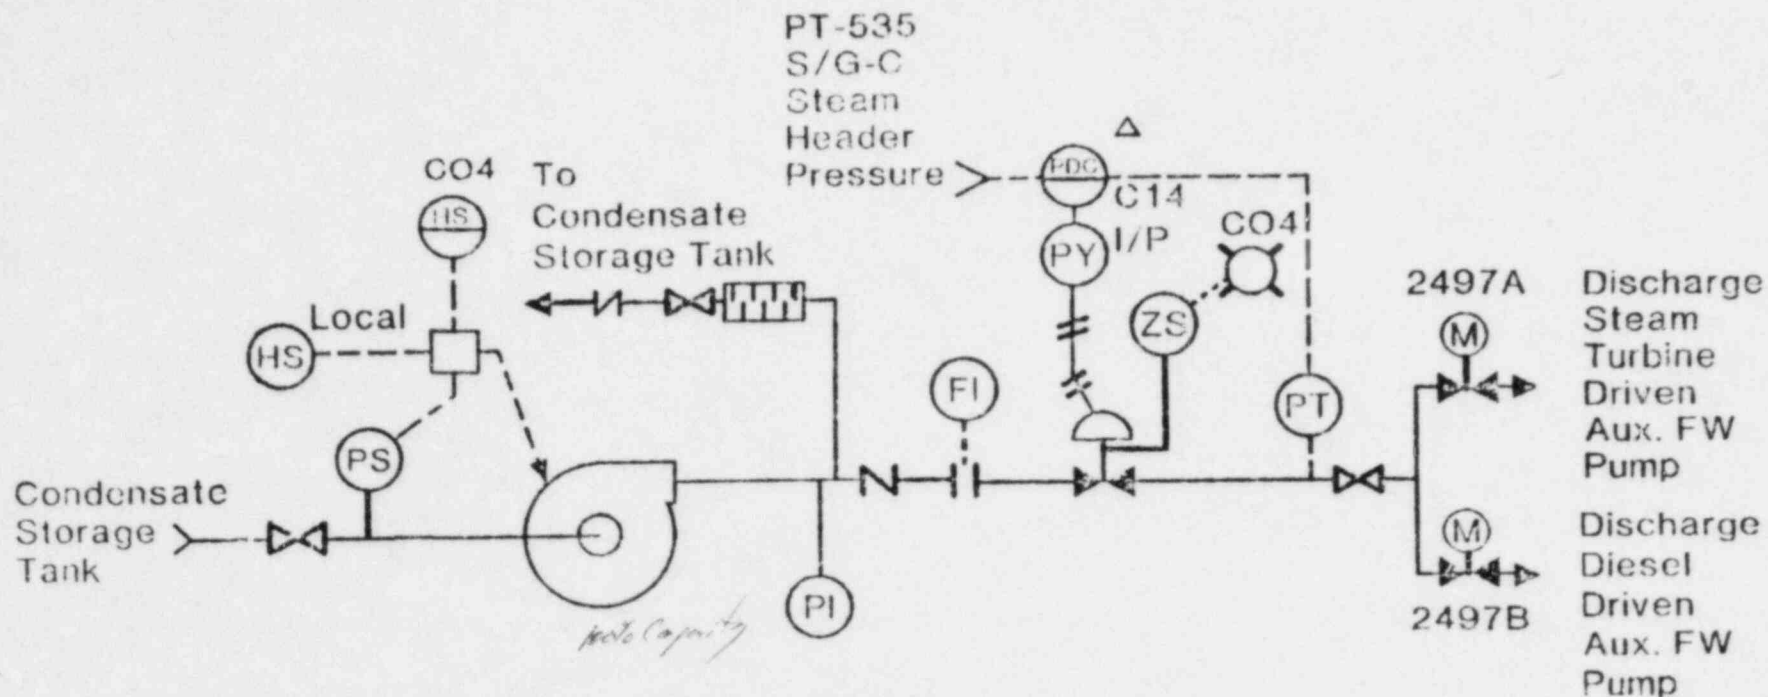
Figure 2

ELECTRIC AUXILIARY FEEDWATER PUMP

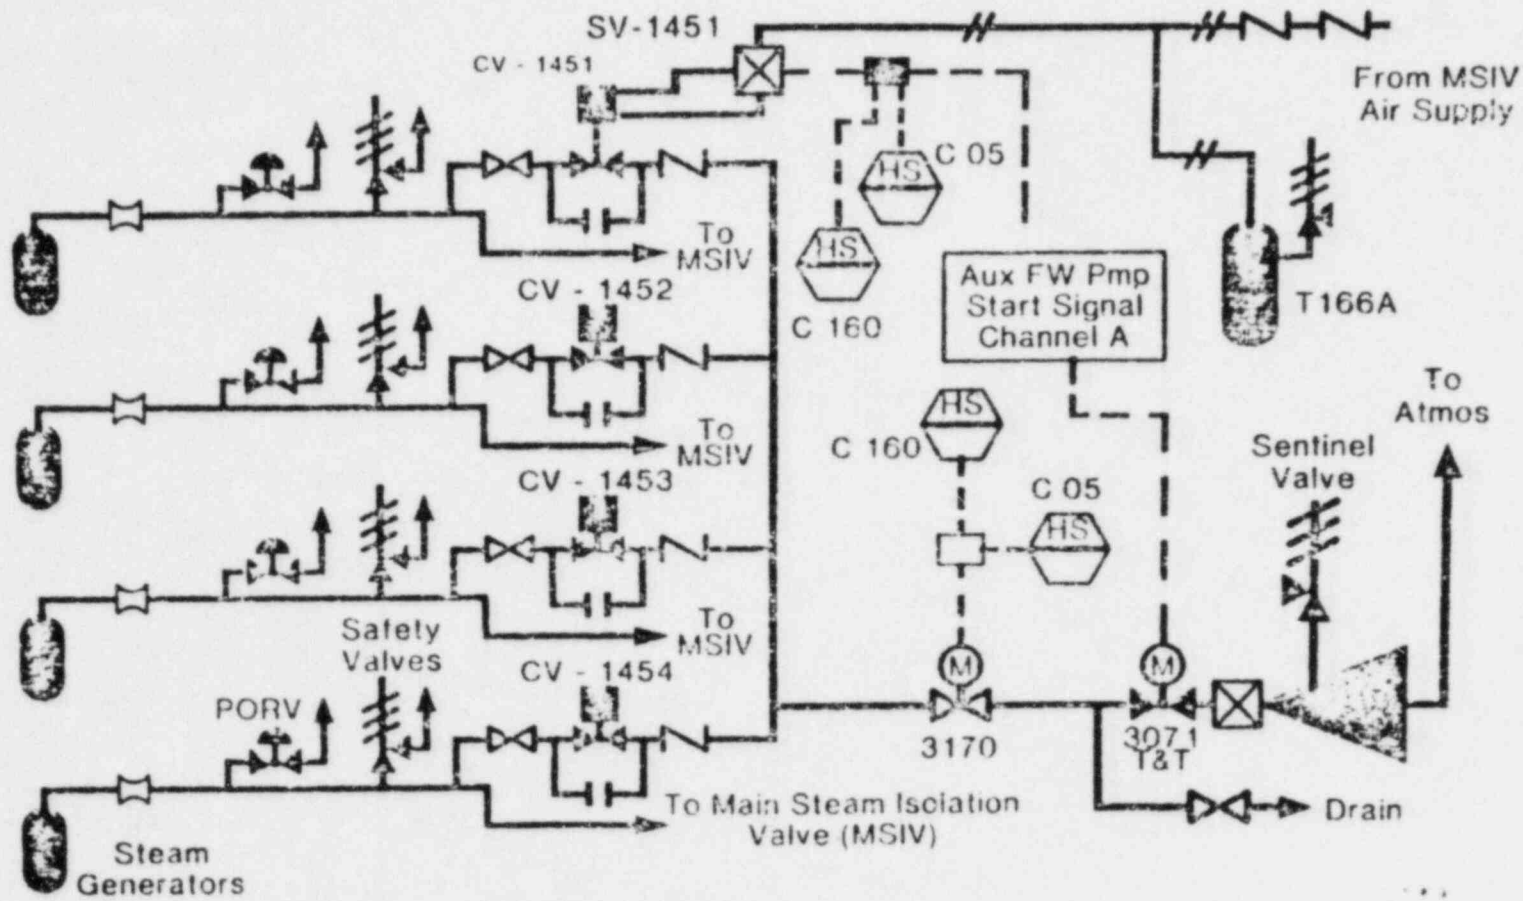
Figure 8

STEAM SUPPLIES TO TERRY TURBINE

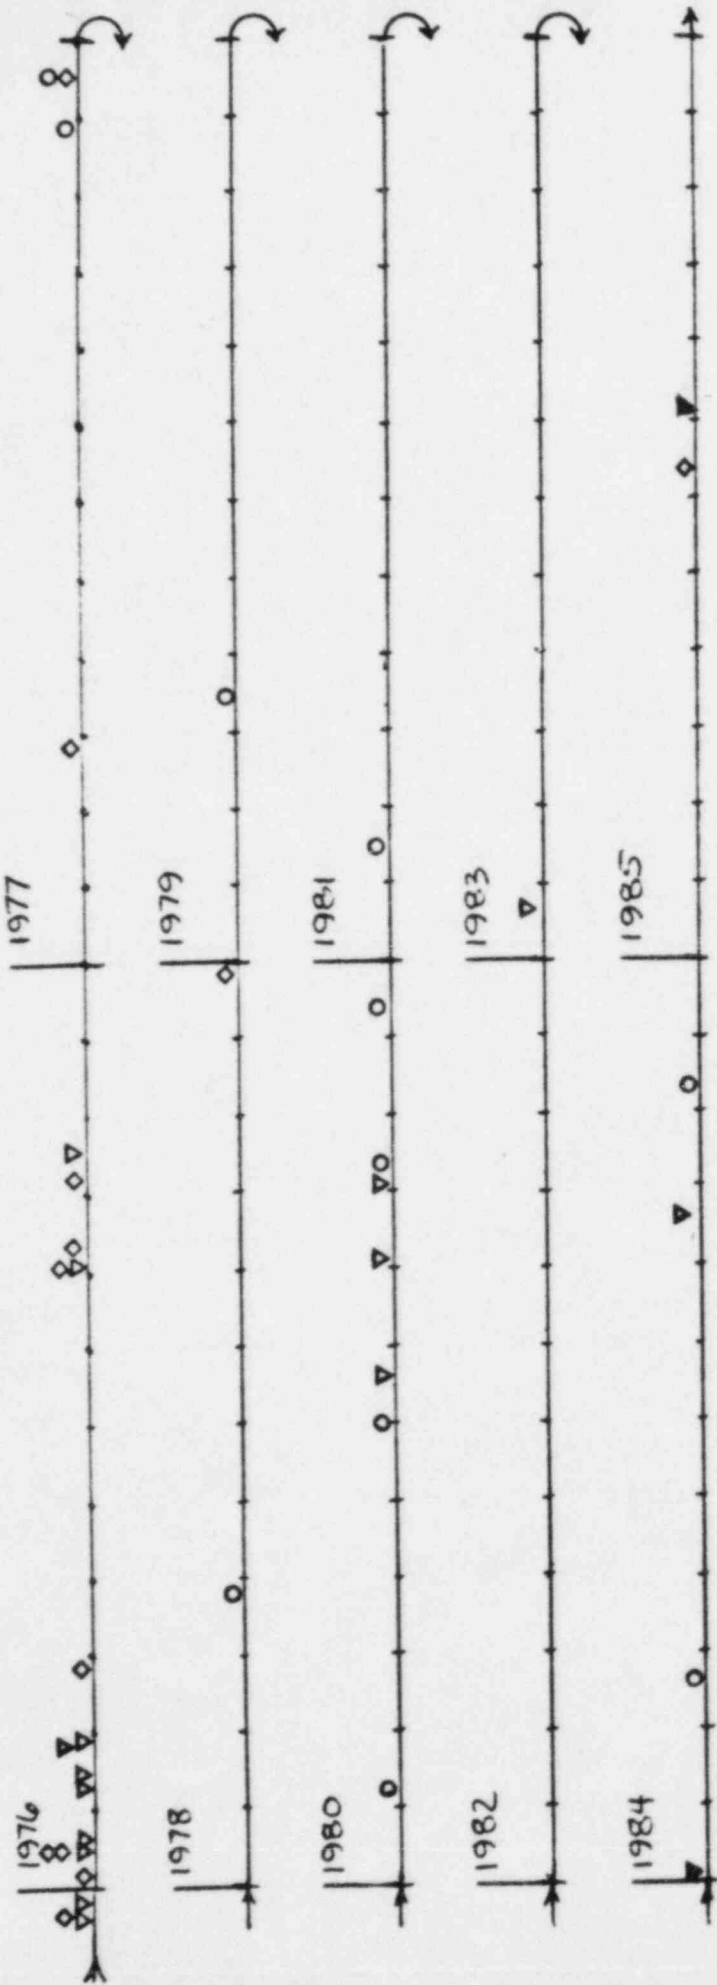
The attached failure history time line shows that since plant startup in 1975 there have been 29 events where the auxiliary feedwater pumps failed to either start or run, out of approximately 356 system demands. In addition, there were 11 other reportable deficiencies for the auxiliary feedwater system.

Eighteen of the 29 failures to start or run occurred during 1975-1976, associated with startup and initial design deficiencies. Three failures occurred in 1980 following an extensive outage which added TMI modifications to the plant. Of the 5 failure events since 1980, 2 are attributable to TMI modifications added to the auxiliary feedwater system without receiving adequate testing prior to placement into service.

FAILURE HISTORY TIME LINE

▼ Fail to START events	17
○ Fail to RUN events	12
◉ Associated events	11
TOTAL	40

ATTEMPTS TO START
APP. 356
