TOLEDO EDISON COMPANY
DAVIS-BESSE NUCLEAR POWER STATION
COURSE OF ACTION REPORT

SEPTEMBER 9, 1985

September 9, 1985

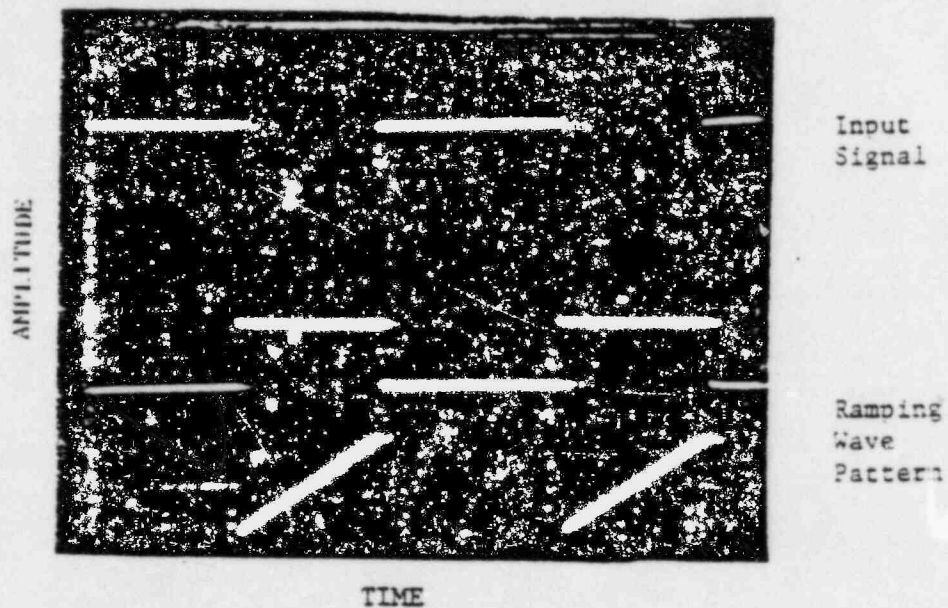
Ramping wave pattern of the F/V
converter with the charge dispensing
capacitor functioning properly.

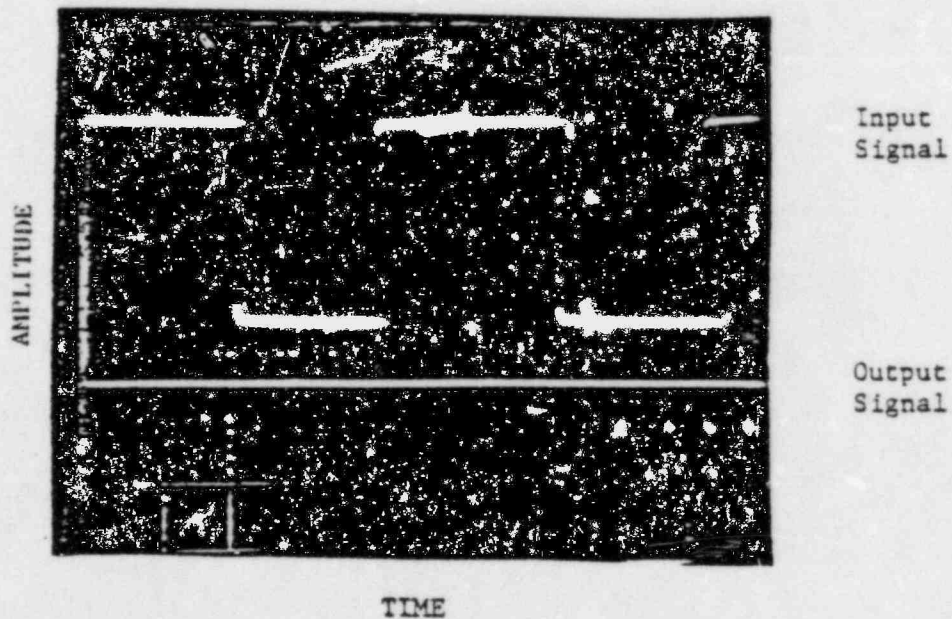
Constant voltage signal on the
output of the failed open charge
dispensing capacitor.

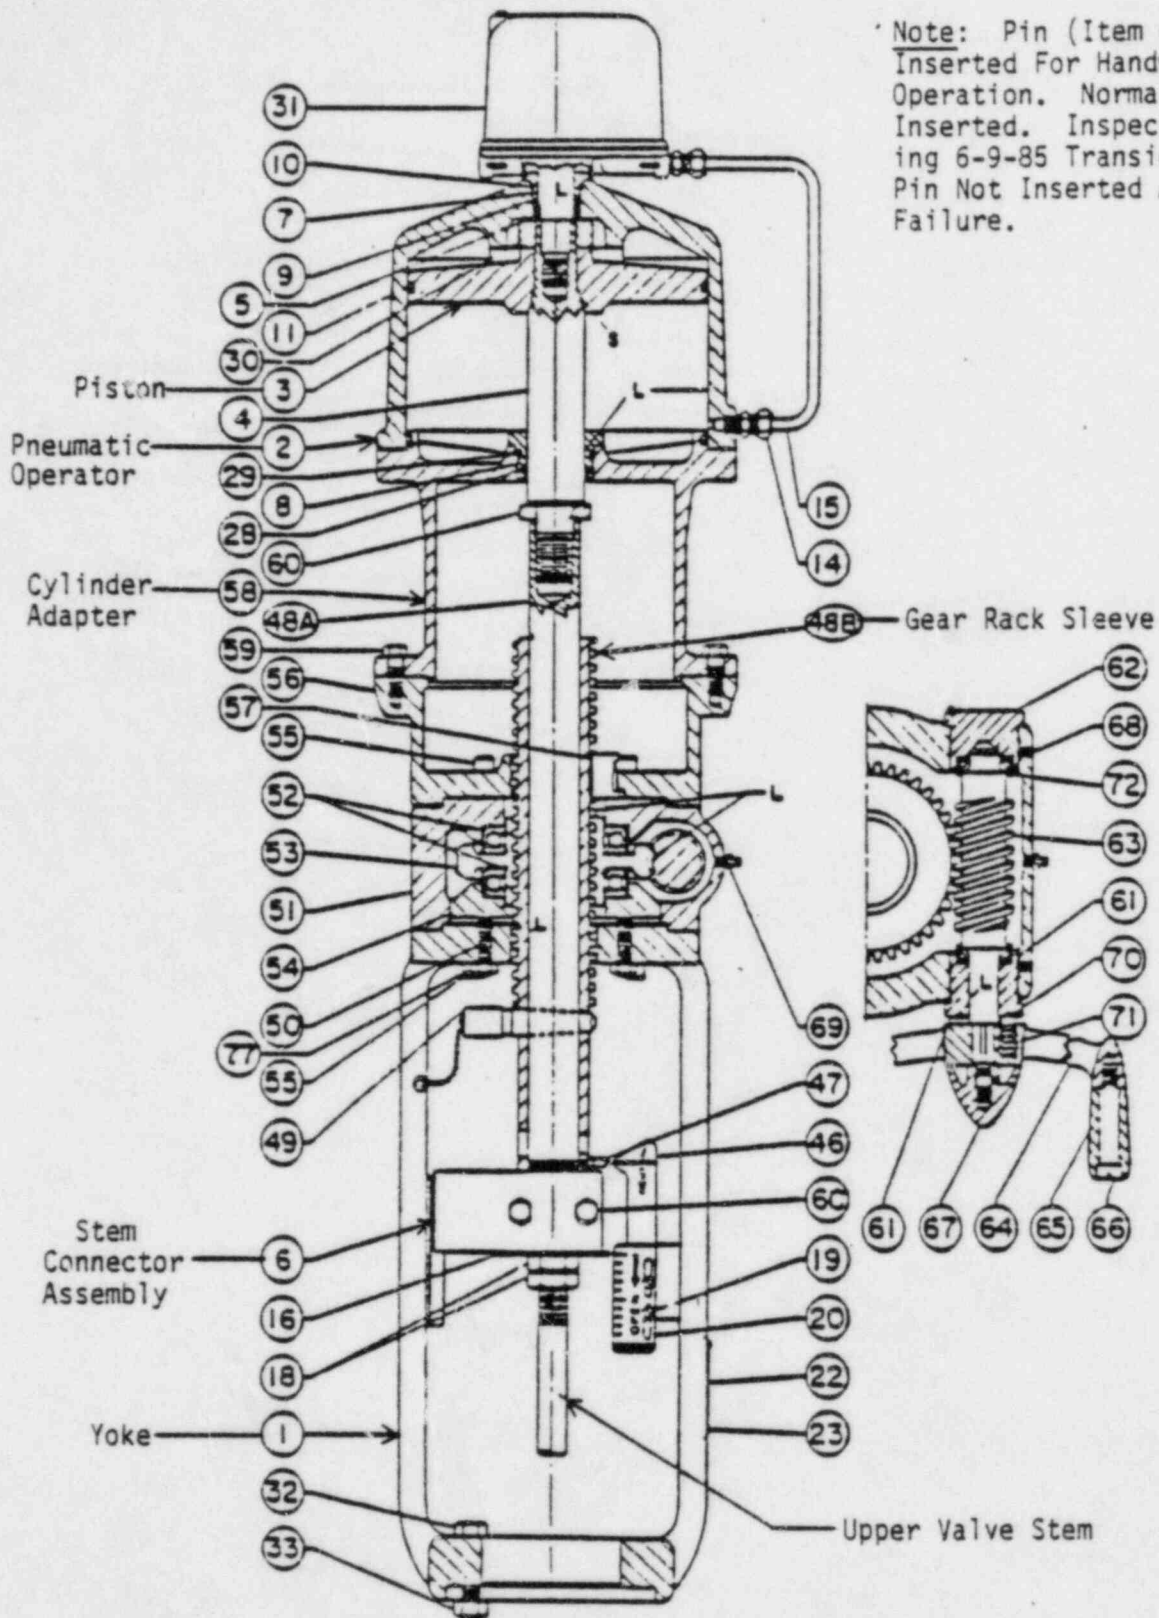
FIGURE 6
DAVIS-BESSE TURBINE BYPASS VALVE ACTUATOR

Also, the valve positioner wire had broken loose from the stem connector assembly (Part 6 - Figure 6).

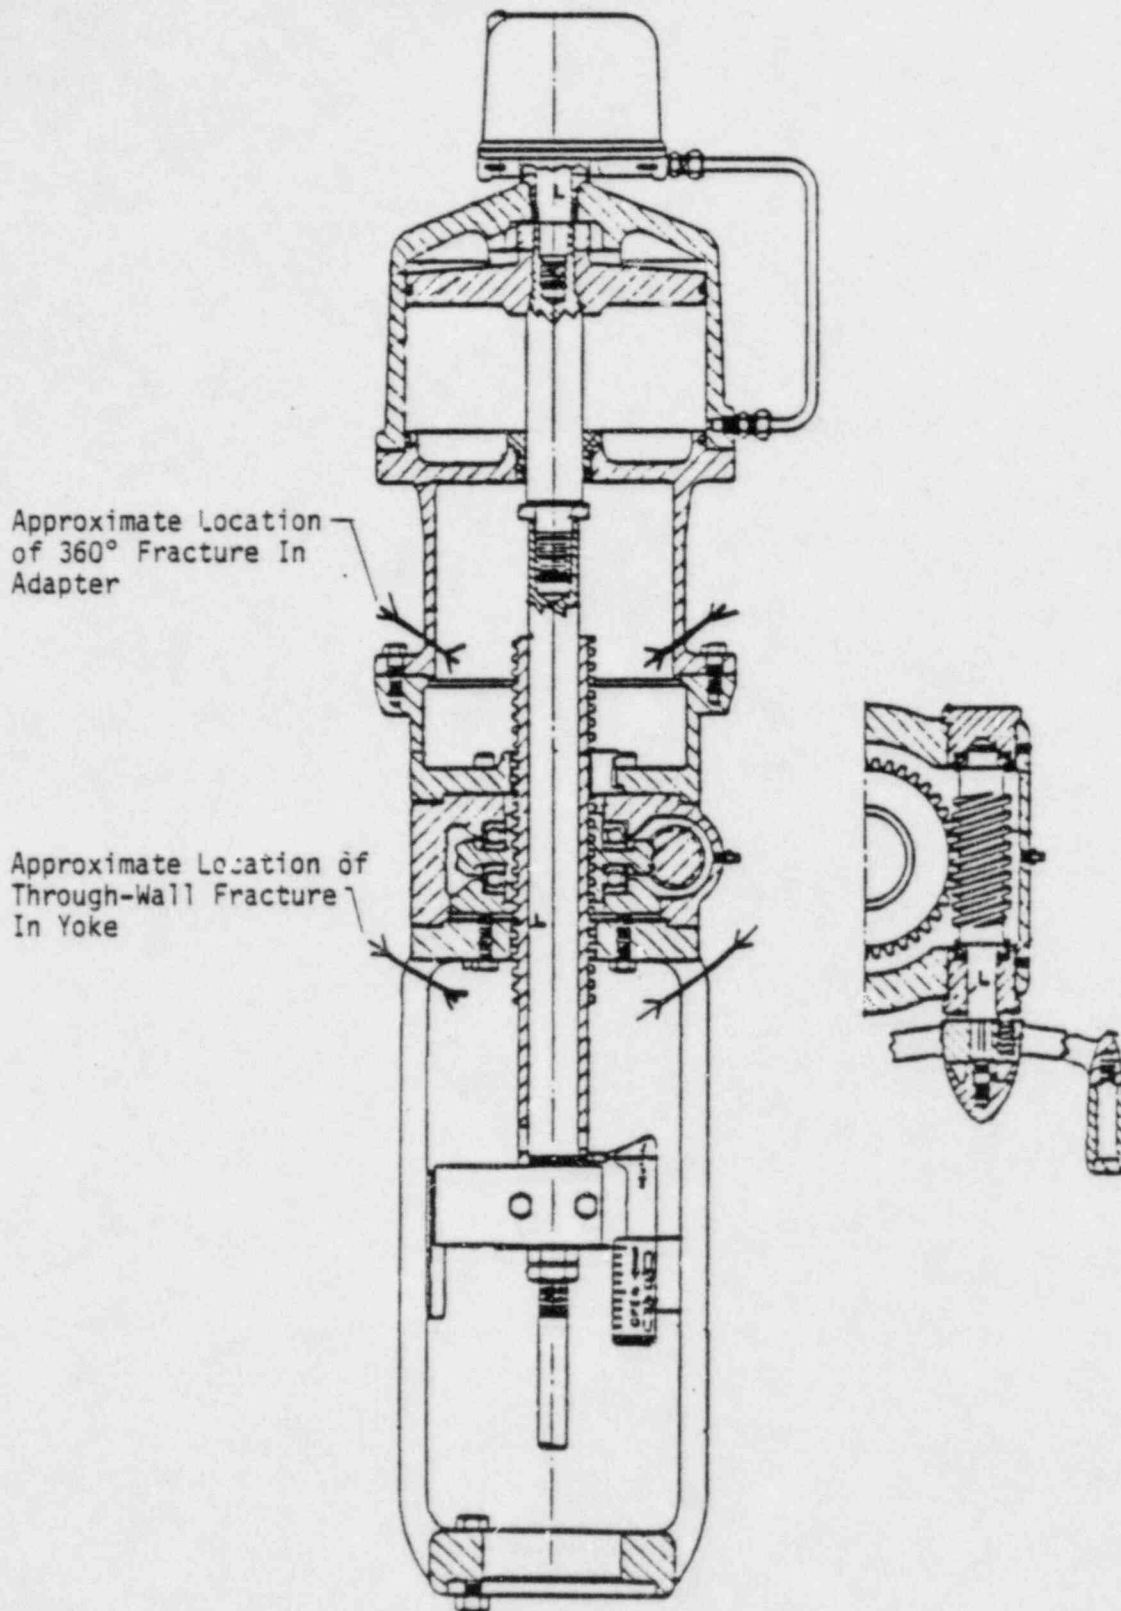
FIGURE 11

Initial visual examinations (Reference 2) found that the SP13A2 turbine bypass valve actuator had failed in two places (see Figure 11):

DAVIS-BESSE TURBINE BYPASS VALVE
ACTUATOR FRACTURE LOCATIONS
