Re: **St. Lucie Units 1 and 2**  
**Docket Nos. 50-335 and 50-389**  
**Special Report on Reactor Coolant Pump Anti-Reverse Rotation Device**

**SPECIAL REPORT FOR ST. LUCIE UNITS 1 and 2**  
**REACTOR COOLANT PUMP ANTI-REVERSE ROTATION DEVICE**

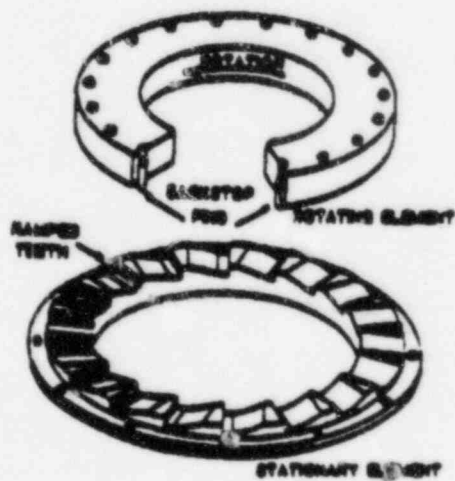
FIGURE 1

On August 31, 1985, St. Lucie Unit 2 was shut down and in Mode 5 for repairs to its 2A2 Reactor Coolant Pump (RCP). During the repairs it was discovered that a significant number of the Anti-Reverse Rotation Device (ARRD) pins were stuck inside their cavities in the rotating disk. (see figure - 1). An inspection of the other RCP motors revealed that two RCP's, 2A1 and 2B1, also had a significant number of stuck pins. The 2B2 RCP did not have any stuck pins.

During the startup and coastdown of the motor, the molybdenum-disulfide tip absorbs the impacts between the pin and the ramps. All of the damaged ARRD pins had significant damage to, or no molybdenum-disulfide tips left. This allowed metal-to-metal contact between the ARRD pins and the ramps causing the ARRD pins to "mushroom" out. Continued impacting of the ARRD pins caused sufficient deformation such that the pins stuck in their holes.

It was decided to replace all ARRD pins during the outage. By September 4, all ARRD pins were replaced. On September 6, the repairs to the 2A2 RCP were complete and a reactor startup was commenced. Unit 2 was back on line on September 7.
