CONTROL ROOM DESIGN REVIEW

Human Engineering Discrepancies

BEAVER VALLEY POWER STATION UNIT 2

HUMAN ENGINEERING DISCREPANCIES

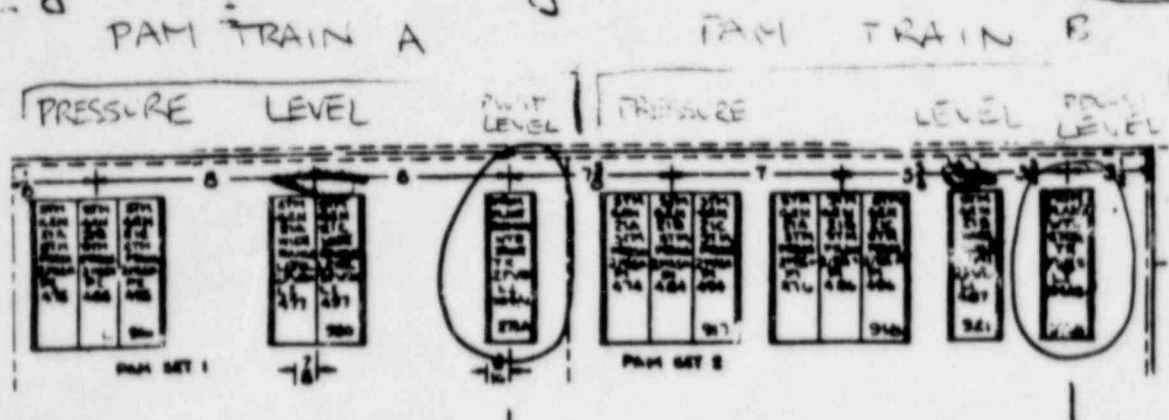
F. Existing PDWST arrangement

Hierarchical labeling should act as a location aid to reduce operator search time.

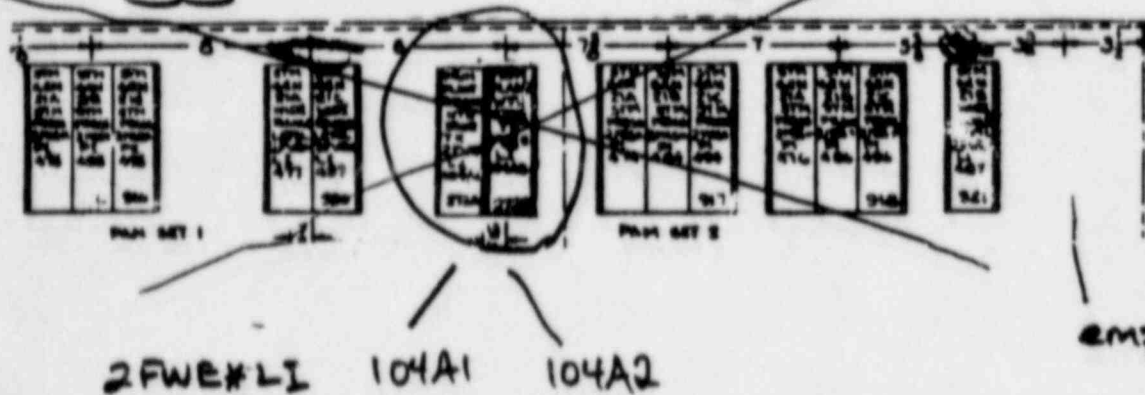
Suggested arrangement

Indicators are separated to satisfy separation criteria (grouped by train). Some type of surface enhancement (e.g. labeling, color-coding) will assist operator. Indicators are separated by PAM Sets, the PAM Sets (2) will be demarcated in some way to further assist operator.

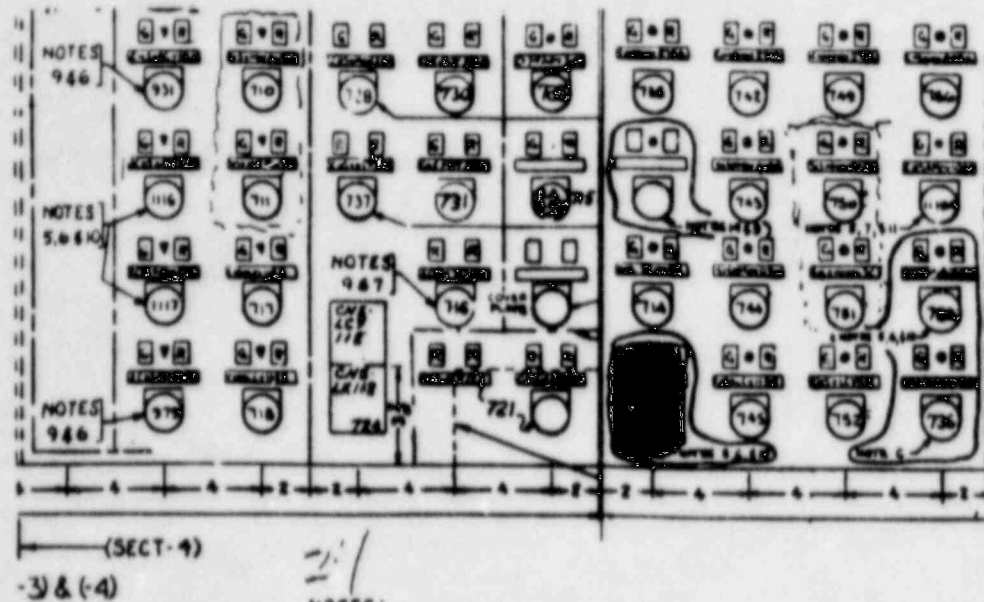
CR No. 81

- ✓ Non symmetrical arrangement
- ✓ B/D on left A/C on right

Suggestion: At a minimum, place
 #s 750 + 751 in locations which
 correspond by row to #s 710 + 711.

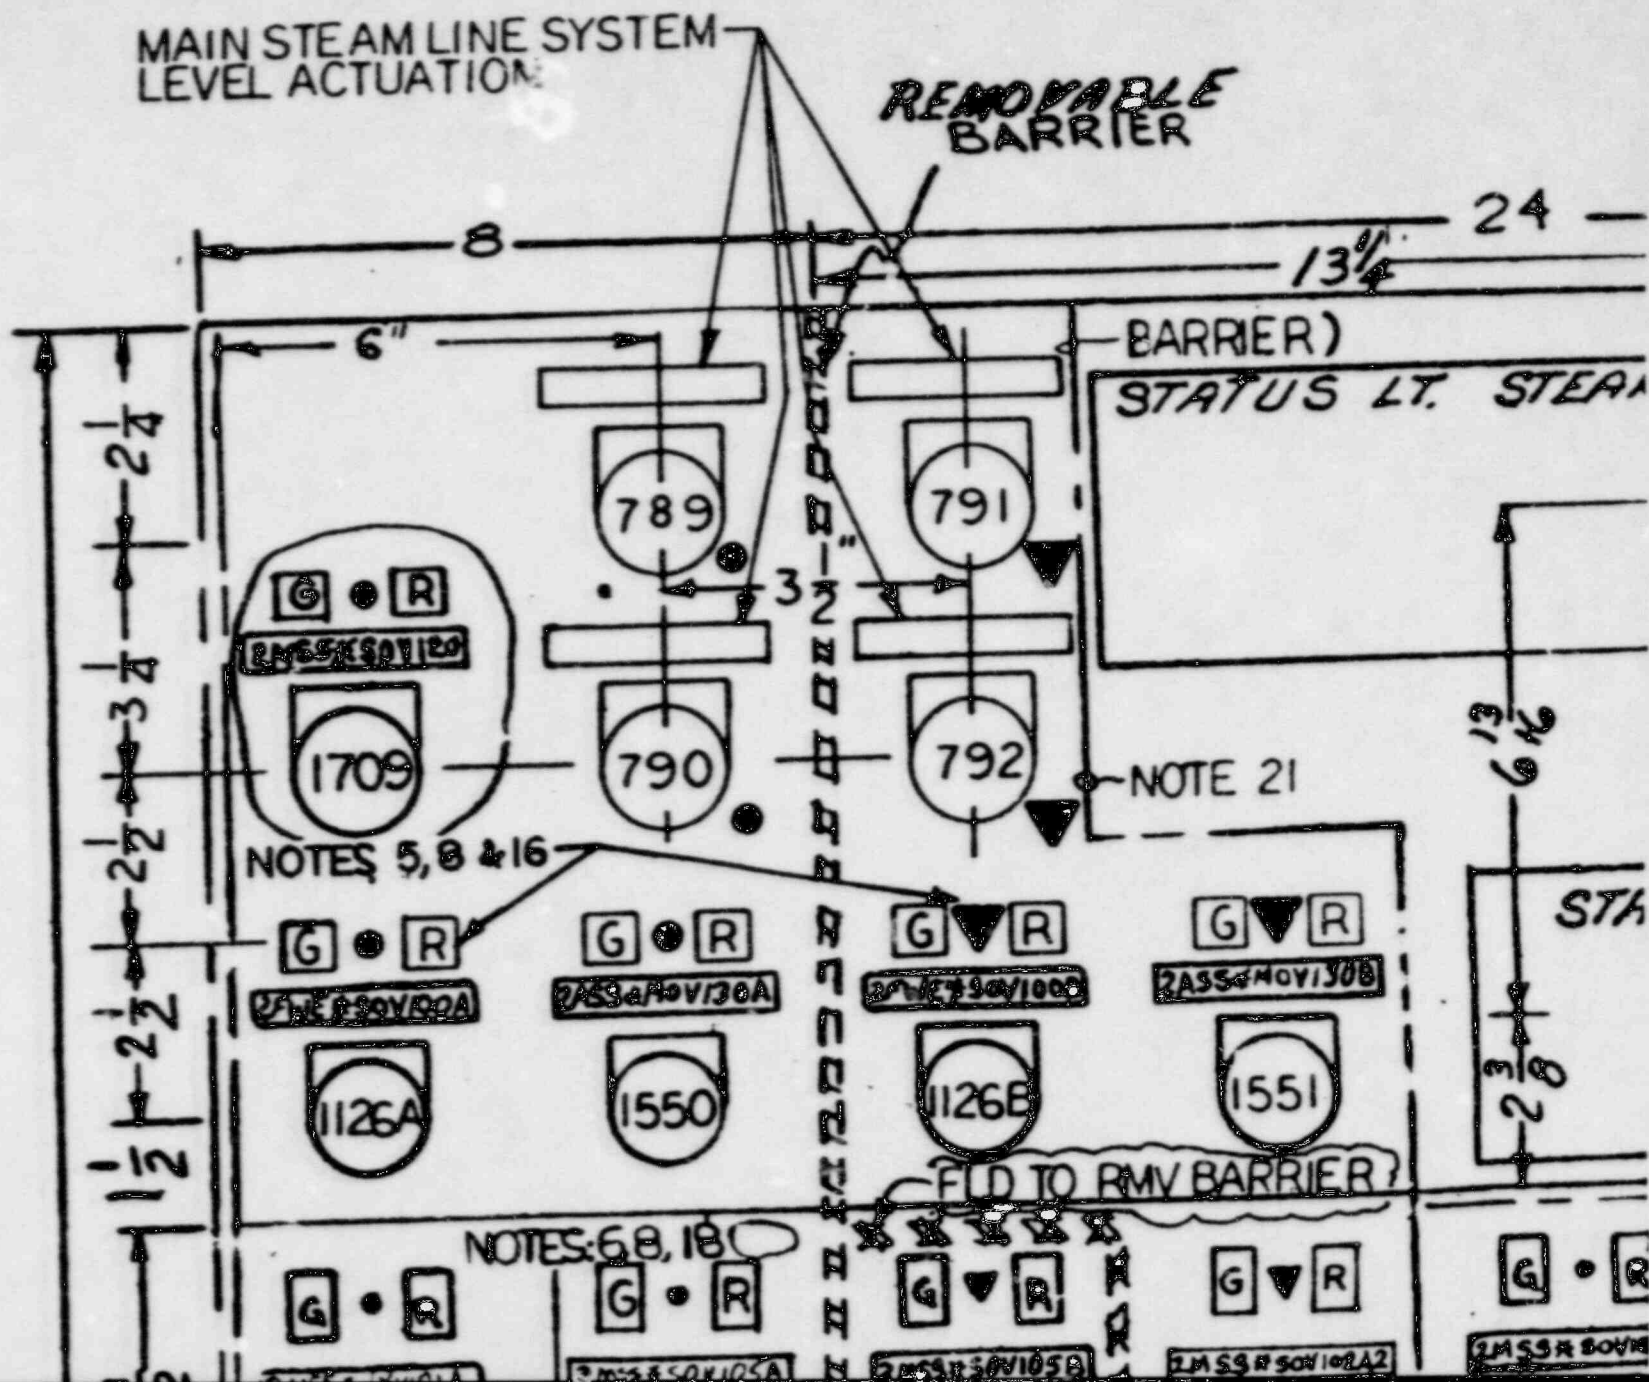
EXISTING ARRANGEMENT OF CONTROLS 789, 790, 791 AND 792
(PART OF HEDRWG. 12241-RE-25V-6)

THE STATEMENT IN THE "REVIEW AND DISPOSITION" SECTION OF THE HED IS ~~THE~~ VAGUE BUT IMPLIES THE EXISTING NAMEPLATE WORDING IS INCORRECT OR INADEQUATE. THE WORDING LISTED ABOVE, HOWEVER, IS CORRECT AND APPEARS CLEAR. THEREFORE, NO CHANGE IN THE NAMEPLATE WORDING IS RECOMMENDED.

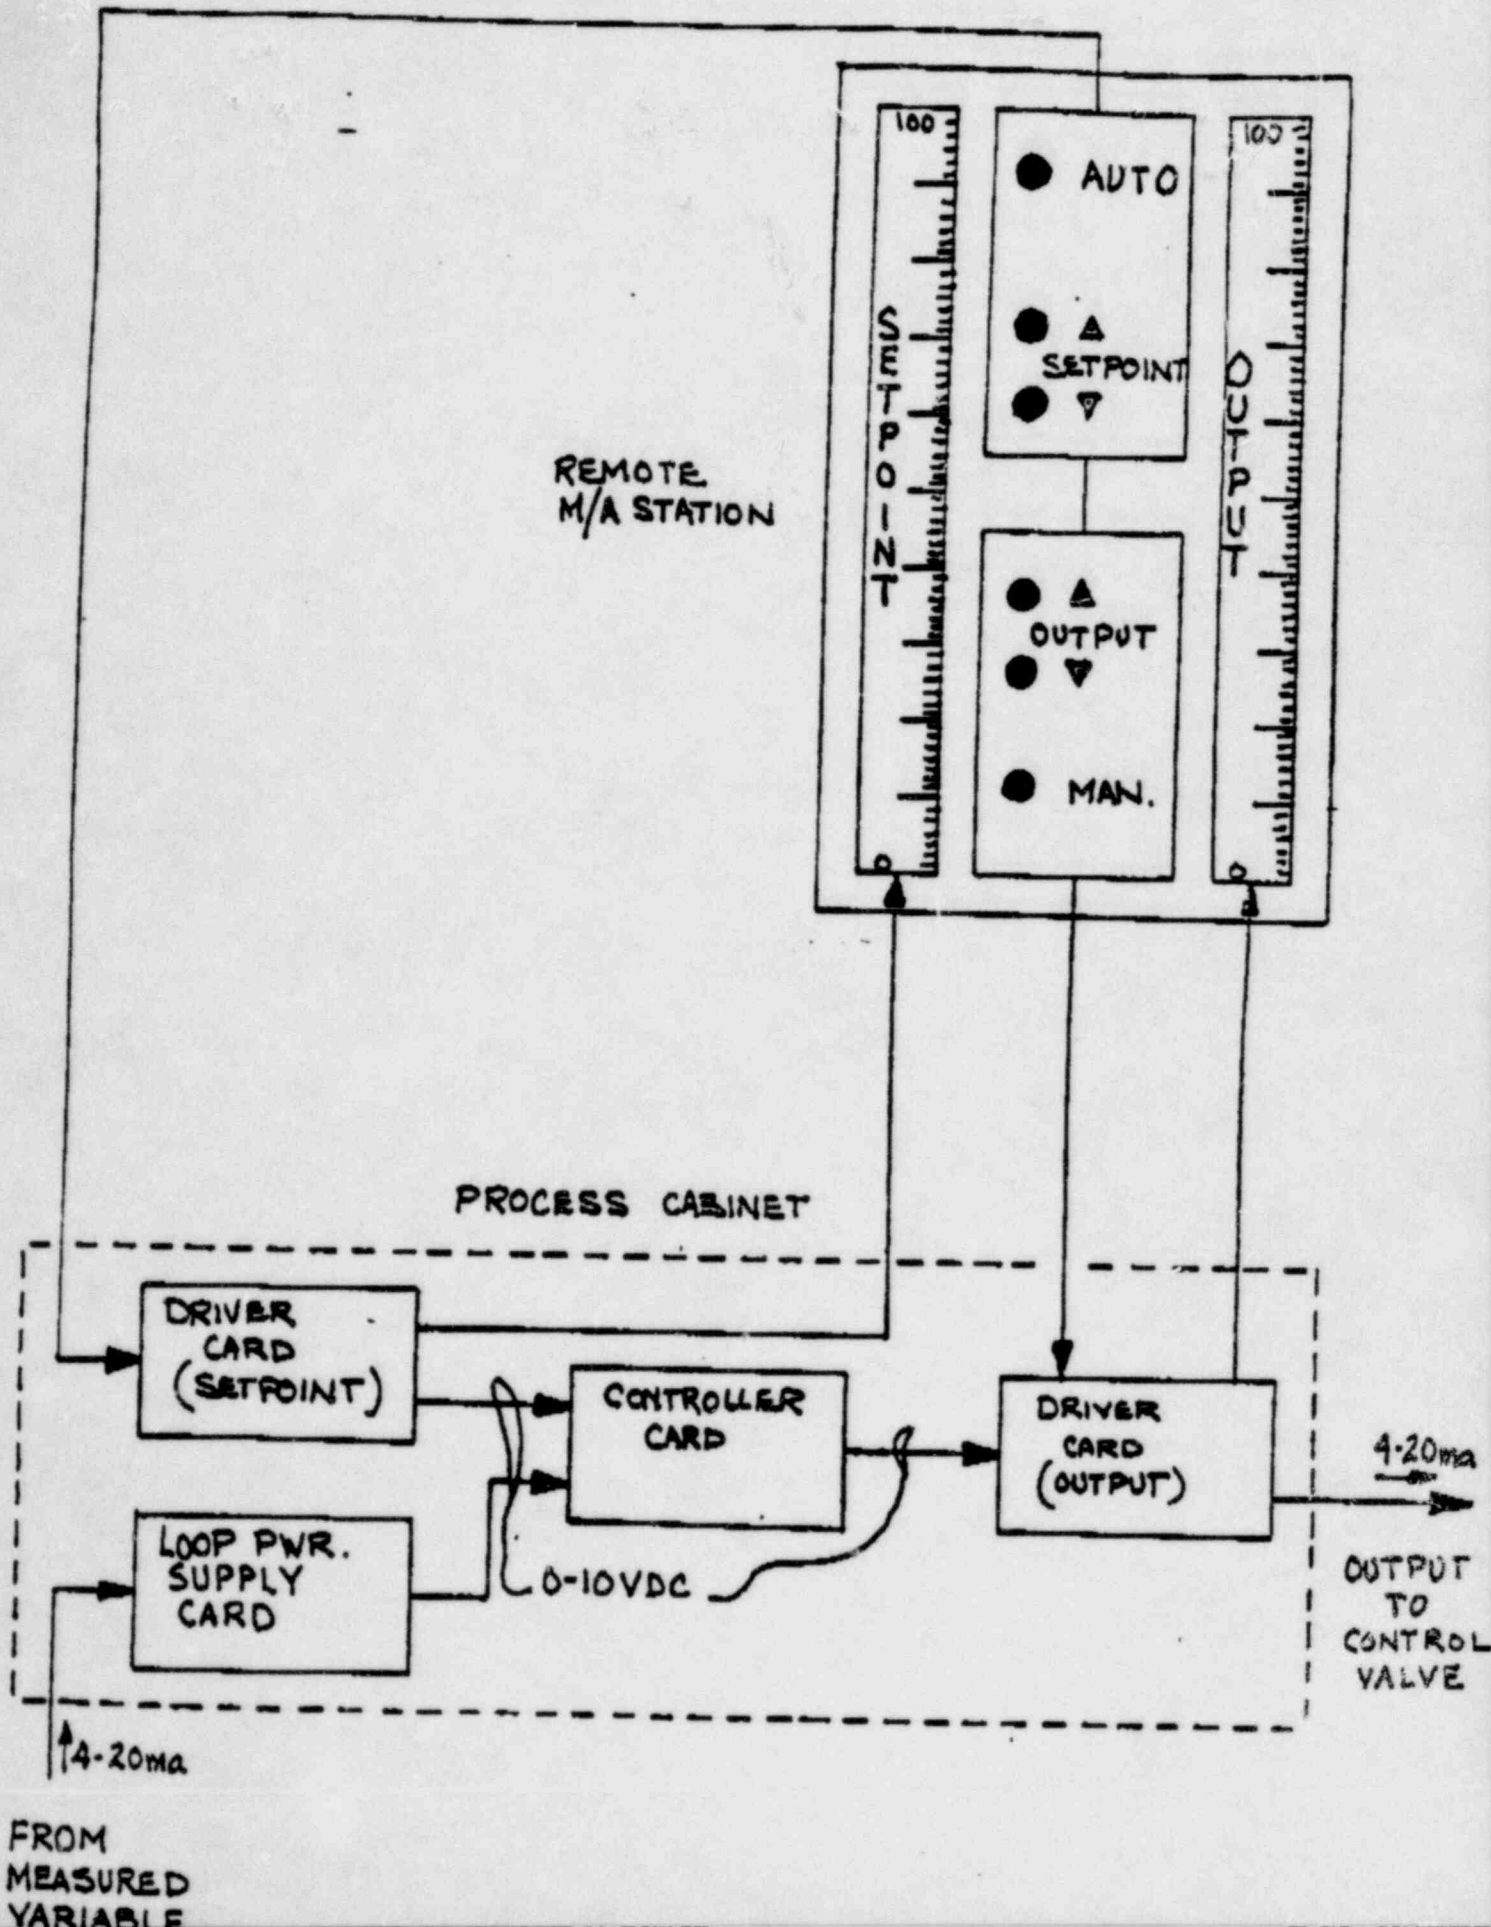
The review team continues to recommend that the controllers be exchanged for controllers that allow the operator to dial in a pressure set point. In addition to present controllers not providing auto pressure control, the controllers are located on Benchhead Section A2/A3 and pressure indicators are on Vertical section C6.

RT review: Stone + Webster is review further. They believe controllers can be set for a specific pressure value. Recommend that S+W verify way in which controllers work. Also recommend label plates be added which correlate pressure to setpoint setting. If controllers cannot be set to maintain a specific pressure value, above recommendation for exchanging controller should be considered.

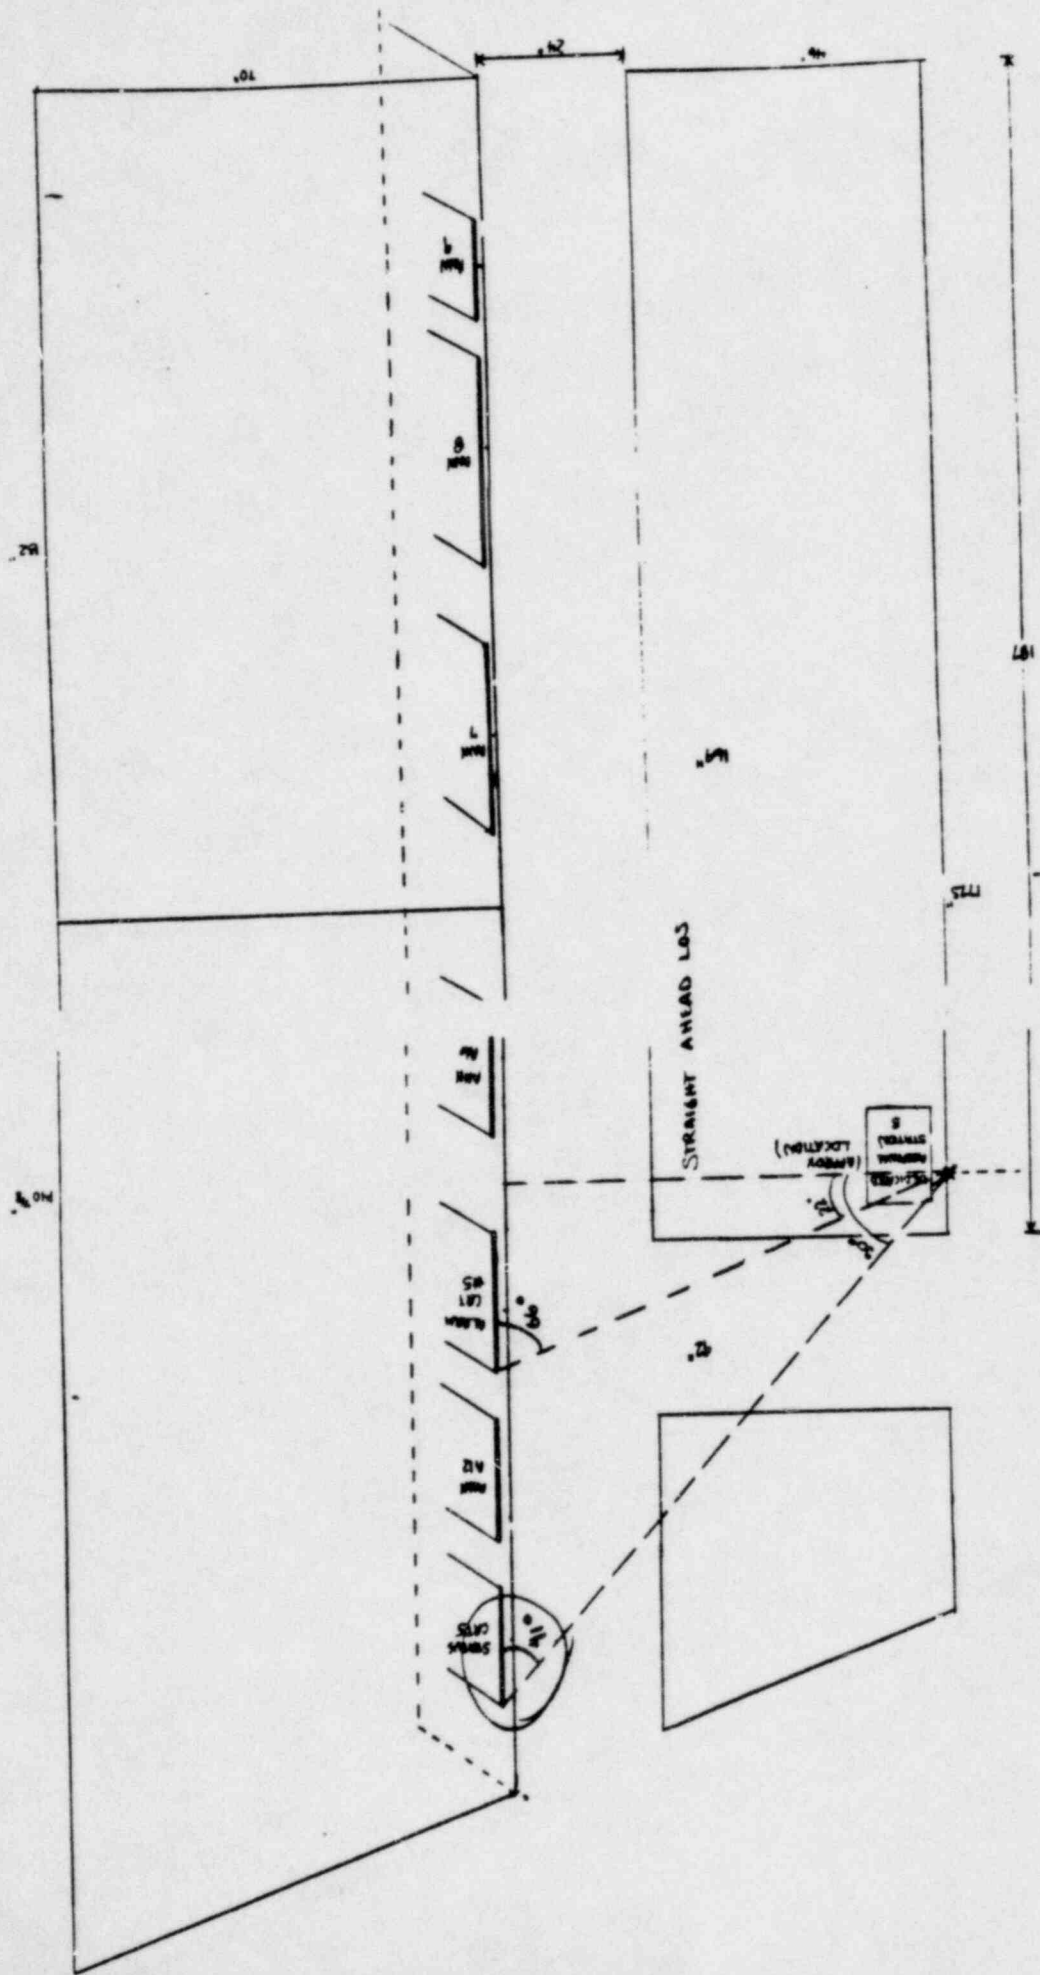
OVERHEAD VIEW
SECTION C

CIT DISPLAYS, HORIZONTAL LIMITS
