NEDC-31115
CLASS II
NOVEMBER 1985

**EVALUATION OF THE LOW CARBON
TYPE 316 STAINLESS STEEL
RECIRCULATION OUTLET SAFE ENDS AT
PEACH BOTTOM UNIT 3**

T. L. Chapman
J. P. Clark
D. E. Delwiche
R. M. Horn

NUCLEAR ENERGY BUSINESS OPERATIONS • GENERAL ELECTRIC COMPANY
SAN JOSE, CALIFORNIA 95125

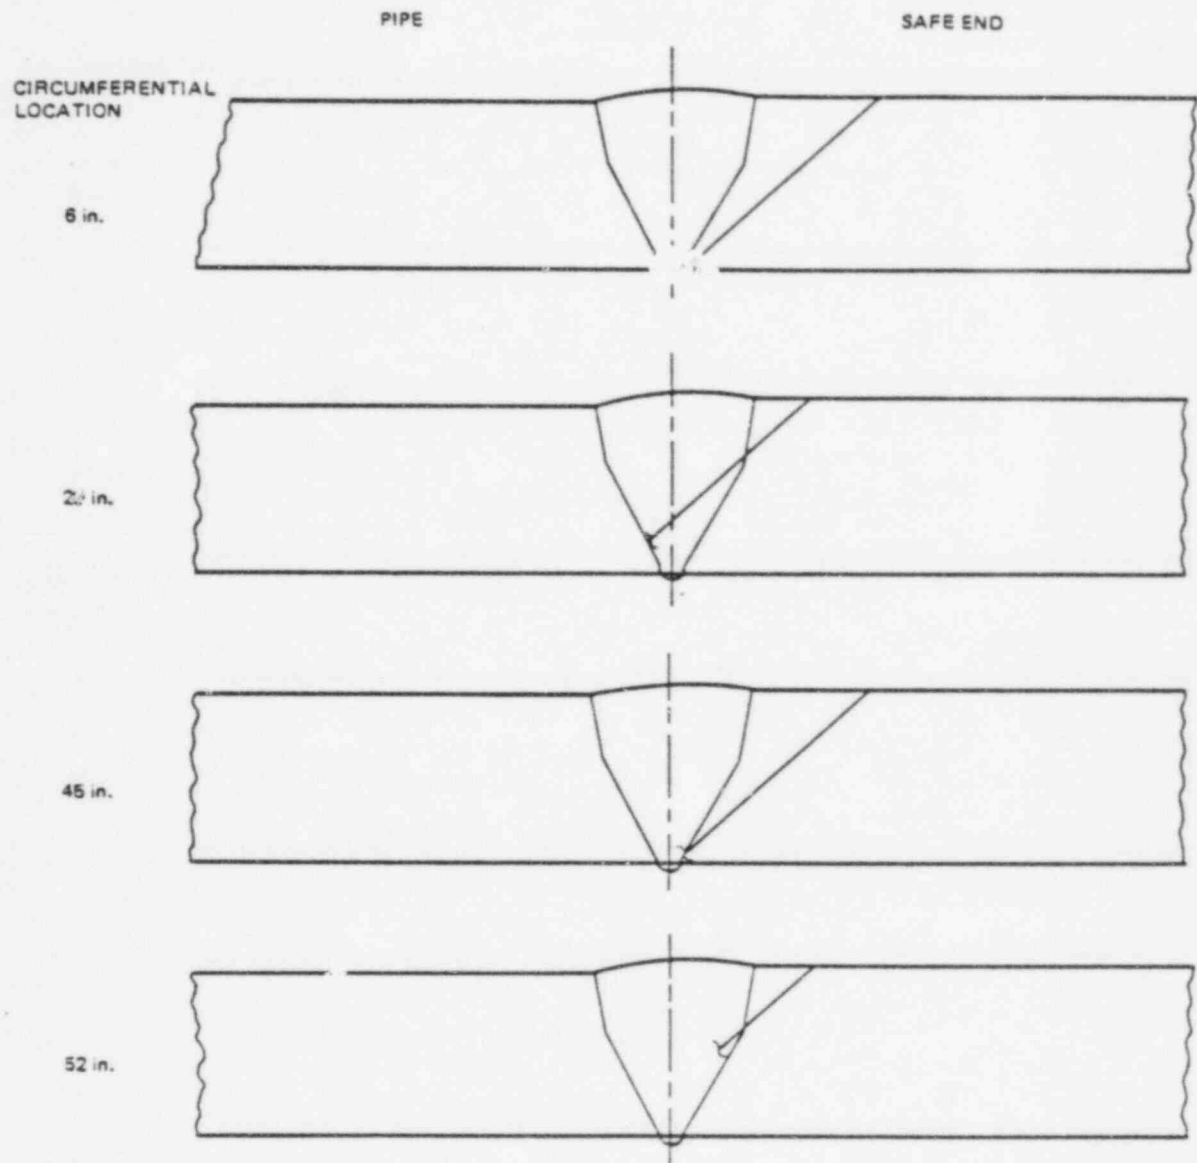
Figure 3-3. Schematic of Weld 2-BS-2 UT Plots Showing Indication Metal Path from Safe End Side at Different Circumferential Locations

Figure 3-3 shows cross-sectional plots of representative UT data from the safe end side of weld 2-BS-2. Similar UT examination results were observed for the companion A-Loop weld 2-AS-2. The plotting in Figure 3-3 shows the safe end crack indications to be at or near the fusion line or in the weld metal. Because the actual I.D. weld root centerline and weld cross-section geometry cannot be accurately predicted based on O.D. weld crown location, these indications were evaluated as IGSCC in the 316L heat-affected zone. Figure 3-4 shows cross-sectional plots of the pipe side indications. Note that the indications are typical of piping IGSCC and are located in the pipe heat-affected zone area, except for the indication at the 31 inch location which could be an indication of cracking on the safe end side.

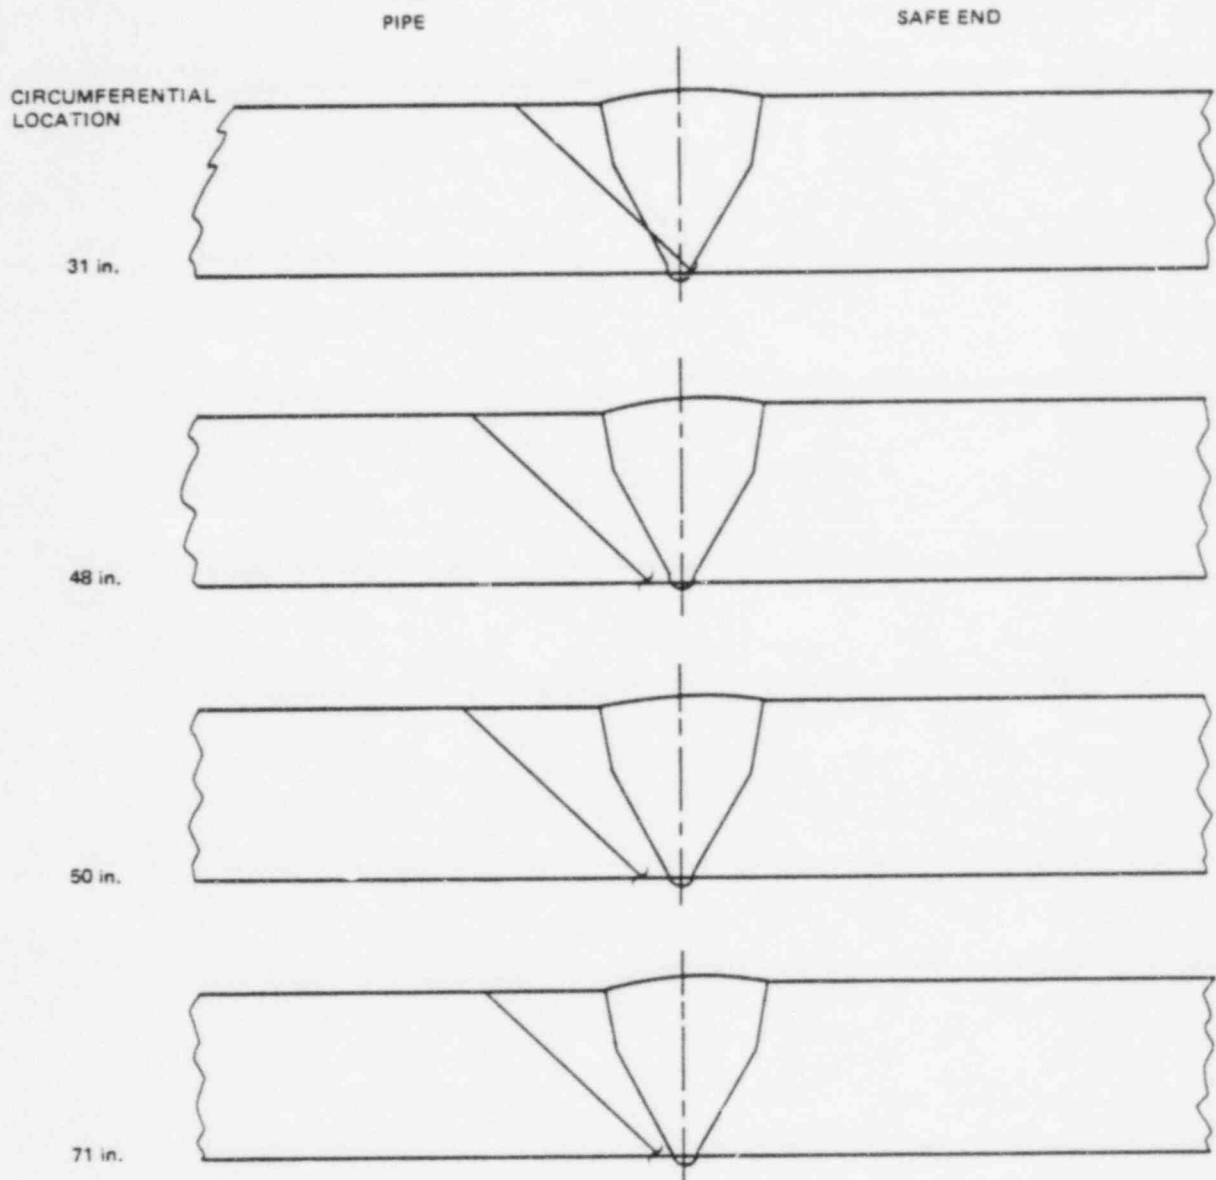
Figure 3-4. Schematic of Weld 2-BS-2 UT Plots Showing Indication Metal Path from Pipe Side at Different Circumferential Locations

The combination of the pipe side and safe end side UT data layouts gave a clear indication of apparent IGSCC on both sides of the joint. As with any field weld, typical weld cross-sections and assumed I.D. root locations can be applied to the layouts, but the data must be interpreted with the appropriate allowance for skewed weld crowns and various as-built cross-sectional geometries. Based on these allowances, and based on prior large pipe experience with IGSCC near the fusion line, the data in Figures 3-3 and 3-4 (and the IGSCC signal characteristics associated with the indications) led to the evaluation of IGSCC.

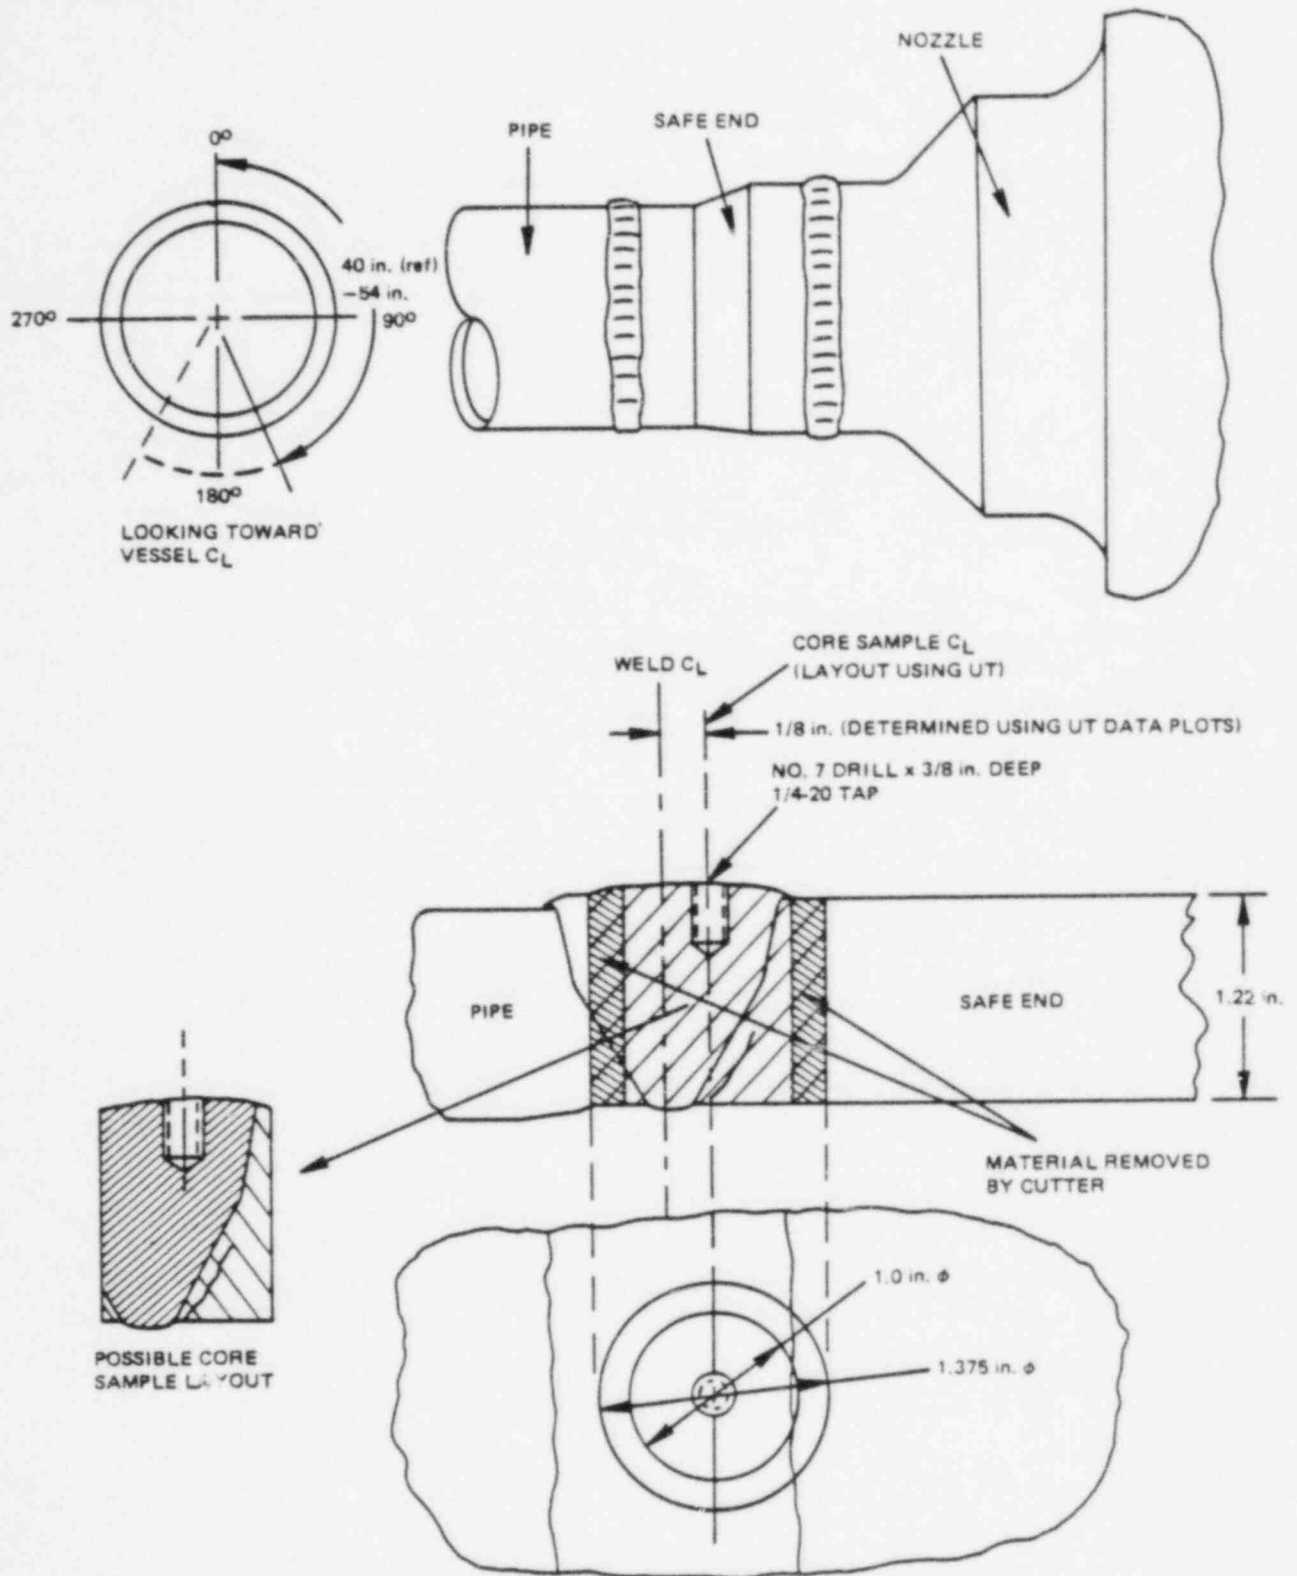
Figure 3-5. Schematic Showing Core Sample Location Plan and Top and Cross-Section Views of Possible Sample

the core sample cutter $1/8$ inch toward the safe end side of the O.D. weld centerline reference point as shown in Figure 3-5. The data plots and sample cross-section layout are shown in Figure 3-7. Note that up to $3/8$ inch of material would be removed on the pipe side of the weld root centerline, and at least $5/8$ inch of material would be removed on the safe end side depending on the actual location of the weld root. This location satisfied the objectives and would include more of the safe end material than the pipe. The actual core sample later verified that the location was selected properly.

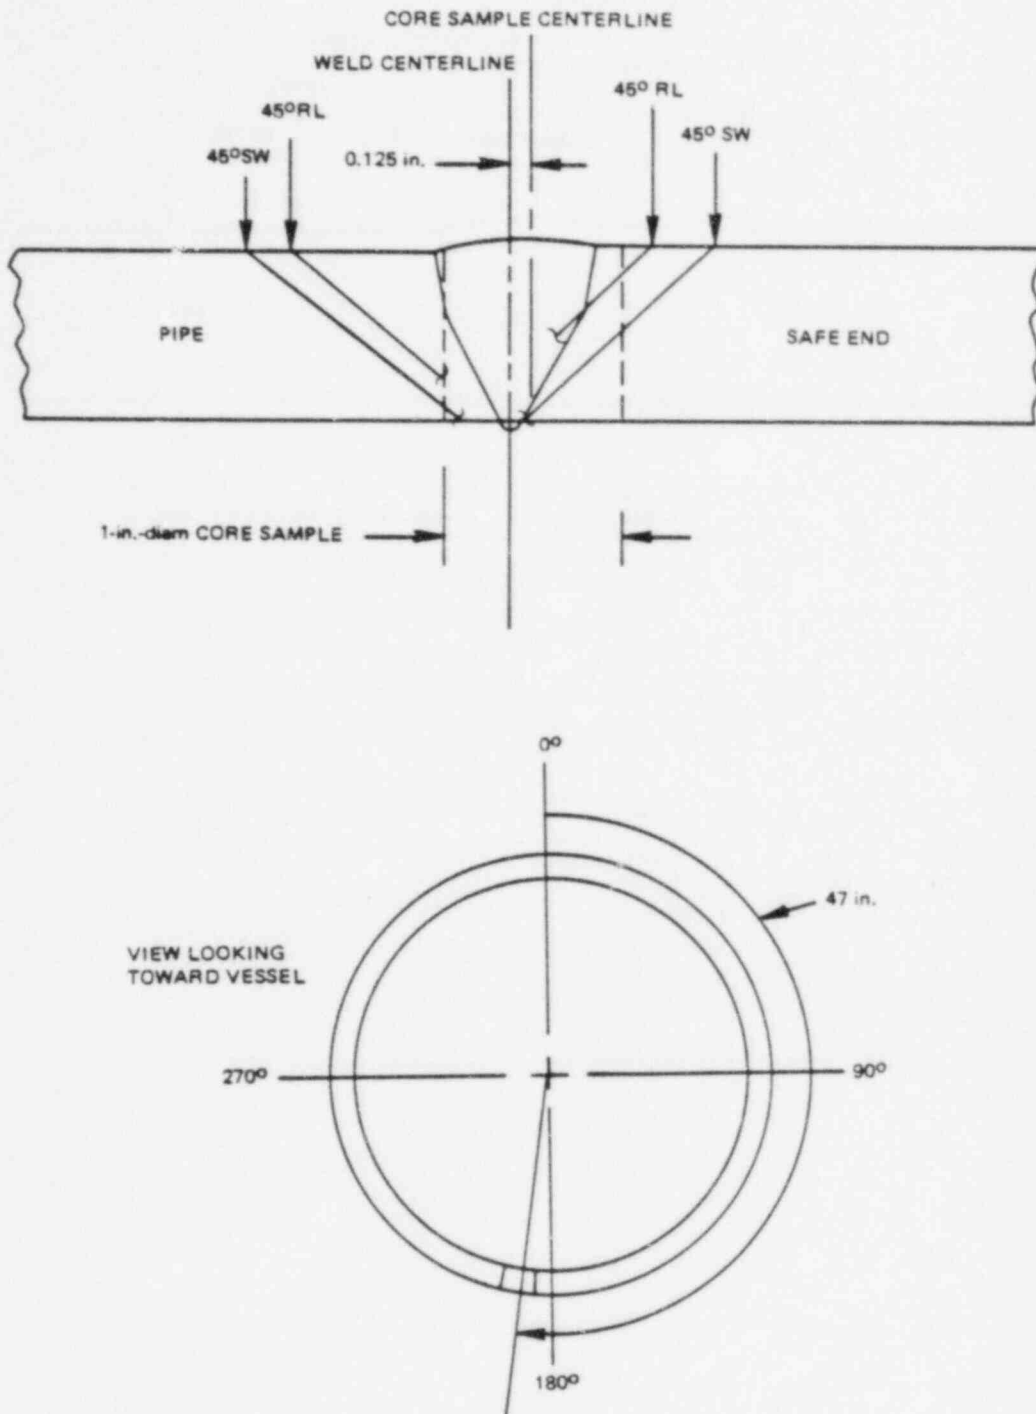
Figure 3-7. Layout of Weld 2-BS-2 Cross Section Displaying UT Plots at Core Sample Location

It should be noted that the O.D. weld centerline was used as a reference point for UT data plotting and sample cutter location; however, it could not be assumed that this point represented the I.D. root weld centerline. The weld crown had been ground nearly flush and there was considerable O.D. mismatch between the pipe and safe end. With these conditions, as with any typical field weld, the I.D. root could actually be located on either side of this apparent O.D. weld centerline. Similarly, the UT cross-section data plots (Figure 3-7) show the crack tip in the weld metal, but a slight shift of weld centerline would place this tip right along the fusion line, typical of large diameter piping IGSCC.

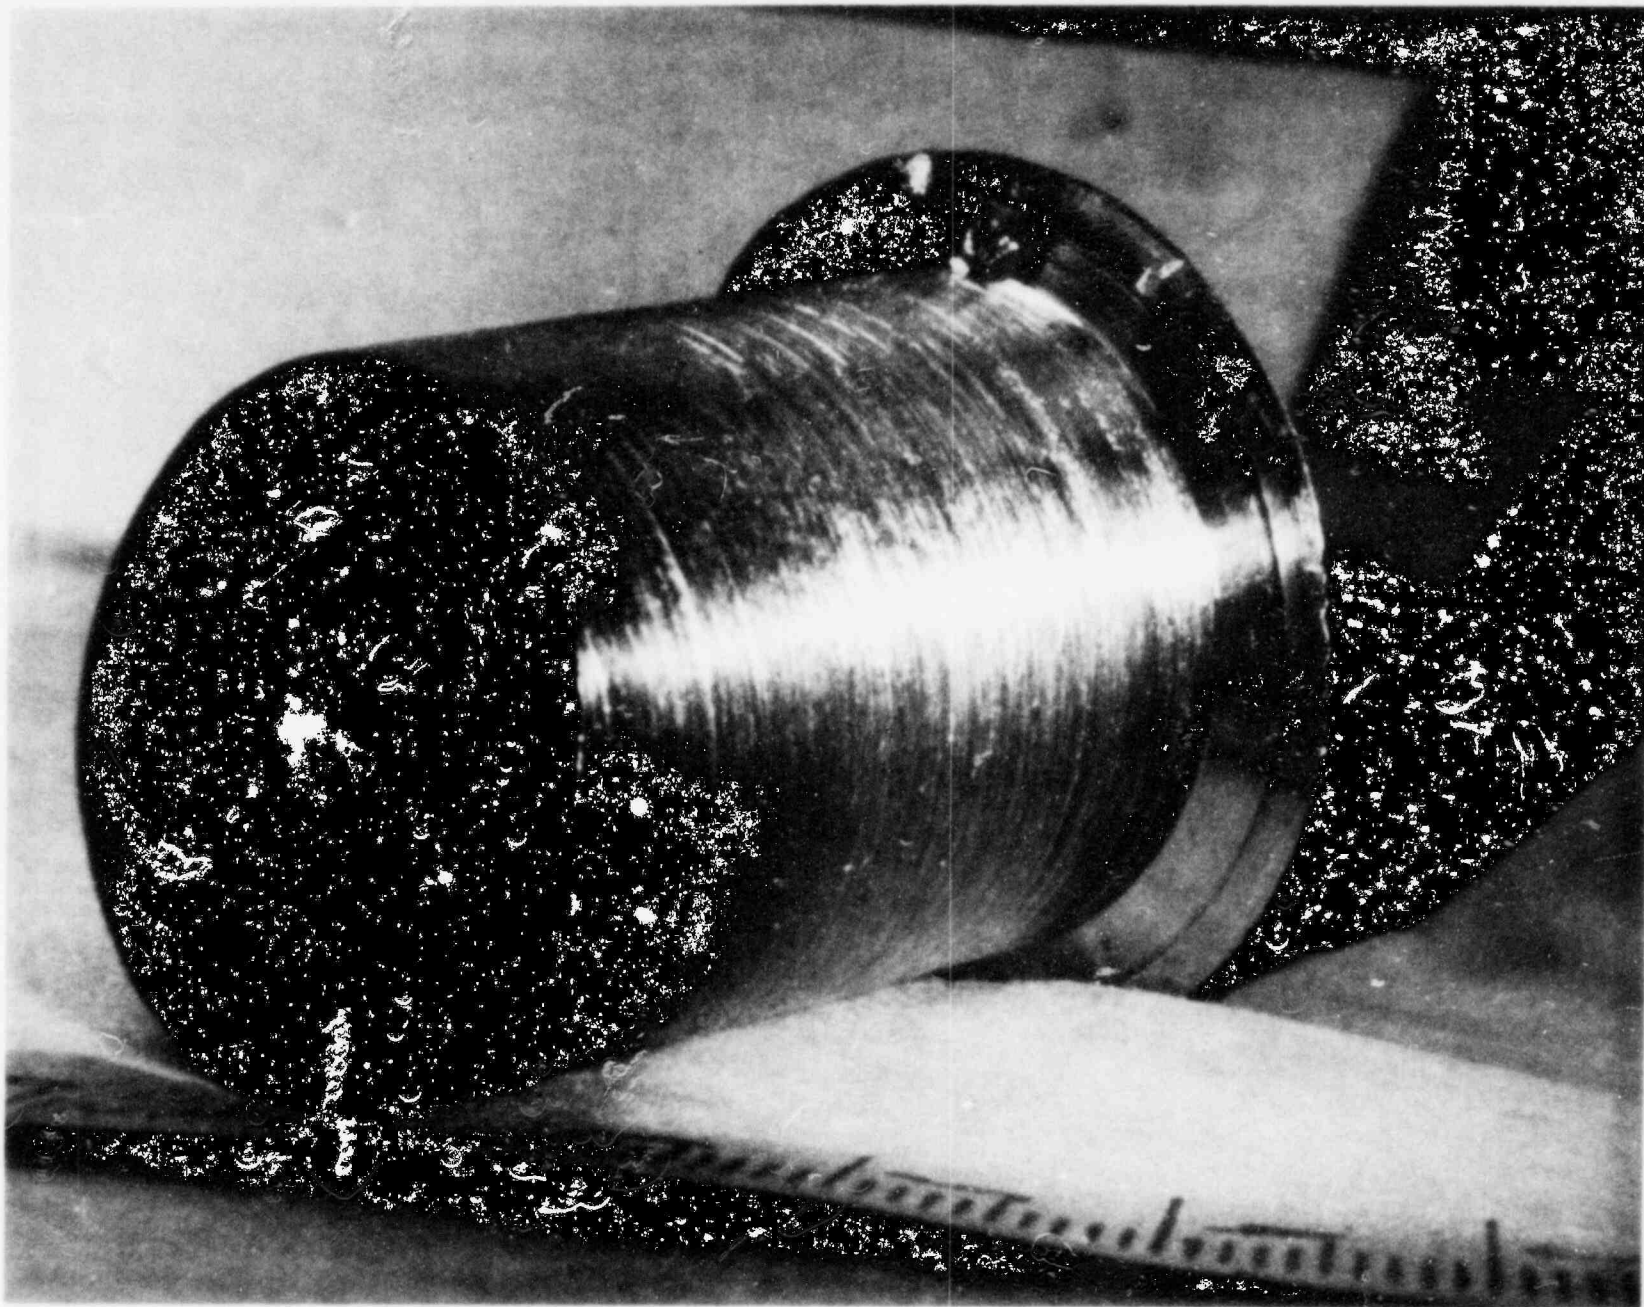
Immediately following removal of the core sample from the safe end it was examined visually (Figure 5-1). Cracking or weld root fusion lines were not evident. Evidence of grinding, however, was present. A ferrite meter (for weld metal ferrite determination) was used to confirm that the core sample was taken at the desired location and the sample contained both safe end and pipe material. The sample was packaged and shipped to Vallecitos Nuclear Center for metallurgical examination.

Figure 5-1. Photograph of Core Sample After Removal

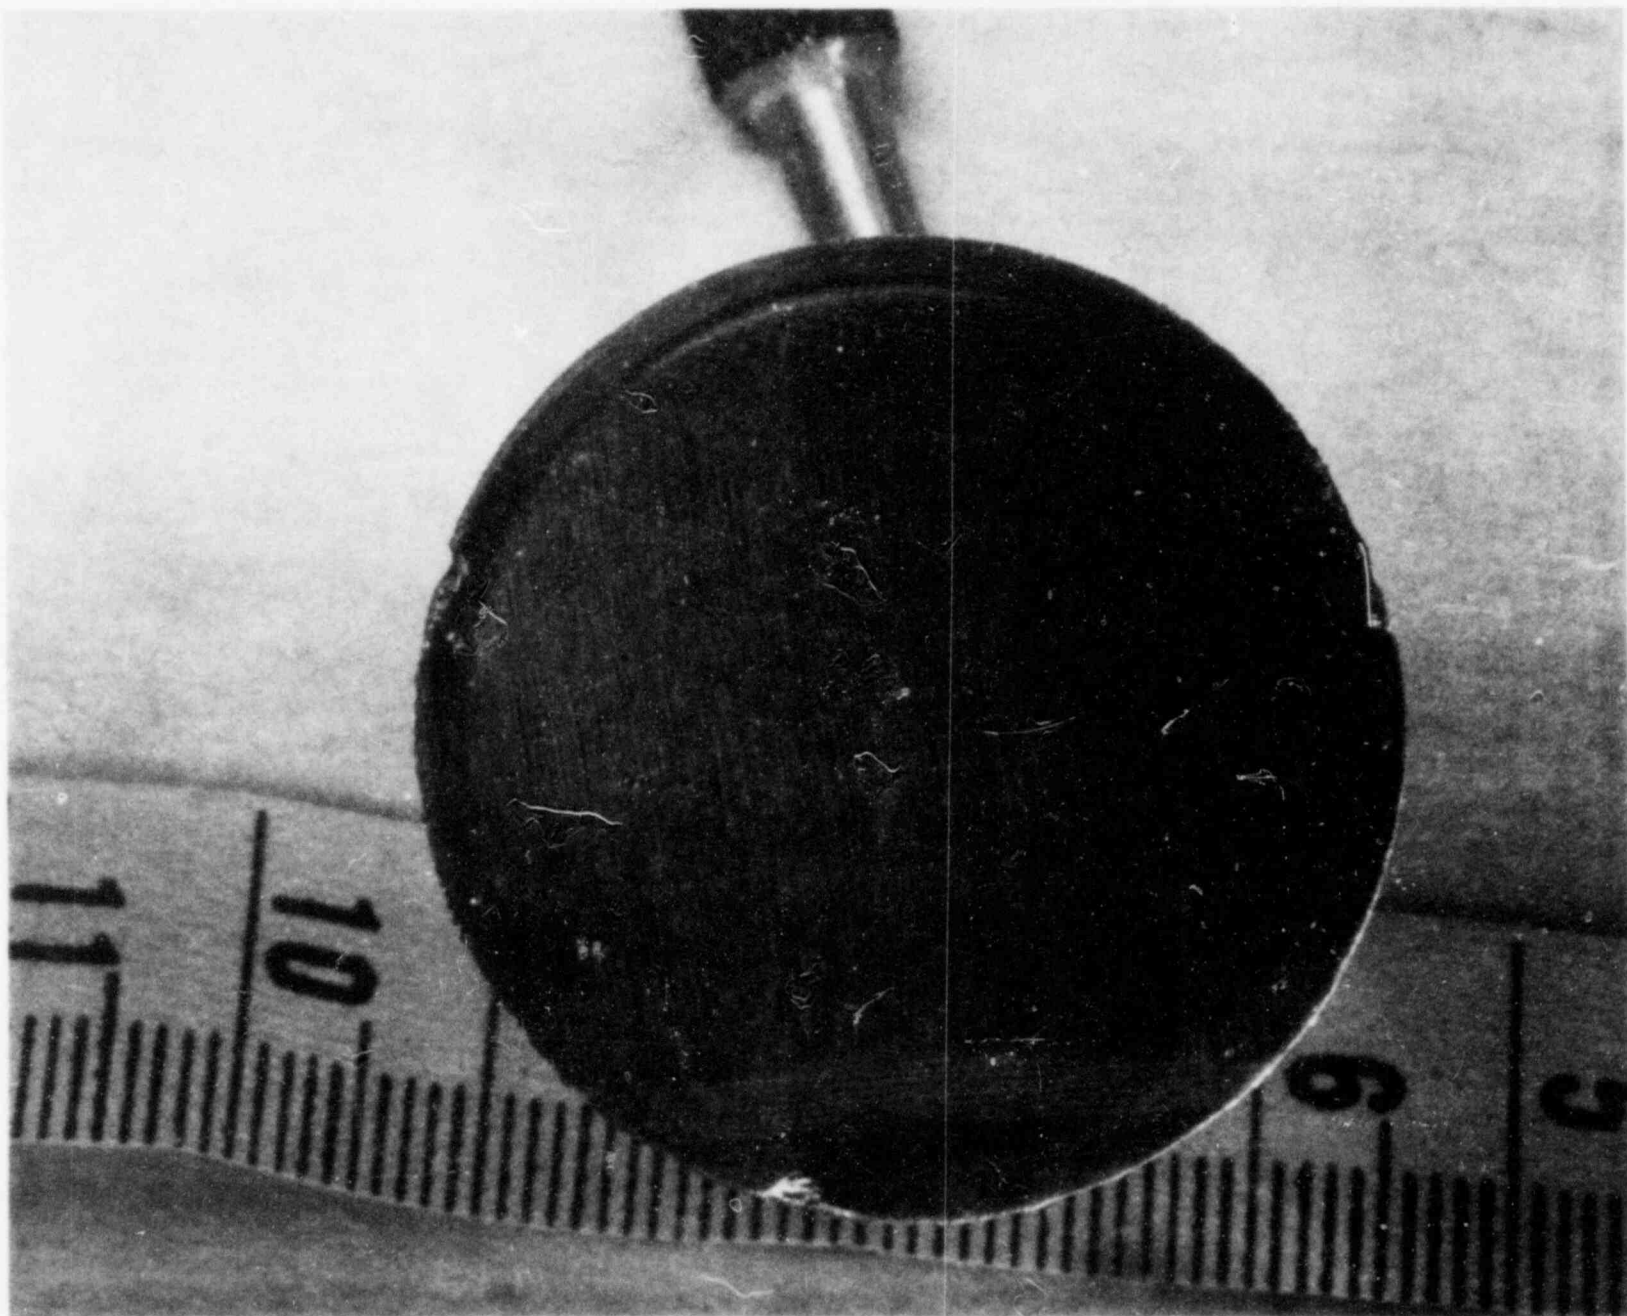
Severe surface cold working, and increased surface hardness levels can be an important causative factor in the initiation and growth of stress corrosion cracking in 316L stainless steels. The macroscopic visual examination of the inner surface of the core sample showed that there had been some weld root grinding at the time of fabrication. The degree of surface working was judged to be normal. There was no sign of aggressive or abusive surface working, as would be evidenced by surface metal smearing and deep, short grind marks or depressions. The surface was found to be smoothly ground with shallow grind marks normal to the fusion line. The weld root was ground flush.

Figure 5-2. Photograph Showing Grinding on the Pipe Inner Surface

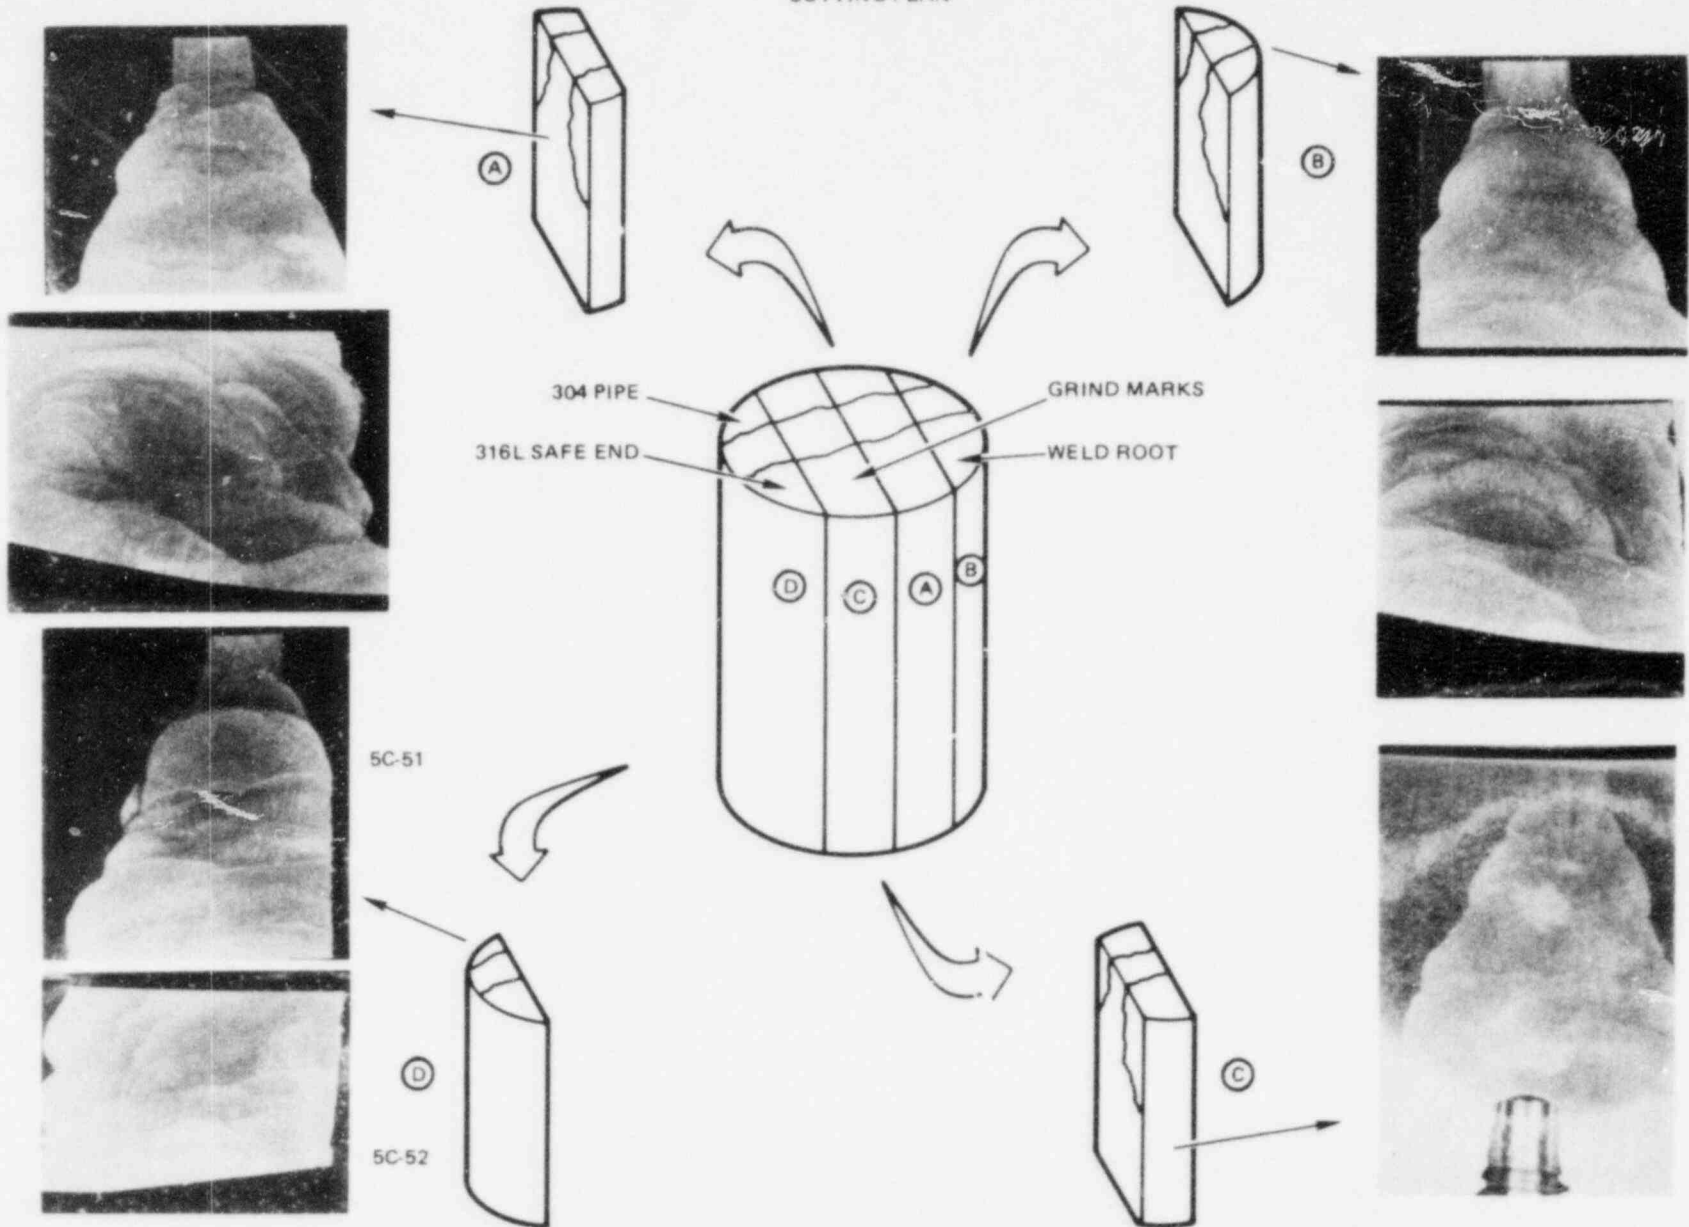
The sample was then decontaminated by ultrasonic cleaning and examined under a stereo microscope. At magnifications up to 33X evidence of cracking was not observed at any locations along the I.D. surface. The core sample was then sectioned as shown in Figure 5-3. Each cutting plane was oriented normal to the weld fusion line such that a polished and etched section would be a transverse cross section of the weld. Figure 5-4 is a polished and etched cross section of the sample. Close examination of this section, and the three other sections prepared from the core sample (Figure 5-5) clearly showed the following:

- a. No IGSCC was found in the entire sample. There is no cracking in the 316L safe end material, or in the pipe material contained within the core sample.*

Figure 5-5. Composite Photograph Detailing Metallographic Sample Location and Results.
No cracking found at any location.

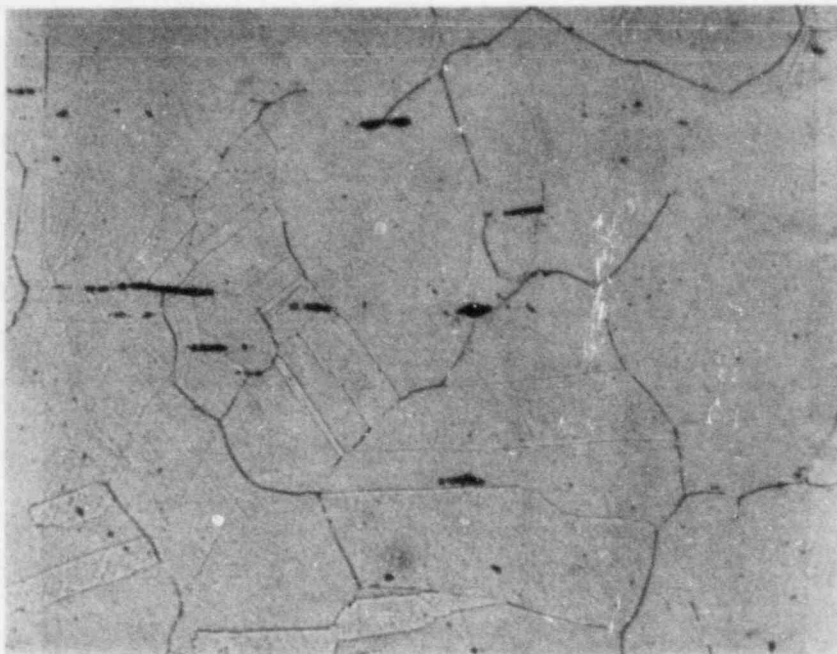
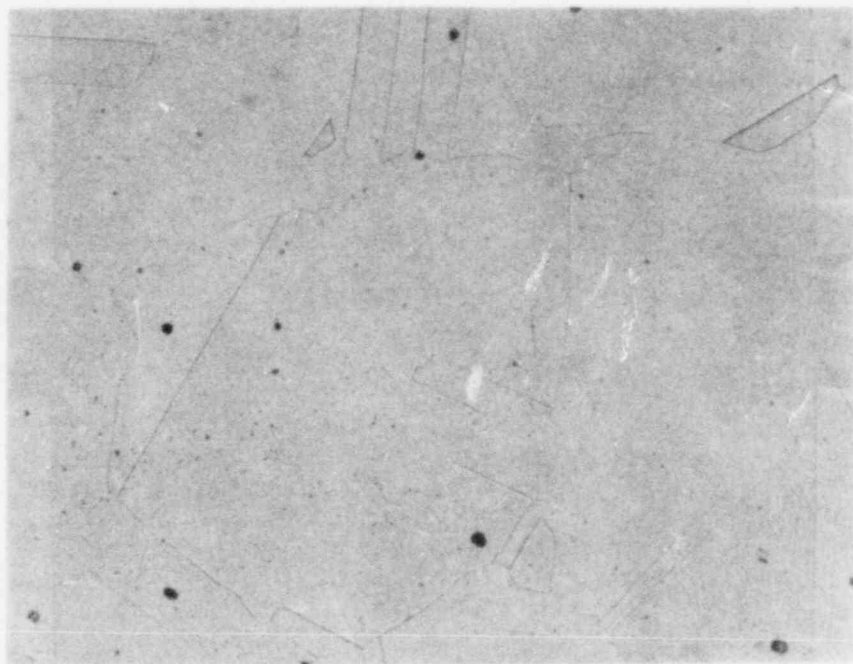
- b. No weld heat affected zone sensitization was found on the safe end side of the weld, as expected with a 0.019 carbon content. The pipe side of the weld (0.054% carbon) did exhibit sensitization as expected. Figure 5-6 are views of the pipe side of weld (HAZ) and the safe end of the weld HAZ, respectively.

(a) PIPE SIDE OF WELD (HAZ) 0.054 CARBON 304 S/S

(b) SAFE END SIDE OF WELD (NOTE NO SENSITIZATION)
0.019 CARBON 316L S/S

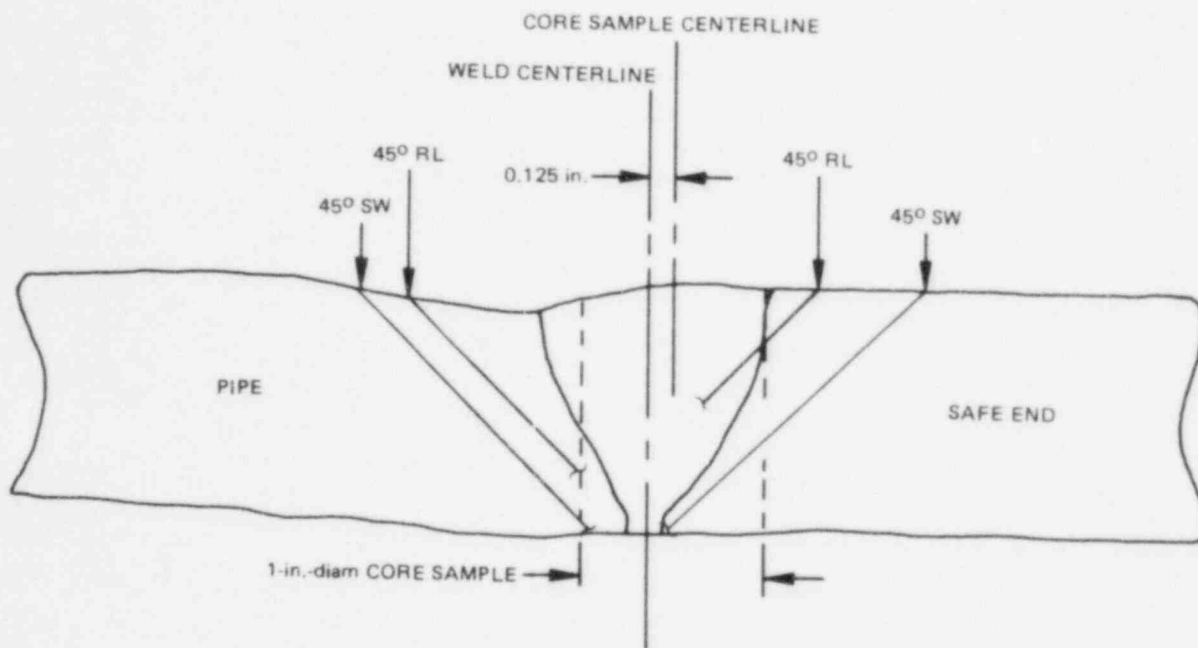
- c. A replotting of the UT metal path assumptions on the actual cross sectional weld geometry showed the safe end UT I.D. indications were actually located in the weld metal/fusion line region and the crack tip indications were located well into the weld metal. This is based on the confirmed location of the root centerline on the I.D. relative to the centerline of the weld on the O.D. surface. Figure 5-7 displays a sketch of the UT metal paths sketched relative to the actual core sample cross-section.

Figure 5-7. Actual Cross-Section of Weld 2-BS-2 Displaying UT Plots Used in Core Sample Selection. (Note: Plots show that indications lie in weld metal/fusion line region.)

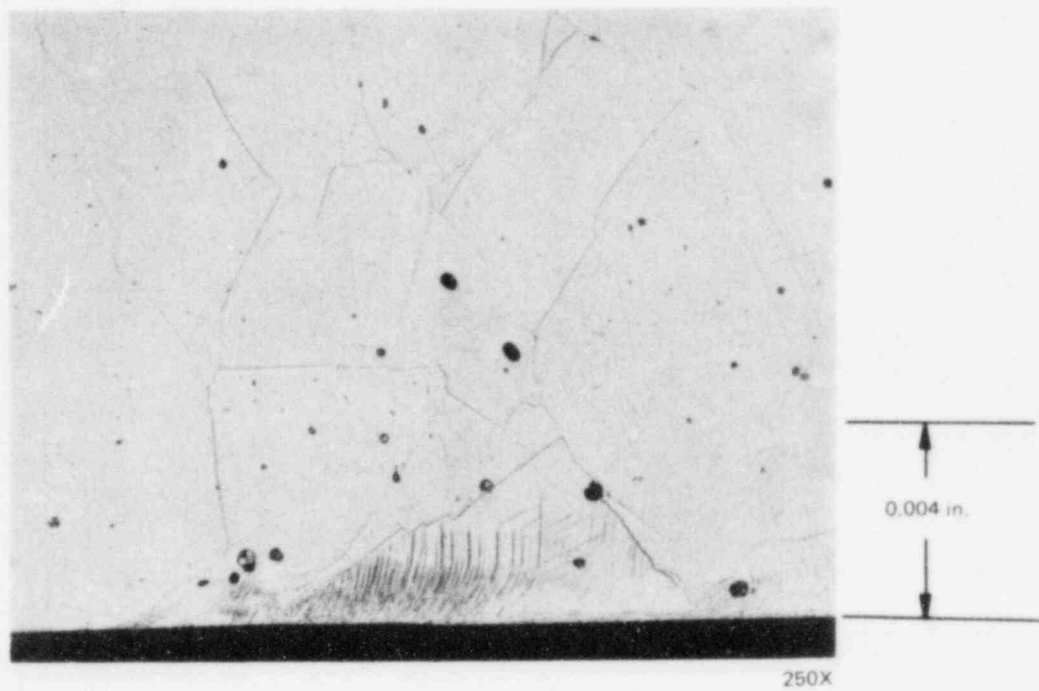
On the through-wall section (marked A in Figure 5-5) polished and etched to reveal the microstructure, the section view of the safe end inner surface showed a cold worked layer, with grain deformation to a depth of less than 0.004 inch. This shallow cold work layer is characteristic of light-to-moderate surface grinding (Figure 5-8). A microhardness traverse was prepared for the safe end at a location approximately 5/16 inch from the fusion line of the weld, to be outboard of the annealing effect of the weld. Figure 5-9 displays the location of indentations and gives a sketch of the hardness profile. Note that within 0.010 inch into the surface the hardness level drops from R_c 26 near the surface to less than R_c 92 for the bulk interior material.

Figure 5-8. View of Cold Work on Inner Surface of Safe End. Note Depth of Grain Deformation is Less Than 0.004 inch.

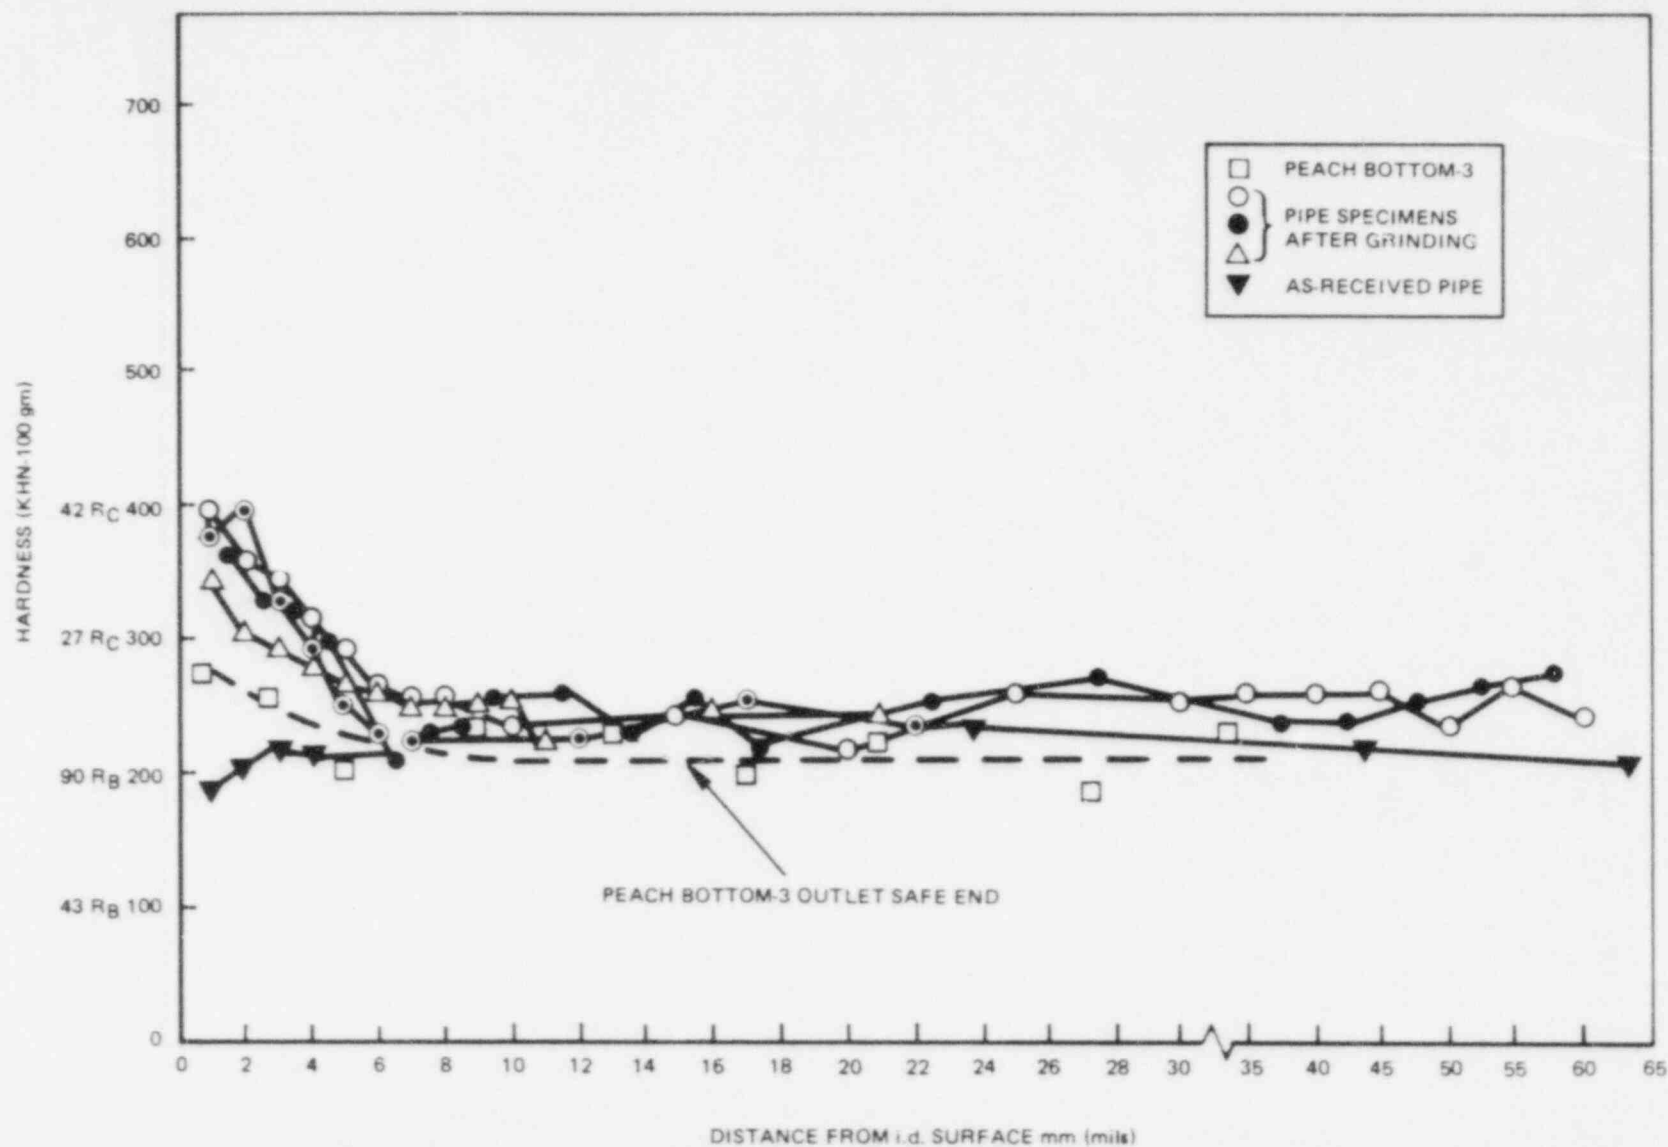
The hardness profile found in typical grinding in Pipe Test Laboratory studies are shown in Figure 5-10 compared to the cold work in the Peach Bottom-3 outlet safe end. The figure shows the Peach Bottom-3 safe end is bounded by the Pipe Test Lab data.

Figure 5-10. Comparison of Hardness Found in Peach Bottom-3 Safe End Core Sample with Hardness Data from General Electric Pipe Test Laboratory 4 inch Pipe Specimens that were Ground

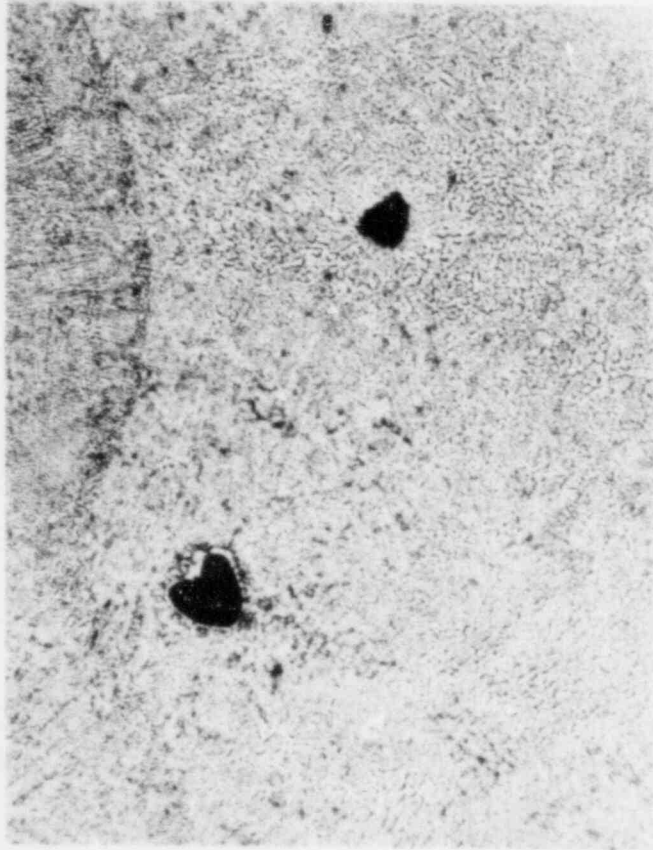
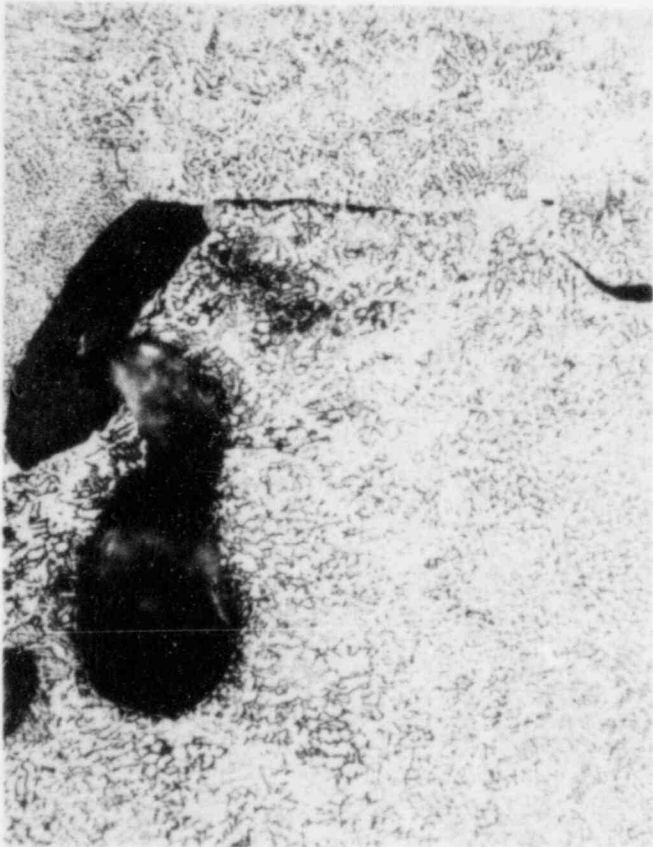
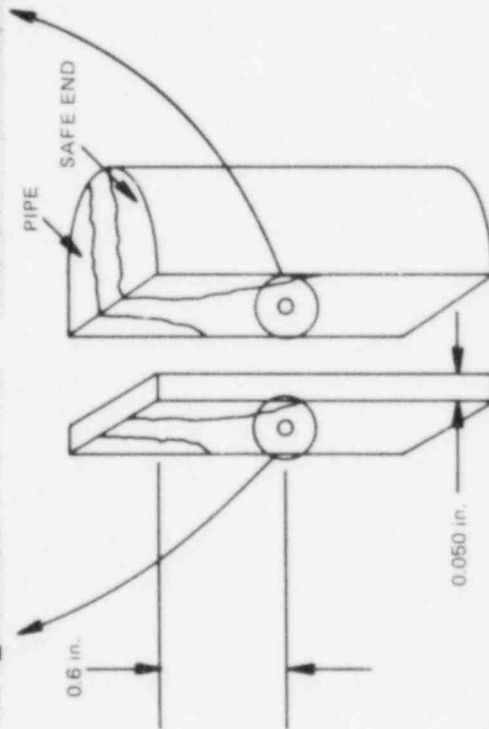
- b. Under optical examination at higher magnification (100 to 500X) some porosity, slag, and minor lack of fusion was found in the weld metal. The largest weld defect was a slag inclusion in the weld metal found approximately 1/8 inch from the safe end weld fusion line. The location coincided with the location where UT crack tip indication. As shown in Figure 5-11 the plane, on which this "large" defect was found, was ground to expose a new plane 0.050 inches below the original surface. The inclusion was still visible on this new surface, though much smaller in size. A rough estimate for length is 1/8 inch. In other regions in the weld small "normal" amounts of porosity were also found.

Figure 5-11. Views of Slag Inclusion on Planes Separated by 0.050 inch Length of Inclusion Estimated to be 1/8 inch.

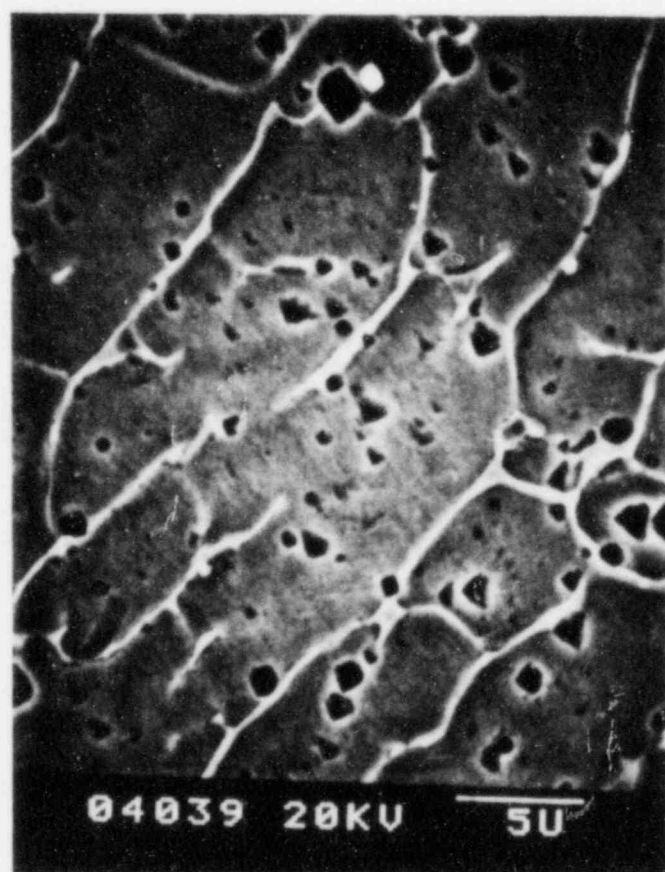
A linearly decreasing gradient of diffused Mo was observed in the weld metal when moving from the 316L fusion line towards the pipe side fusion line. In addition, there was an enrichment of Mo in the ferritic phase of the weld. The enrichment gradient from the 316L fusion line to the 304 fusion line was linear, suggestive of mechanical mixing. Figure 5-12 is a photo of the 316L weld interface boundary and Figure 5-13 is a SEM photo of the Mo enriched ferritic phase within the austenitic matrix. Figure 5-14 is an energy scan made on the SEM with the energy dispersive X-ray detection equipment providing confirmation of Mo enrichment in the light second phase regions of Figure 5-13.

Figure 5-13. High Magnification View of the Weld Matrix Approximately 100 mils from the 316L Fusion Line. (The light phase in the dendrite boundaries has approximately a 4 to 1 enrichment of Mo over the austenitic phase.)

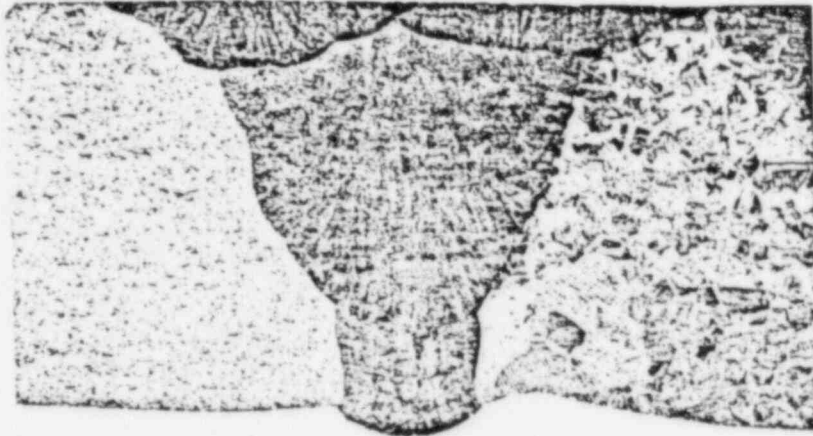
Figure 6-2. Cross Section of Weld A Associated with UT Indications

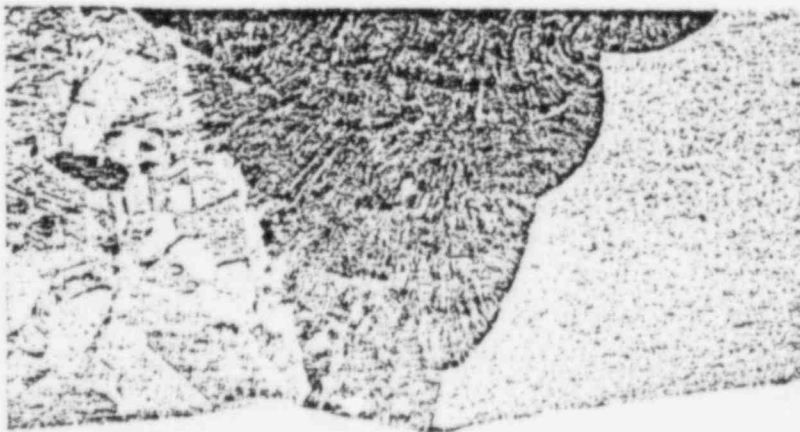
Figure 6-3. Cross Section of Weld B Associated with UT Indications

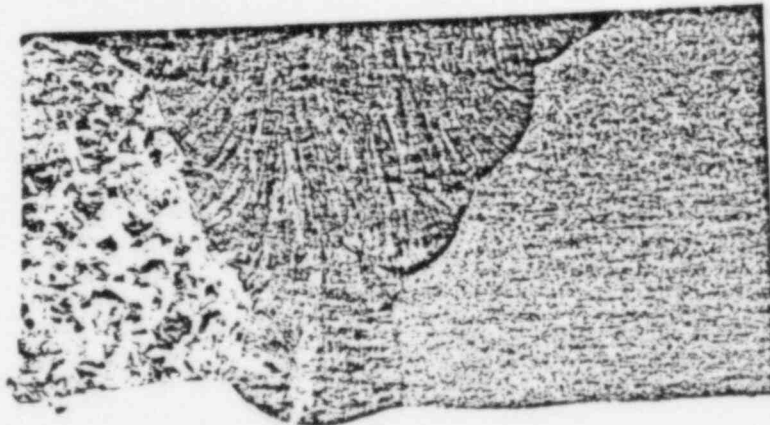
Figure 6-4. Cross Section of Weld C Associated with UT Indications
