Subject: Inspection No. 50-219/85-33

Subject: Oyster Creek Nuclear Generating Station  
Docket No. 50-219  
Inspection Report No. 85-33  
Response to Violation

Subject: Operation Critique -  
O. C. Radioactive Material  
Shipment Number 1036-85

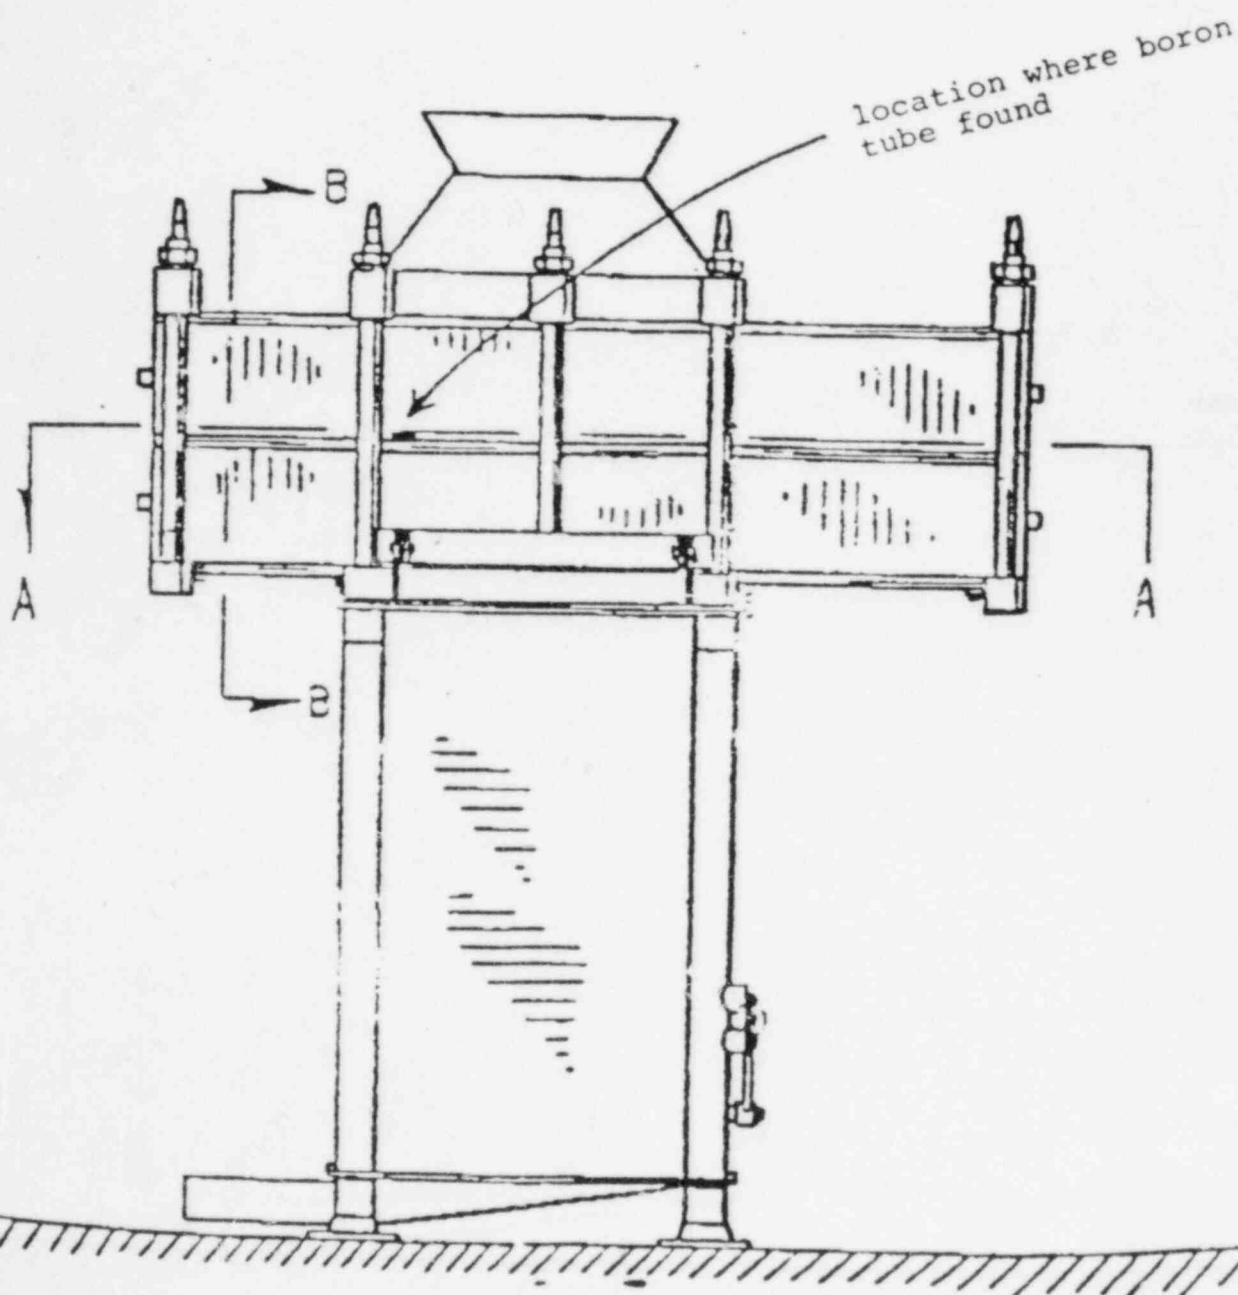
FIGURE 1

Upon disassembly of the equipment, a segment of a boron tube from a CRB was discovered below the hydraulic processing cylinder internal to the USC in the area shown on Figure 1 (attached). The tube was approximately 2 1/2 inches long, 3/16 inch outside diameter, with a contact radiation level of 25 to 40 R/hr. GPUN was notified of the finding and Quadrex agreed to place the piece of boron tube in a secure area for evaluation and subsequent dispositioning.

It was determined after extensive discussion that the only possible method of entry for the boron tube segment was to fall from a control rod being processed, with the control rod being simultaneously raised as the press jaw was being retracted. The boron tube would then have entered the space where it was found by falling behind the jaw to the area below the cylinders. This space is inaccessible except when the jaw is partly open. Such an occurrence was believed so improbable that this space had been left open in design. It is now being modified to seal it and preclude recurrence.

In conclusion, it was determined that the unknown piece of boron tube segment moving freely within the USC during transit, caused the increase in the two meter radiation levels which exceeded the permissible limits specified in 173.441(B)(3).

To prevent the entrance of contaminated or irradiated hardware into the USC internals, and to enhance the effectiveness of decontamination of internal surfaces, WasteChem Corporation has made the following physical changes to the USC.

1. Introduction of barriers to seal the entrances of areas difficult to flush clean and prevent the entrance of foreign material.
2. Addition of a "Sweep" to push scrap, which could potentially settle on the moving knives, into the collection bucket.
3. Twenty four access holes will be drilled in the side plates for the introduction of a hydrolaser lance. The hole pattern provides excellent coverage to machine internals to dislodge foreign material and contamination. These holes will also permit introduction of a survey instrument for accurate detection of radioactive material.
4. Addition of a pump interlock to insure that the USC cannot be operated without the filtration cleanup system in service.
5. Use of a compacting jaw set to "crimp" the work piece and thus retaining the boron tubes in the control rod blade sheath.
