# University of Pittsburgh

RADIATION SAFETY OFFICE

June 14, 1977

This letter responds to your May 11, 1977 inquiry regarding the Co-60 Teletherapy Facility, (Presbyterian-University Hospital, License Number 37-00245-05) survey results.

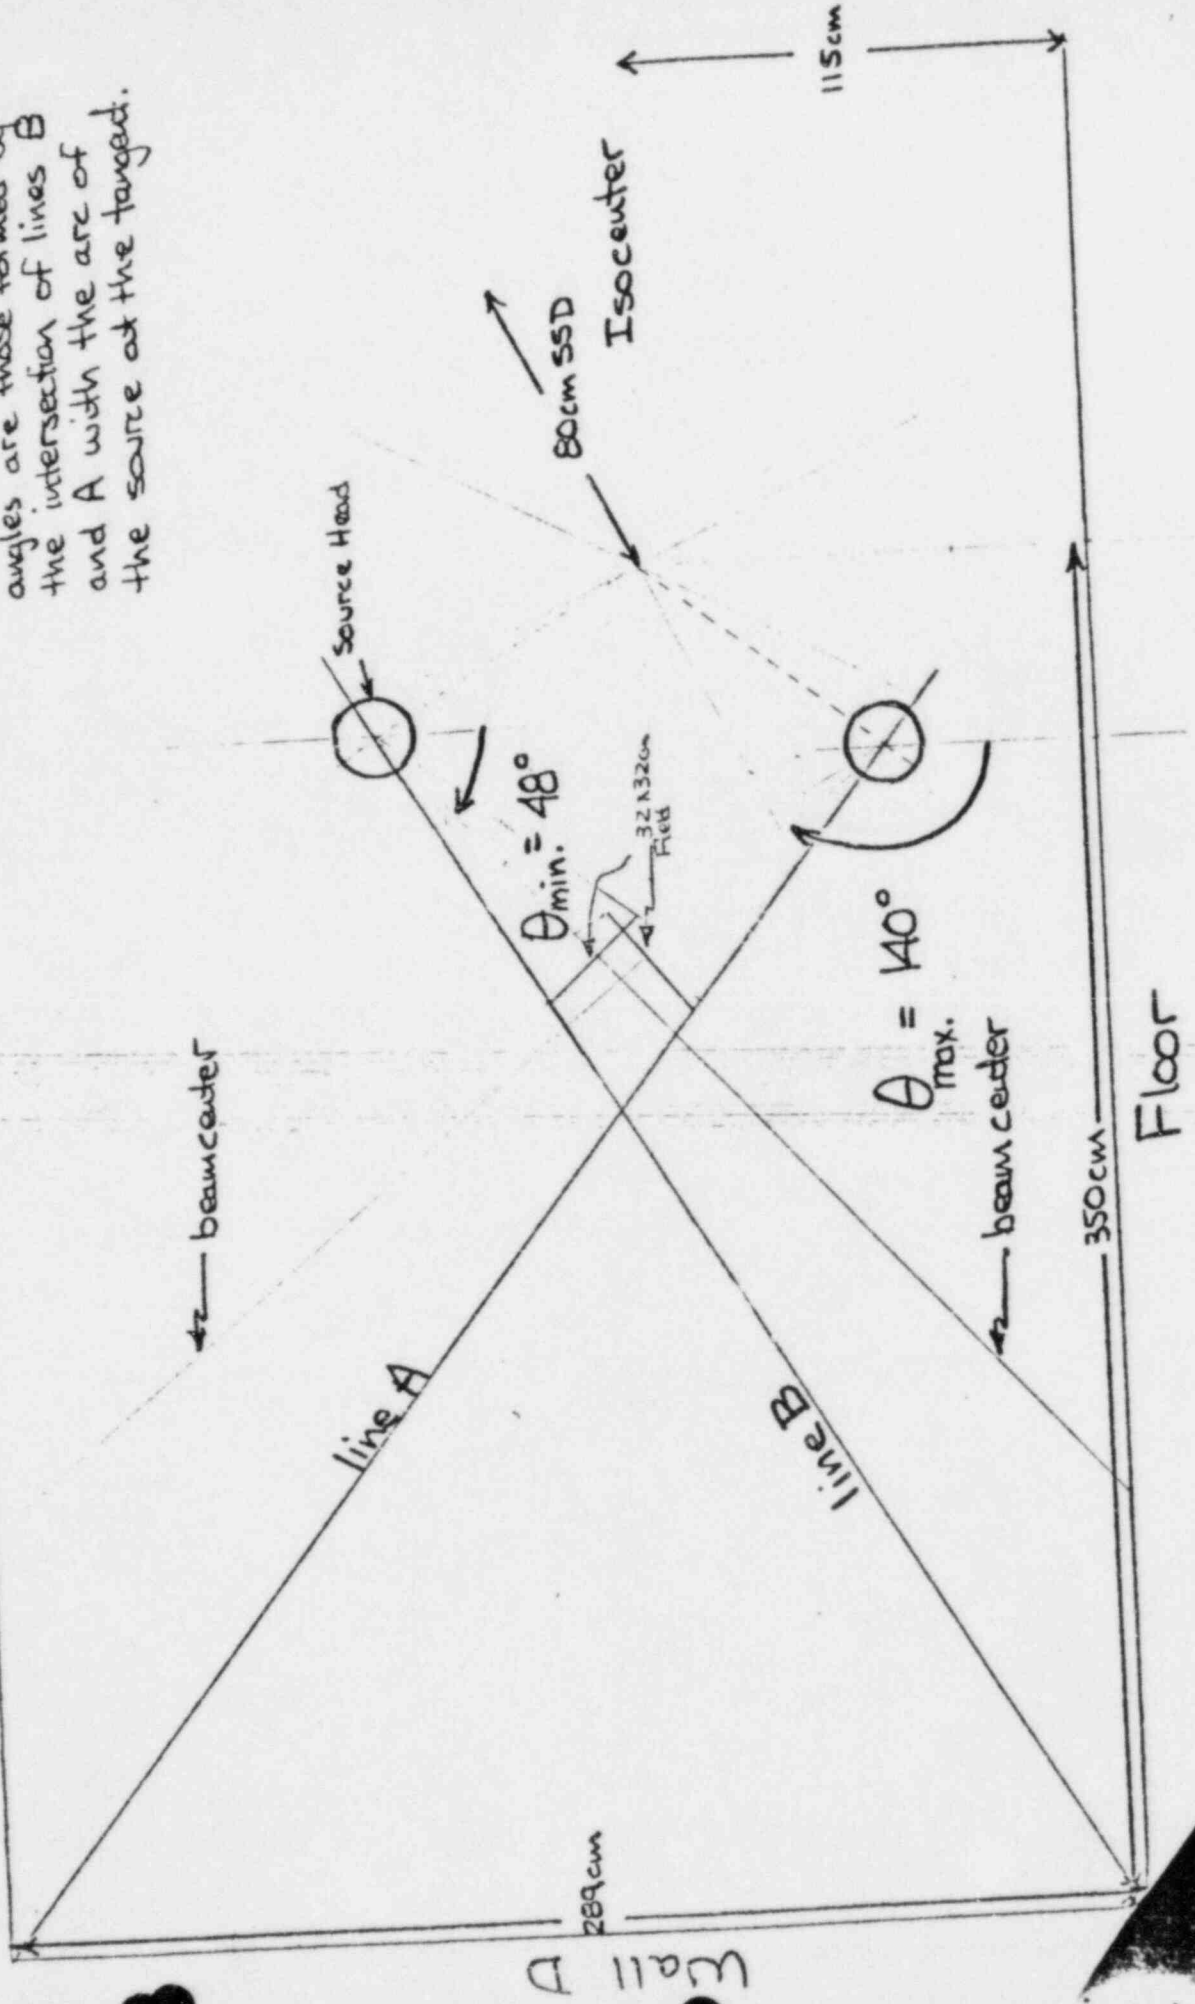
Figure #1  
Scale 1/20 Full size

Since the beam limiting mercury switches allow the source to operate independent of the gantry rotation angle, a set of minimum angles from the vertical can be specified for the source head rotation. This will define the area of Wall D from the floor to the ceiling in terms of an angle from the vertical which can be readout directly on the source head housing. Referring to Figure #1 as attached, the maximum angle from the downward vertical position will be defined by the angle  $\theta_{\max} = 140$  degrees and the minimum angle  $\theta_{\min} = 48$  degrees. At any head rotation from  $\theta_{\max}$  through and including  $\theta_{\min}$ , the source is electrically inoperable, therefore incapable of striking any portion of Wall D with the unattenuated primary beam. This is for a maximum field size of 32 x 32 cm at 80 cm SSD.

minimum and maximum limiting angles are those formed by the intersection of lines B and A with the arc of the source at the target.

- b. The tests to be conducted by this office are (1) verify the electrical interlock system is actually independent of the gantry position by placing the head at angle  $\theta_{\max}$  and angle  $\theta_{\min}$  as aimed toward Wall D for each of 8 gantry positions at increments of 45 degrees and test firing; (2) successively test fire toward Wall D and rotate the source head at 10 degree increments from 0 degrees through 180 degrees from the vertical to check for the proper operation of the interlock; and, (3) verify that the stipulated minimum through maximum angles in 4a. provide the proper electrical source interlock feature.

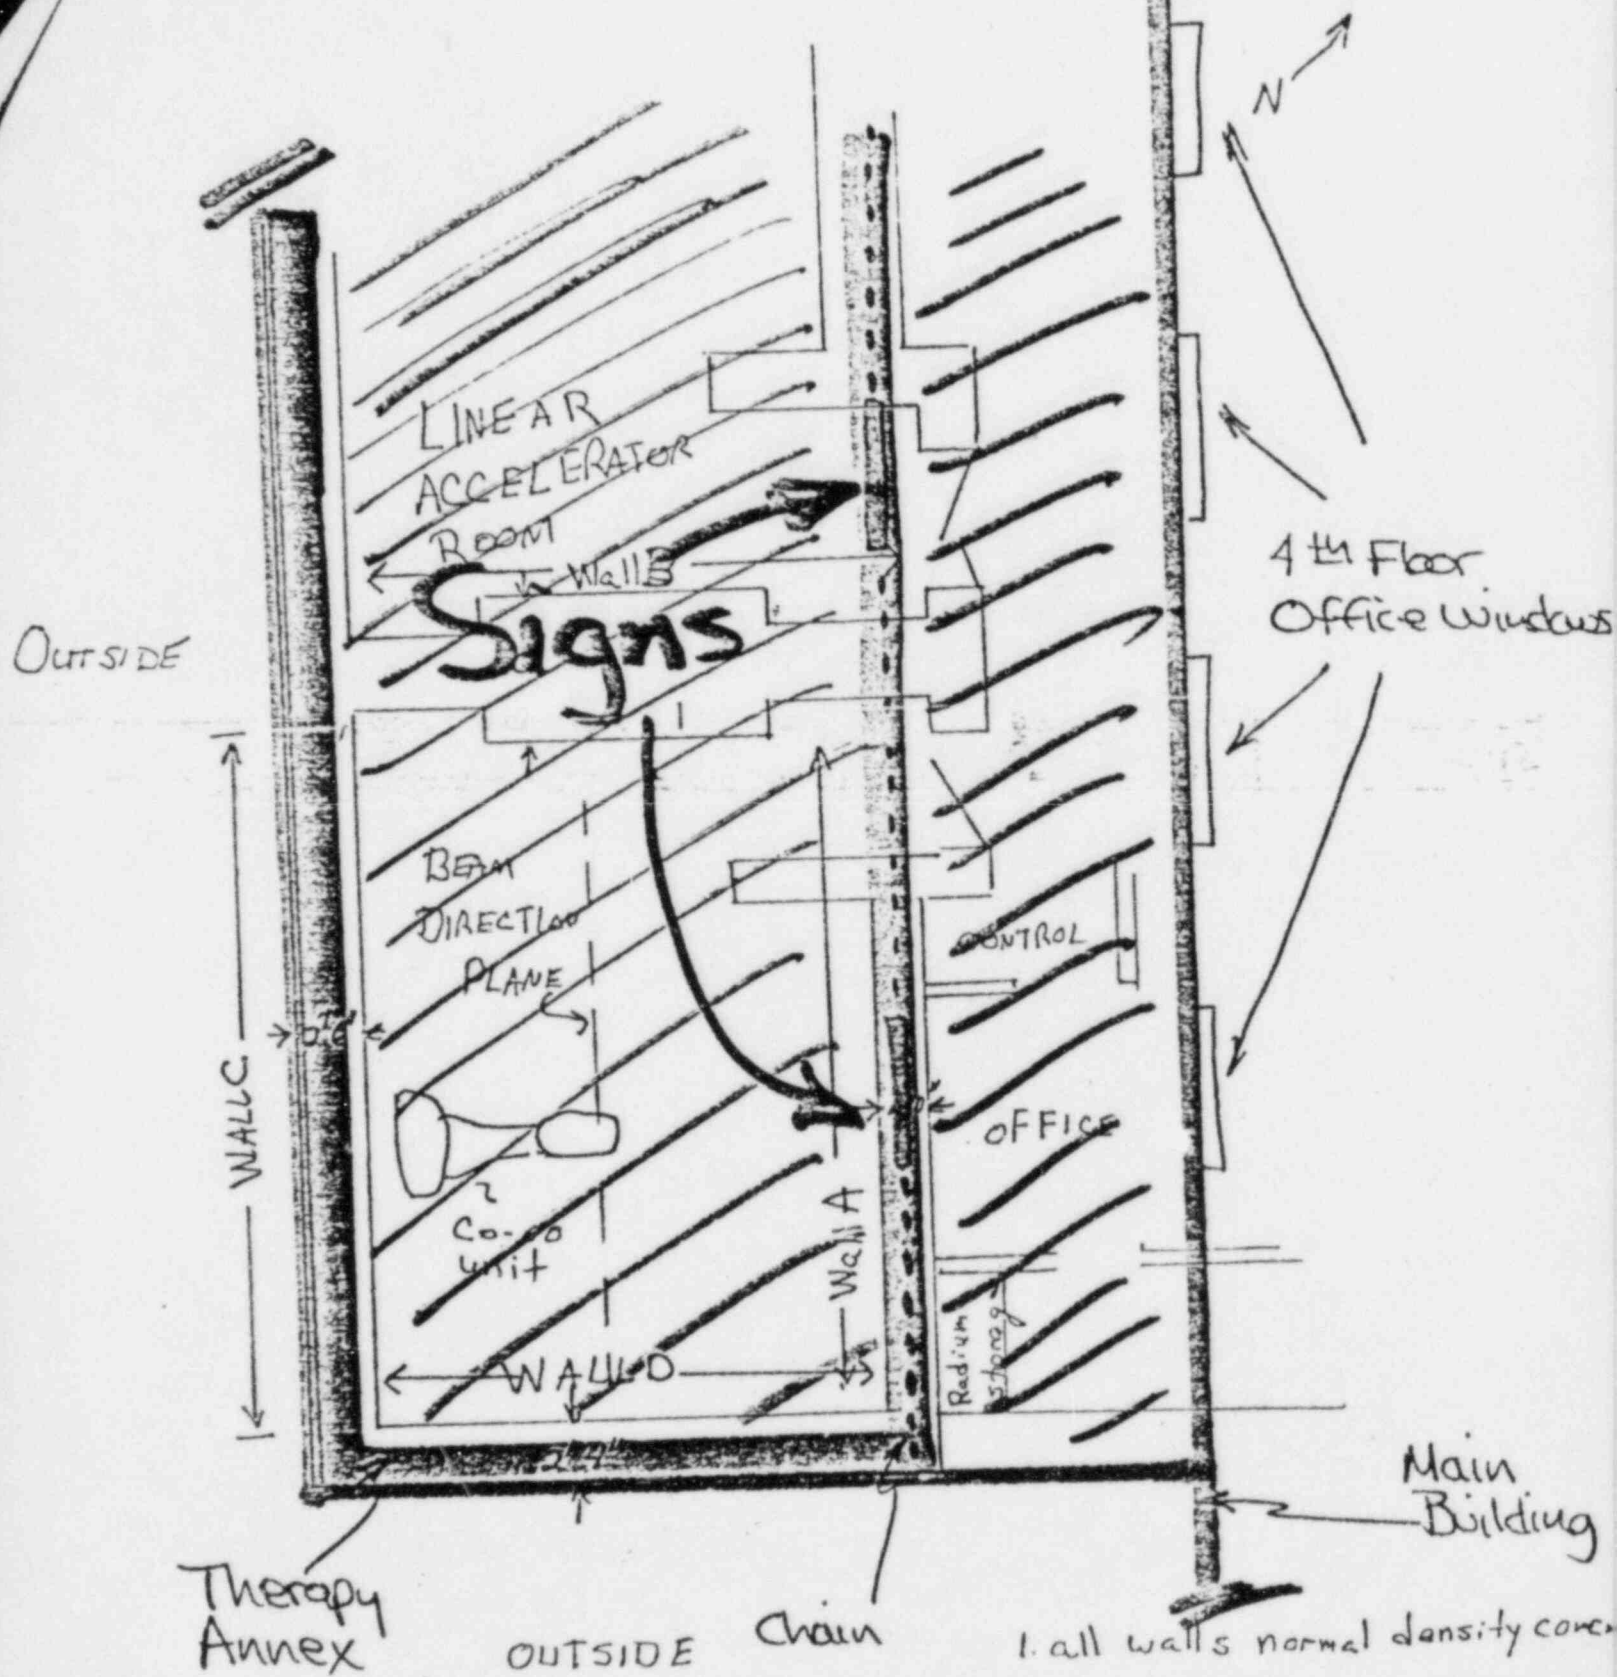
Figure #2

5. The roof of the Co-60 Teletherapy Room is now posted as a radiation area.
  - a. The controls used to restrict access to this area are primarily administrative, in nature. The area has been posted as a radiation area at the point of typical access to the annex roof (see Figures 2 & 3). The signs are conspicuously posted and are visible to persons who try to gain access to this roof from (1) an adjoining roof of the main building and (2) by use of a ladder from the loading dock level. Typical access to this roof is through the use of keyed windows on the 4th floor of the main building, allowing access to the previously mentioned adjoining roof.

- b. Four 8" x 10" metal signs have been posted on the annex building roof (see Figures 2 & 3) they are placed two (2) back-to-back and each carries the words "Caution - Radiation Area - Contact the Radiation Safety Office before entering this roof area 624-2728".

- c, d. These instructions will allow this office to ensure the Co-60 unit either not operating or allow appropriate personnel monitoring when people will be working on this roof. In either case, by contacting us when personnel wish to gain access to the roof, we shall be able to instruct these people in accordance with Section 19.12 of 10 CFR 19, if the situation requires.
