LICENSEE EVENT REPORT (LER)

FACILITY NAME (1)										DOCKET NUMBER (2)					PAGE (3)	
CRYSTAL RIVER UNIT 3										0 5 0 0 0 3 0 2					1 OF 0 6

TITLE (4)
UNPLANNED ACTUATIONS OF EMERGENCY FEEDWATER SYSTEM

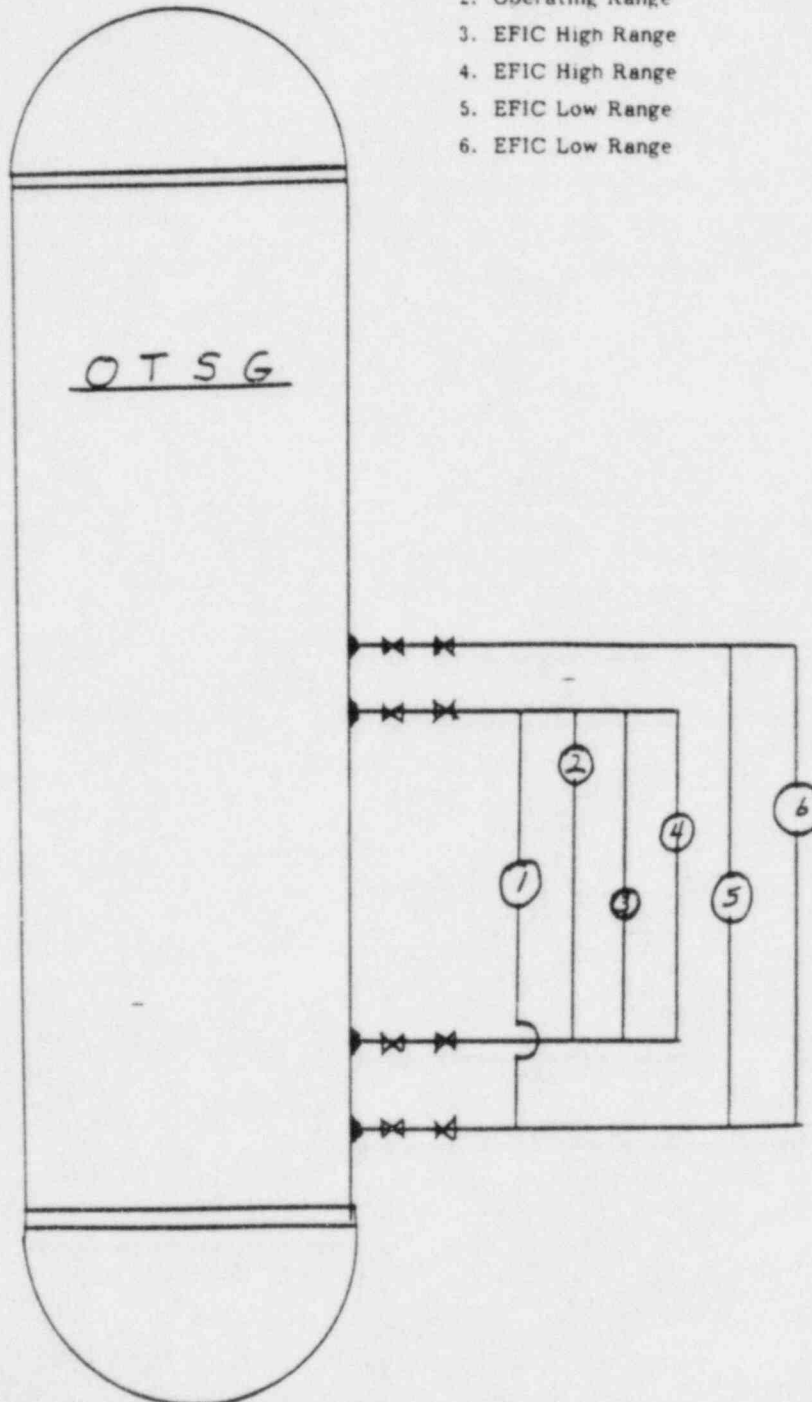
FIGURE 1

Low Margin - During the refueling and modification outage, a plant modification was accomplished which installed additional steam generator level sensors and created a new emergency feedwater actuation system termed Emergency Feedwater Initiation and Control, EFIC. These new EFIC sensors are of a different design than the existing startup level transmitters which are used for level control at low feedwater flow rates. EFIC level transmitters tap into the steam generator at different levels (see Figure 1). This results in a divergence of level indications between the startup level and the EFIC low range level as a function of feedwater flow rate. The startup range level sensor is used to control steam generator levels at low power conditions. The margin between EFIC level indication and the actuation setpoint becomes increasingly smaller as feedwater flow rate increases. This condition is shown graphically in Figure 2. Additionally, the EFIC level instrument is compensated by changes in steam generator pressure, which is more rapid than the temperature compensation method employed by the startup range level instrument. Thus the EFIC level instrument will tend to fluctuate more often and with a larger amplitude than the startup range level instrument. These two factors combined to cause an unacceptably low margin to EFIC actuation at low main feedwater flow rates which is amplified by minor fluctuations in feedwater flow rate or steam generator pressure.

1. Startup Range
2. Operating Range
3. EFIC High Range
4. EFIC High Range
5. EFIC Low Range
6. EFIC Low Range

A satisfactory margin to EFIC actuation was established by raising the steam generator level control setpoint.
