FLORIDA POWER AND LIGHT COMPANY
ST. LUCIE UNIT 2

SAFETY EVALUATION FOR THE
PROVISIONS TO TRIP EMERGENCY DIESEL GENERATOR OUTPUT BREAKER
ON CIAS IN PLANT MODES 5 AND 6

JPN-PSL-SEES-95-034
REVISION 0

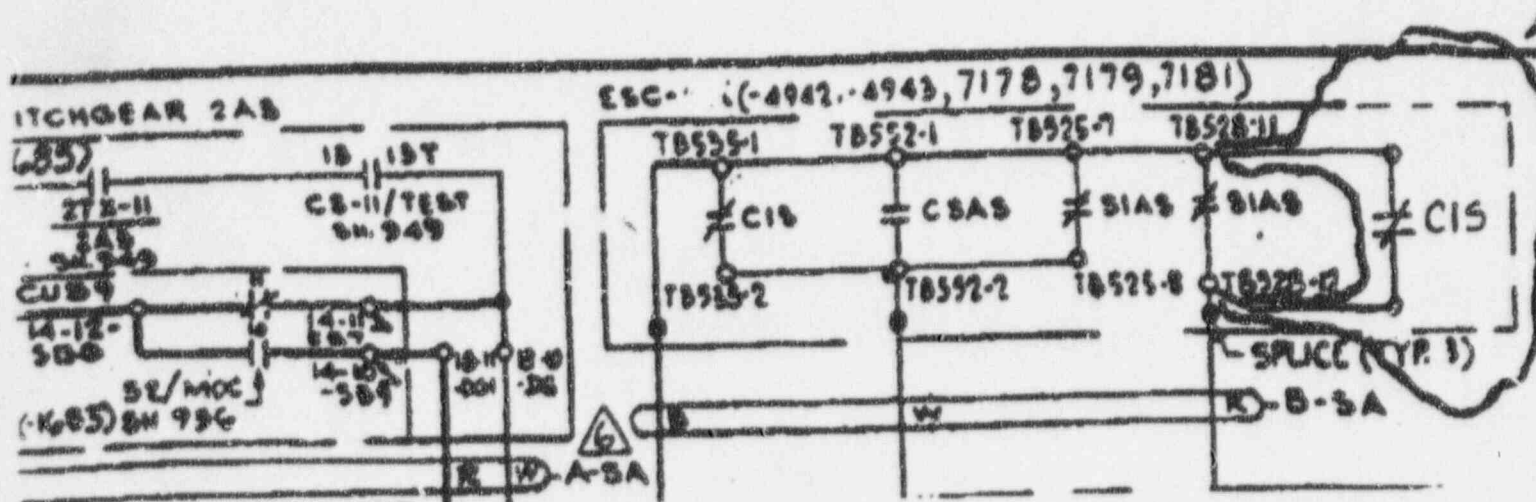
MODIFIED

TYPICAL SPARE CONTACTS

TB540(10.11) TB637(7.8) RECOMMENDED

CIAS shall be incorporated into the trip circuit of the EDG output breaker by wiring any available "deenergize to close" spare CIAS contacts in parallel with the SIAS contact as shown in Attachment 1.

- ◆ The relay, contact of which will be used, should be verified to be operational prior to implementation of the modification. Ensure that a CIAS A contact is used for A train logic and CIAS B contact is used for B train logic.
- ◆ Verify by test that the CIAS contact provides an EDG breaker trip signal.
