QUIVIRA MINING COMPANY

Re: License SUA-1473
Docket No. 40-8905

Completion Report of Minor Liner
Damage to Evaporation Pond #19

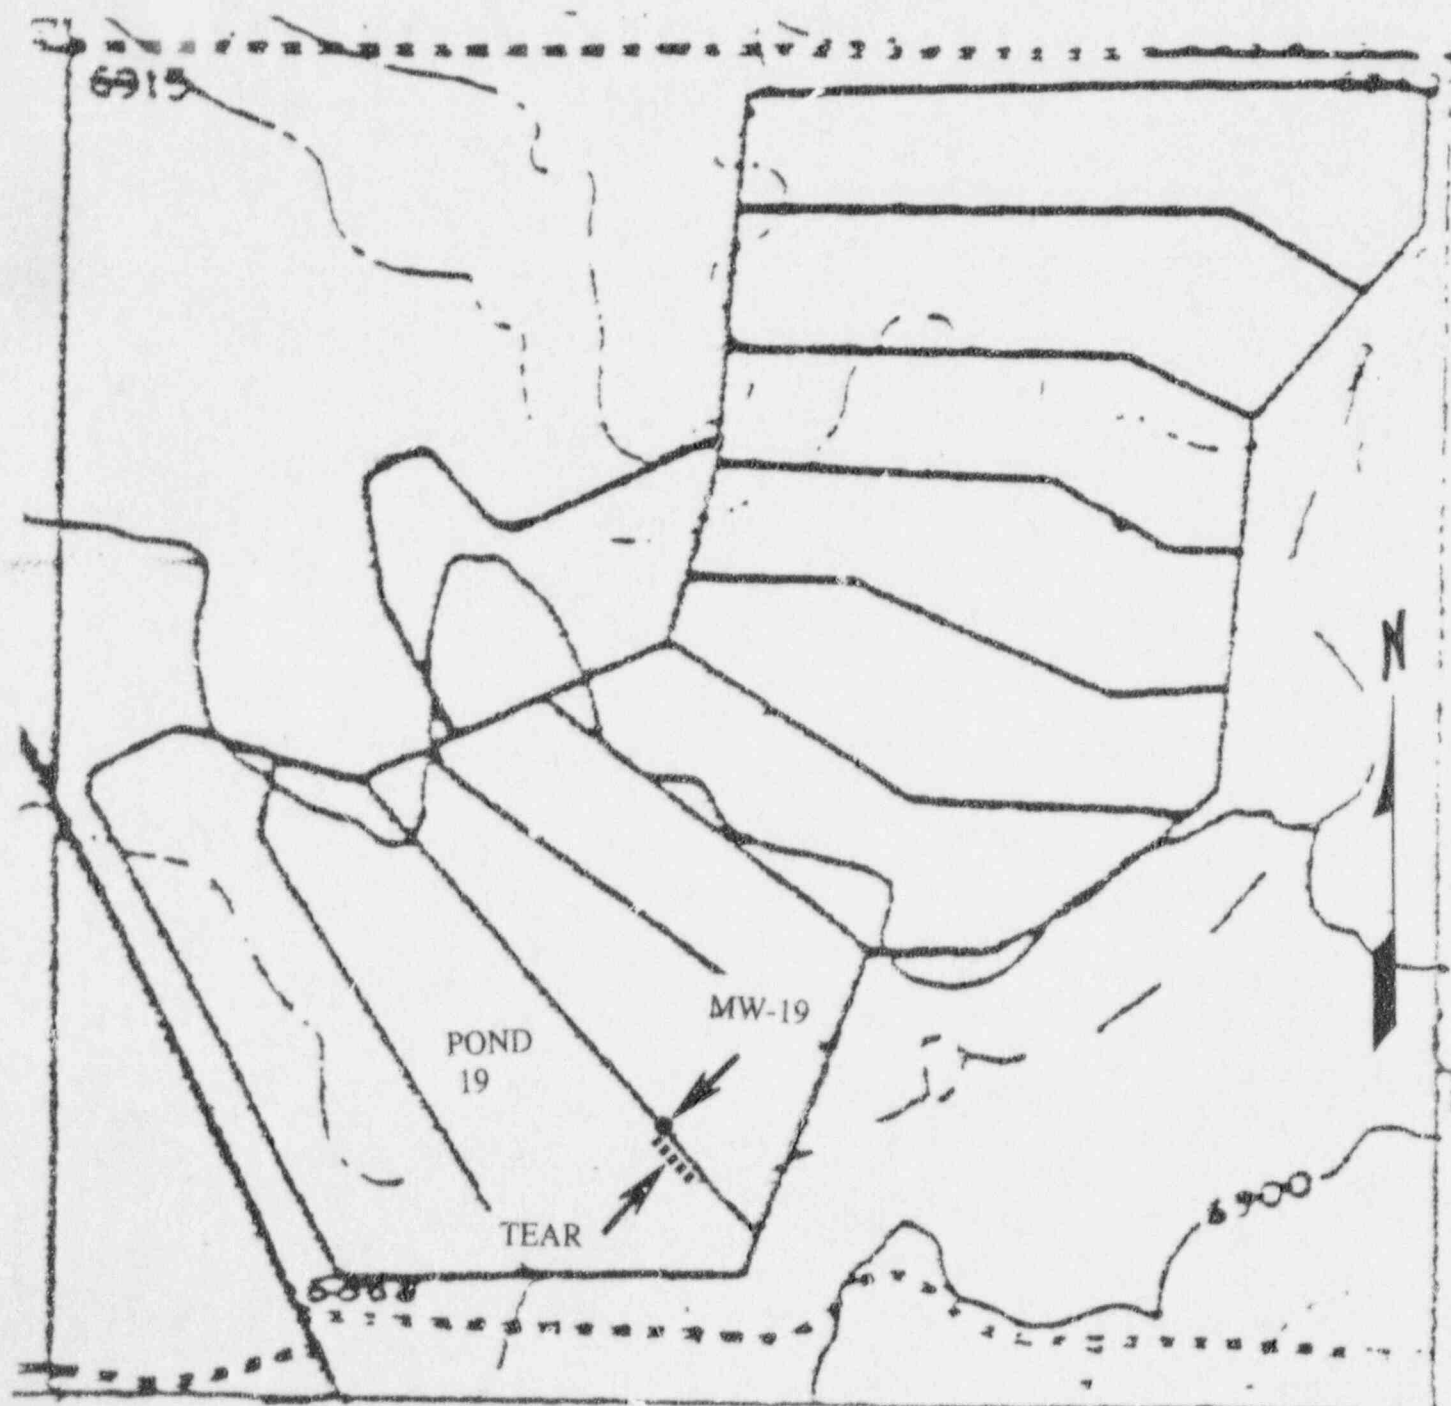
MAP 2

On March 4, 1997, some minor liner damage was discovered on the east berm of lined evaporation pond #19 resulting from abnormally strong winds. The attached maps indicate the location of evaporation pond #19 and the location of the liner damage. The horizontal liner tear, which is located above the water level along the east berm adjacent to monitor well MW-19, allowed a portion of the lower segment of the liner to sag below the water level allowing pond water to contact the earthen berm under the liner.

LOCATION OF POND 19 LINER TEAR

Repairs to the berm and liner were initiated on March 5, 1997. As a result of the pond water being in contact with the earthen berm, some minor erosion occurred to the berm due to the wave action caused by the strong winds. Clean alluvial fill material was utilized to replace and refortify the pond berm and to facilitate repairs to the liner. Upon satisfactory completion of the berm restoration, repairs to the damaged liner were initiated.

The upper and lower portions of the torn liner were positioned on the earthen berm and all foreign matter and dirt were removed from the repair area in order to provide a good bonding surface. In addition to this, the edges of the liner along the tear were also cleaned to ensure proper bonding. To ensure a satisfactory seal, an additional piece of liner material was used to overlap the upper and lower liner segments. This "patch" was overlapped at least one (1) foot on all sides of the damaged area.

The bonding material, specifically Chevron Industrial Membrane (CIM), was prepared in accordance with the manufacturer's specifications. After spreading the CIM along all edges of the torn liner, the liner patch was then carefully positioned on top of the CIM layer. After additional CIM was placed on the patch to ensure proper sealing of all edges, the CIM was allowed to cure for approximately 24 hours.
