Subject: Docket No. 50-361
Voluntary Report
Licensee Event Report No. 97-004
San Onofre Nuclear Generating Station, Unit 2

LICENSEE EVENT REPORT (LER)																		
Facility Name (1) SAN ONOFRE NUCLEAR GENERATING STATION, UNIT 2												Docket Number (2) 0 5 0 0 0 3 6 1				Page (3) 1 of 0 4		
Title (4) Reactor Coolant System Leakage - Pressurizer Thermowell																		
EVENT DATE (5)			LER NUMBER (6)				REPORT DATE (7)			OTHER FACILITIES INVOLVED (8)								
Month	Day	Year	Year	///	Sequential Number	///	Revision Number	Month	Day	Year	Facility Names				Docket Number(s)			
0 3	0 3	9 7	9 7	---	0 0 4	---	0 0	0 4	0 2	9 7	None							
OPERATING MODE (9) 4			THIS REPORT IS SUBMITTED PURSUANT TO THE REQUIREMENTS OF 10CFR (Check one or more of the following) (11)															
POWER LEVEL (10) 0 0 0 0			20.402(b)				20.405(c)				50.73(a)(2)(iv)				73.71(b)

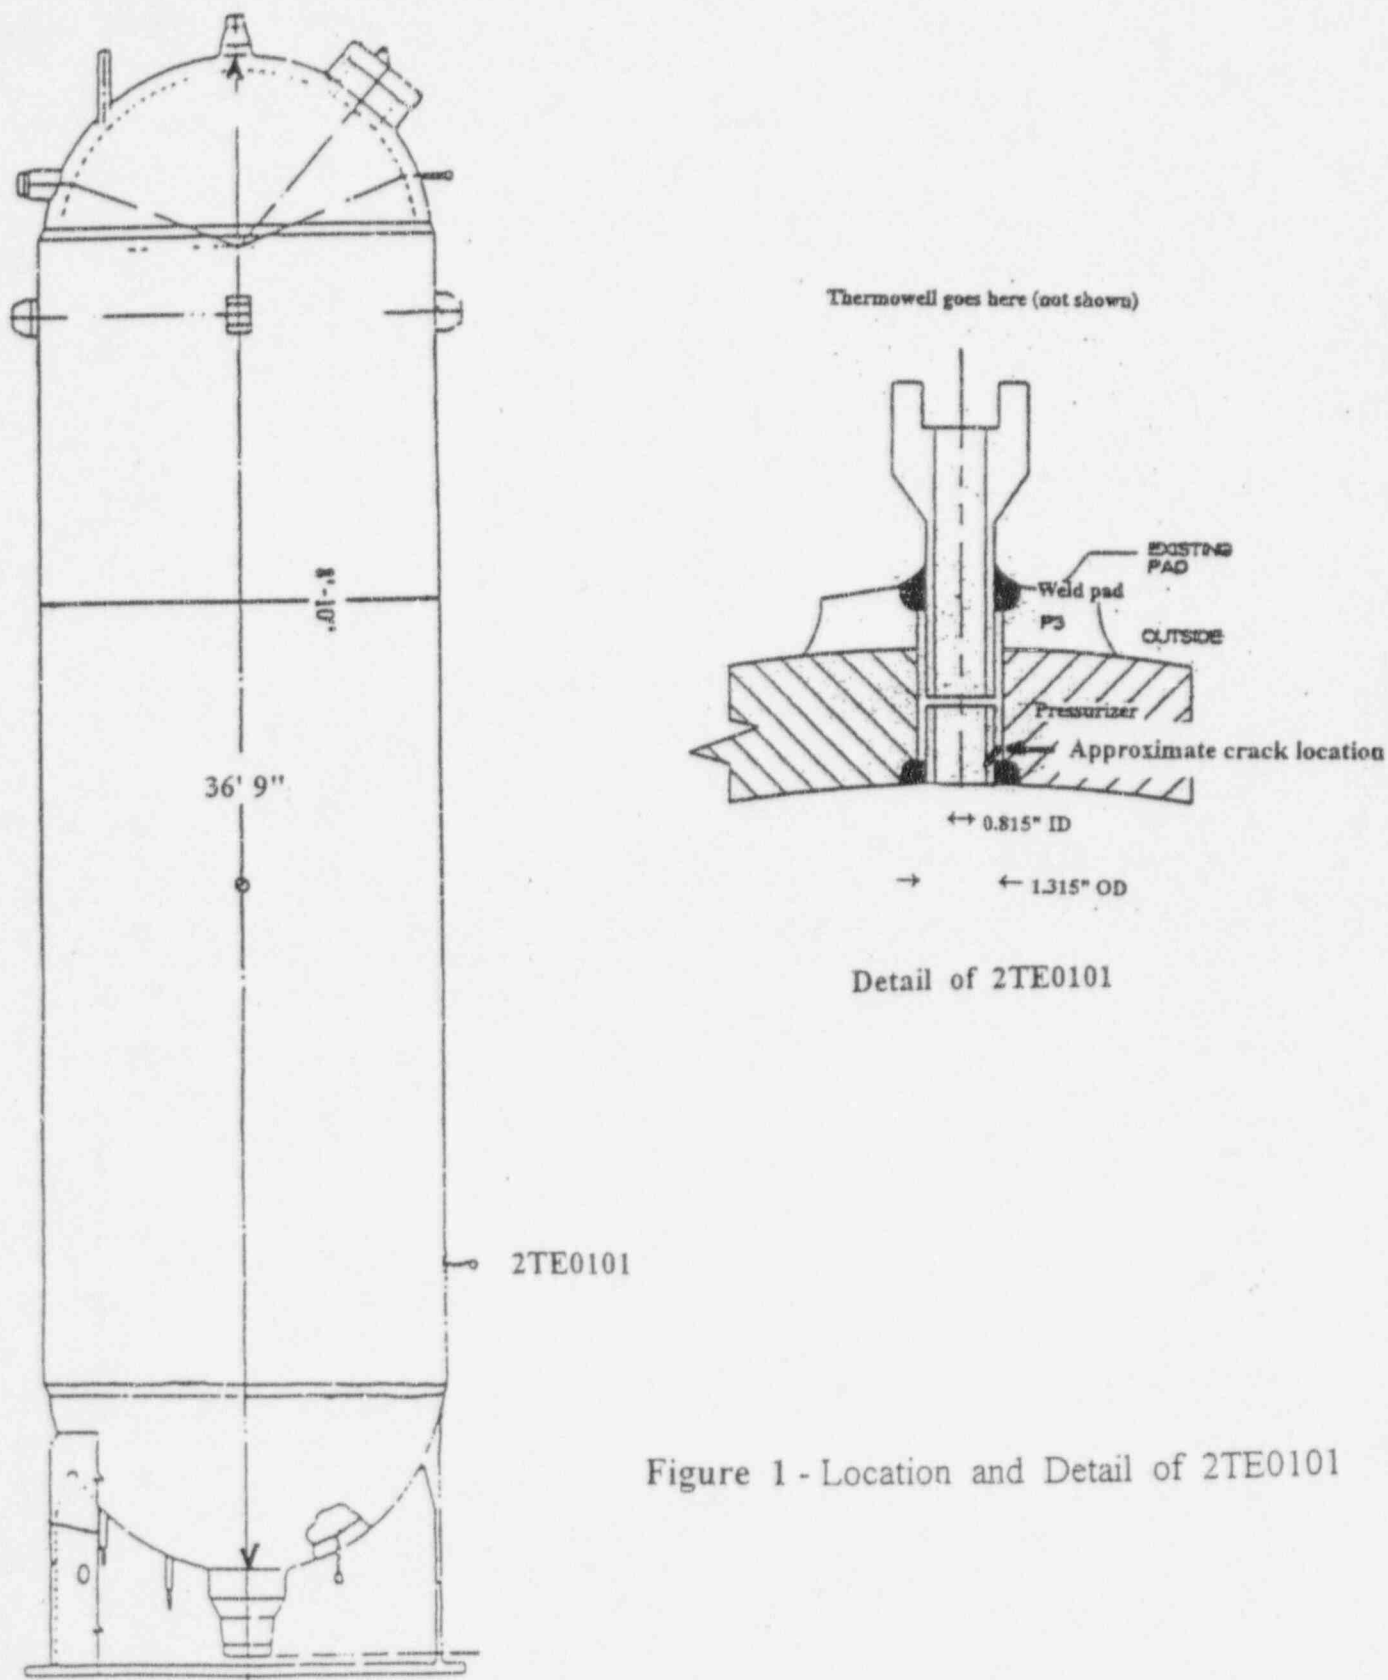
Figure 1 - Location and Detail of 2TE0101

Edison concluded the leak was caused by Primary Water Stress Corrosion Cracking (PWSCC) of alloy 600 type materials of the pressurizer liquid temperature thermowell nozzle. The nozzle was removed and replaced with Inconel 690.

The crack was oriented parallel to the long axis of the nozzle. Consequently, a complete circumferential failure of an RCS instrument nozzle is not believed to be a credible event. Nevertheless, the consequences of such a failure would be bounded by the small break loss of coolant accident (SBLOCA) analyzed in the UFSAR. The actual leak rate during this occurrence was about 0.76 gpm of water. Consequently, this event had minimal safety significance.

The leak was determined to be from a crack in the heat affected zone (HAZ) of the weld for pressurizer liquid temperature instrument 2TE0101 nozzle. See Figure 1. Edison has concluded the crack was caused by Primary Water Stress Corrosion Cracking (PWSCC) of alloy 600 type materials. Cracking of Inconel 600 material is well known and was the root cause of this leak. The crack initiated on the inside diameter of the nozzle in the HAZ (not the weld).

2TE0101 was originally designed and installed as a one piece nozzle made of Inconel 600 and SA-182, F316 stainless steel, welded with a J-Groove weld on the inside of the pressurizer (see Figure 1).

Edison replaced the outer half of the Inconel 600 material of the original nozzle with Inconel 690. Required welding was completed in accordance with ASME III, Class 1 welding guidelines. [Note: This repair was similar to that reported in LER 3-95-001; see additional information section below].
