Fort St. Vrain, Unit No. 1

LICENSEE EVENT REPORT (LER) TEXT CONTINUATION

January 25, 1986
Fort St. Vrain
Unit No. 1
P-86060

SUBJECT: Licensee Event Report
85-030, Final Report

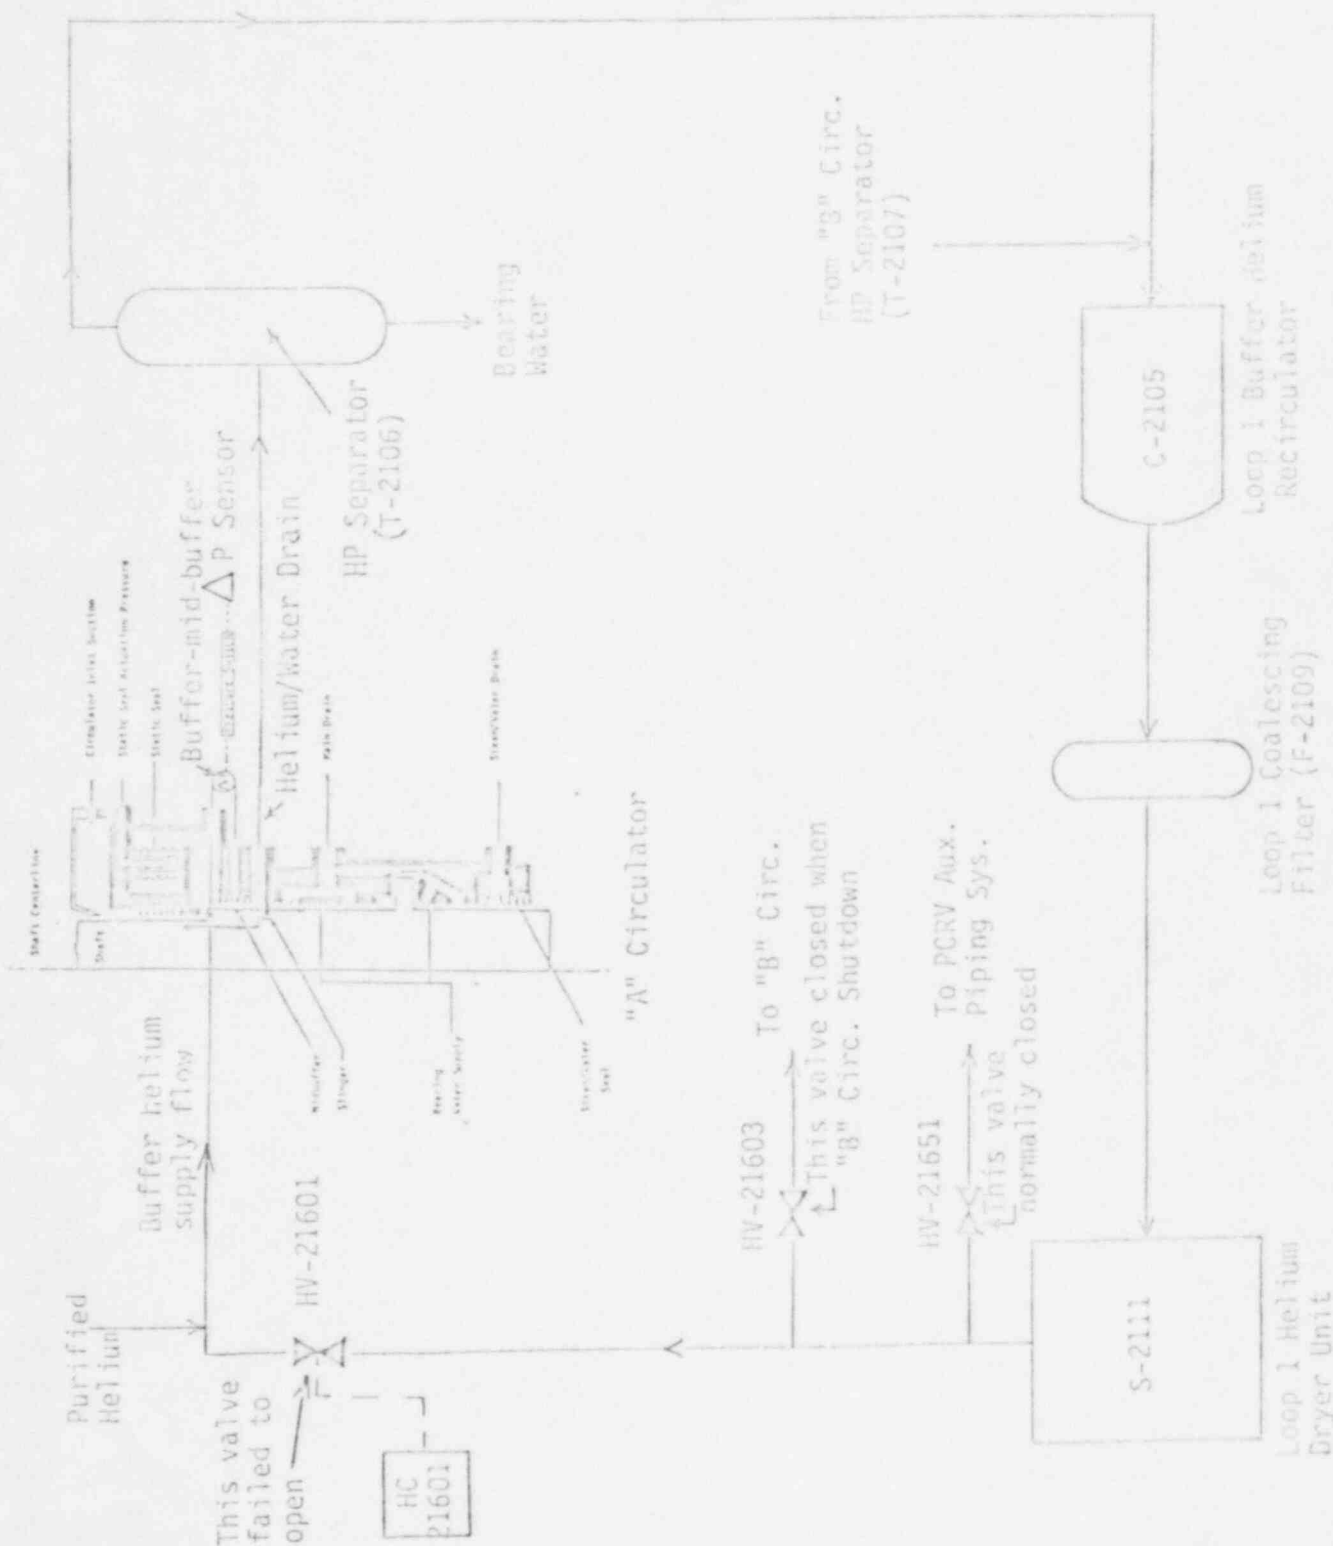
Figure 1

V-21601 failed to open upon actuation of controller HC-21601. With HV-21601 closed and "B" circulator shutdown for Environmental Qualification work, buffer helium could not be discharged from the Loop 1 helium dryer unit (S-2111) (see Figure 1). Eventually, buffer helium flow through the helium/water drain stopped, and all buffer helium makeup flow to "A" circulator from the purified helium header was directed up the circulator shaft into the primary coolant system. This resulted in low buffer-mid-buffer P on "A" circulator and a subsequent circulator trip.

Foreign material in the valve operator of HV-21601 is postulated to have prevented the valve from opening. This resulted in low buffer-mid-buffer ΔP on "A" circulator, and a subsequent circulator trip.

HV-21601 was manually unseated, and "A" circulator was returned to operation without further incident. Following this circulator trip, a Station Service Request (SSR) was initiated to repair HV-21601 (SSR #85515215). Through this SSR, the valve operator will be cleaned, as necessary, to prevent recurrence of this event.
