DEPARTMENT OF VETERANS AFFAIRS
Medical Center
West Los Angeles
11301 Wilshire Boulevard
Los Angeles CA 90073

On December 26, 1996, a few days after the Dual Timer was installed, the Co-60 Teletherapy Unit experienced source drawer malfunctions. Then, a Theratronic's serviceman attempted to determine the root cause but was not successful. Not until the 7th of March did the malfunction in question reoccur. Theratronics was not able to determine the cause but did find a loose wire and made some other minor adjustments. Since that time the failures have again ceased. It is not yet known if these adjustments were directly related to the root cause. Another possibility is that these minor alterations may have temporarily masked the root cause and now it may require quite some time before a source drawer failure occurs again. The serviceman indicated that in order to pinpoint the cause the machine must malfunction again so that he can conduct the appropriate testing which requires the machine to be in the failed state. The amount of time before the next malfunction occurs is not known and may again require several months wait.

Subject: Theratron T780 SN037 - Parts Returned for Investiga

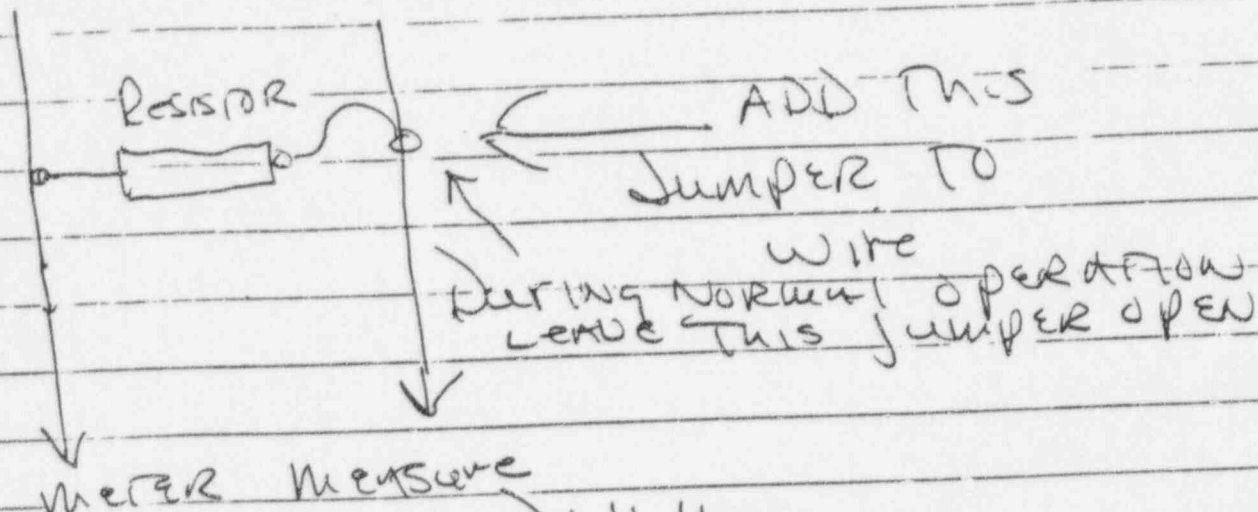
FOR FAILURE MEASUREMENT

WIRES AT Console.

DO NOT MAKE CONNECTIONS WITH SOURCE DRIVE ON (WIRES ARE 115 VOLTS AT THIS TIME)

TO MEASURE K23 IN ROOM USE DC VOLTAGE

AT MEASURE AT BETWEEN

TB2 19 WIRE # 311

TB5 19 WIRE # 105

YOU SHOULD MEASURE 6VDC
