MEMORANDUM

TO FILE: American Nuclear Corp., Permit 357
 FROM: Jim Finley, Hydrologist
 DATE: October 29, 1985
 SUBJECT: Review of Groundwater Conditions and
 at the American Nuclear Mill Site

B. Discussion1. Groundwater Assessment

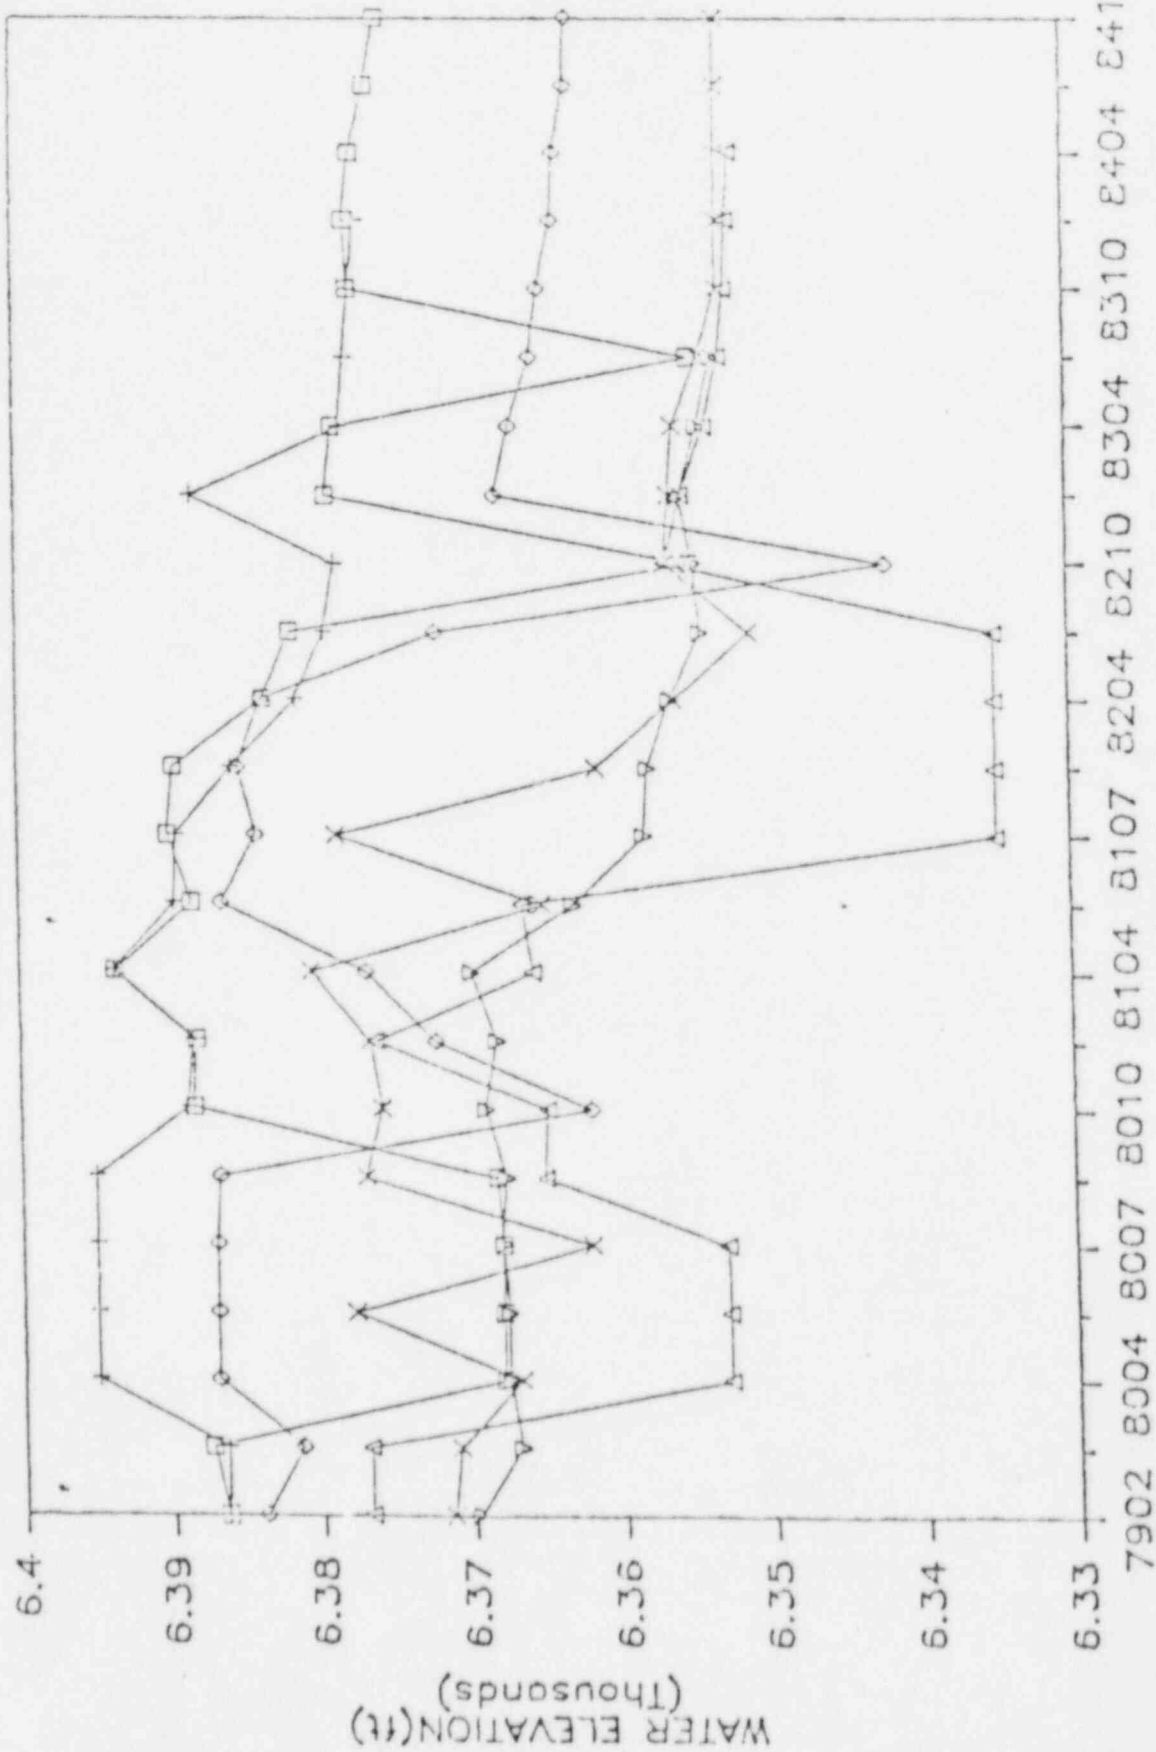
Figure 2

Periods of active pumping from the recovery wells have been sporadic for all wells (Figure 2). Water levels in the recovery wells have decreased since 1979, which is a combination of pumping and decreased water levels in Tailings Pond 1. R-4 has been pumped the most actively though water remains in all wells but R-5. This is not surprising considering that these wells should be drilled to the top of the clay and pre-mining water levels existed in the perched aquifer. Through time, decreased water levels in these wells should become stable, at which point seepage from the tailings pond will have ceased.

An effective pumpback system is necessary in order to minimize further seepage movement into the perched aquifer. The well system has not worked very reliably to date (Figure 2; see August 6, 1985 memo Niles Andrus to NRC). A rejuvenation of the well system coupled with a more effective evaporative technique (e.g. a mist system) should be considered for any decommissioning of this tailings pond.

WATER ELEVATION

1. Renovation/upgrading of the pumpback system below Tailings Pond No. 1. This is imperative if the Susquehanna tailings are disposed of at this site.
2. Construction of a lined evaporation pond outfitted with equipment to enhance evaporation. Pumpback well operation is suggested during the summer months.

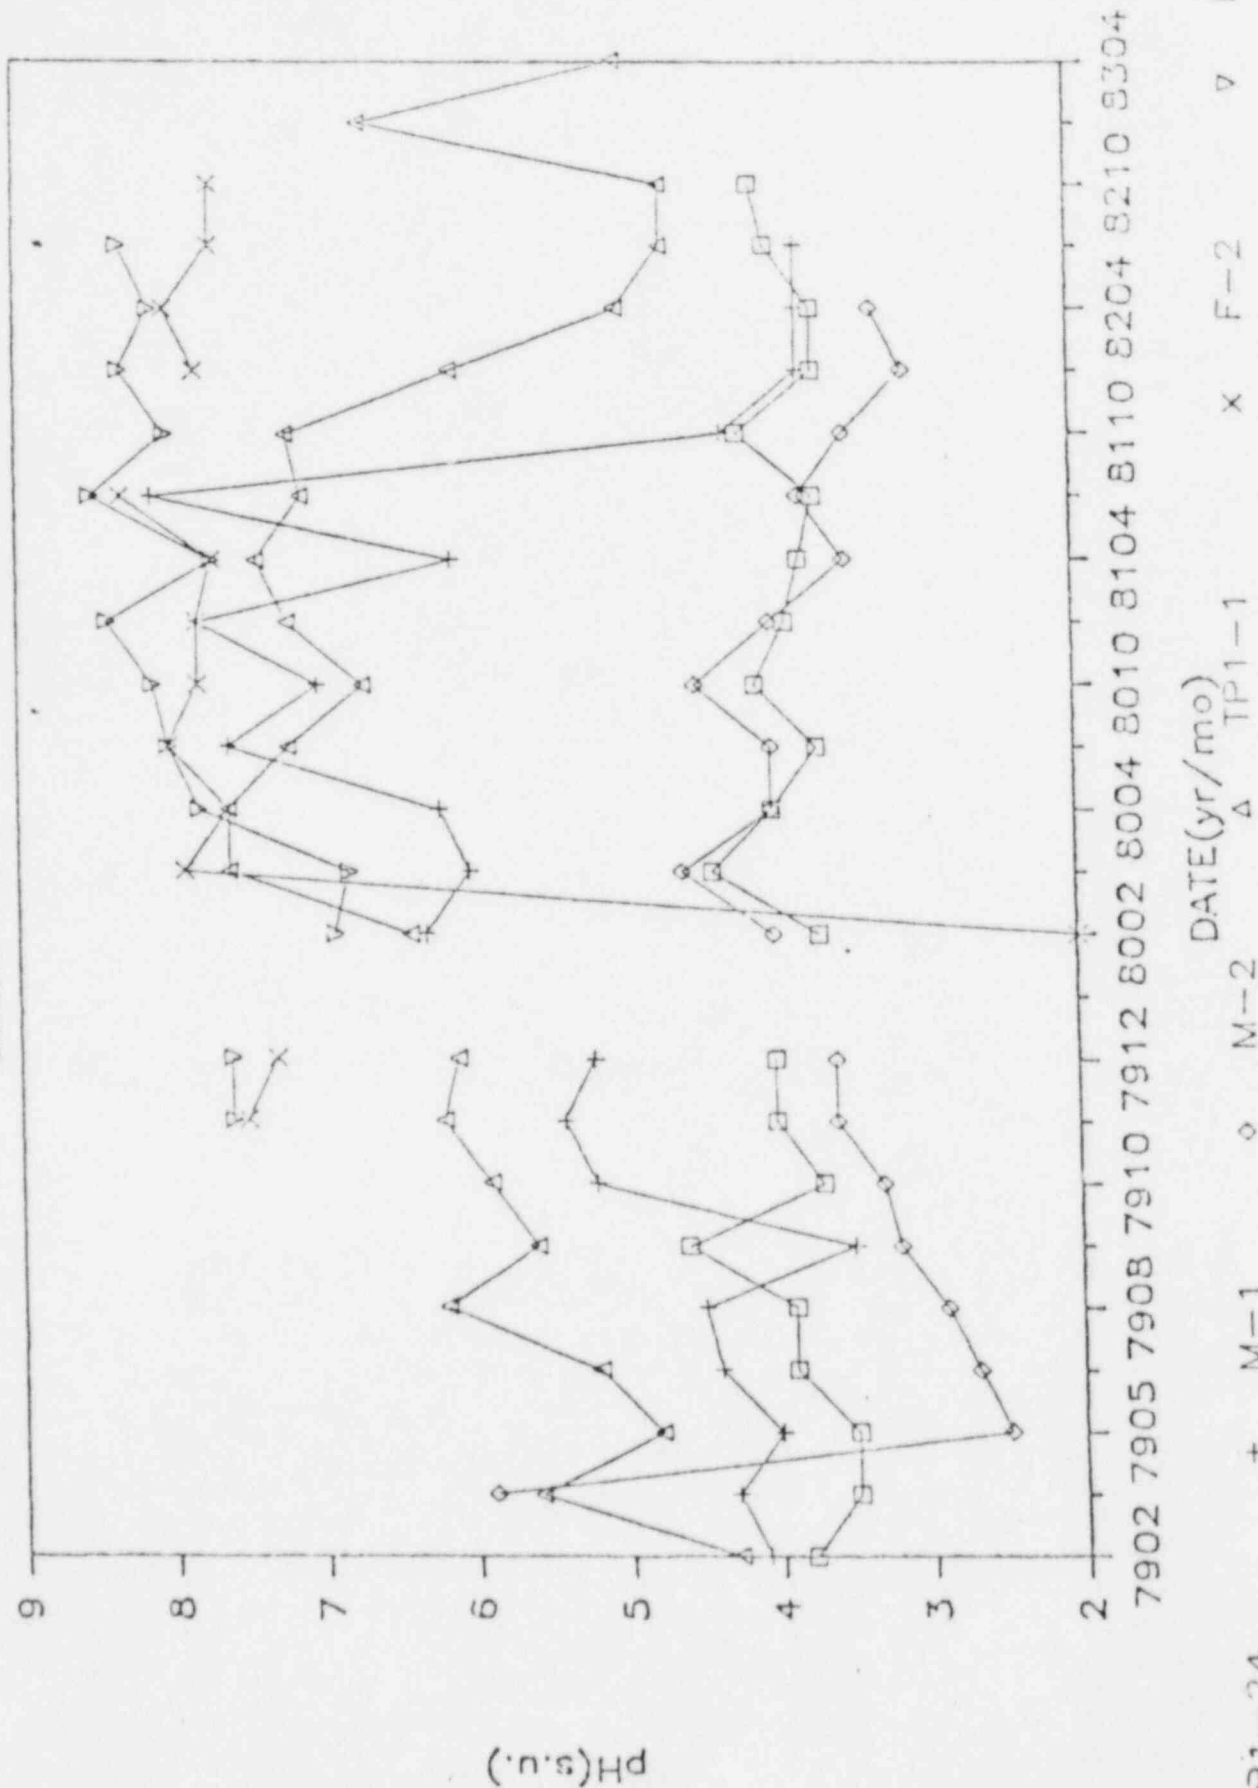
Figure 3

Several water quality parameters were plotted against time for wells in a down gradient direction (Figures 3, 4, 5, and 6). Values of pH rise from two (tailings liquor) to eight as distance down gradient of the tailings is increased (Figure 3). Low pH fluids seeping from the tailings pond are buffered by the natural salt content of the perched aquifer. The rate at which the buffering occurs is controlled by two processes: (1) reaction kinetics; (2) and relative permeability of the aquifer. Reaction kinetics is fixed if the medium is homogeneous. Directional permeability will control rates of flow affecting contact time. Zones of increased permeability (e.g. sand or gravel lenses) will transport low pH water further from the tailings pond. Changes in pH and Eh regulate the relative solubility of major cations and anions, and indirectly the chemistry of toxic trace elements (Johnson, 1985). Values of pH below 6 occur as far down gradient as TP1-1 (Figure 3). It is expected that the zone of low pH will slowly increase in size as the buffering capacity of the aquifer material is exhausted.

pH CONCENTRATION SELECTED WELLS AT FAP
