Florida Power & Light Company, P.O. Box 14000, Juno Beach, FL 33408-0420

Re: St. Lucie Unit 1
Docket No. 50-335
Inspection Report 96-03
Reply to Notice of Violation EA 96-040

Re: St. Lucie Unit 1
Docket No. 50-335
Reply to Notice of Violation
Inspection Report 96-03

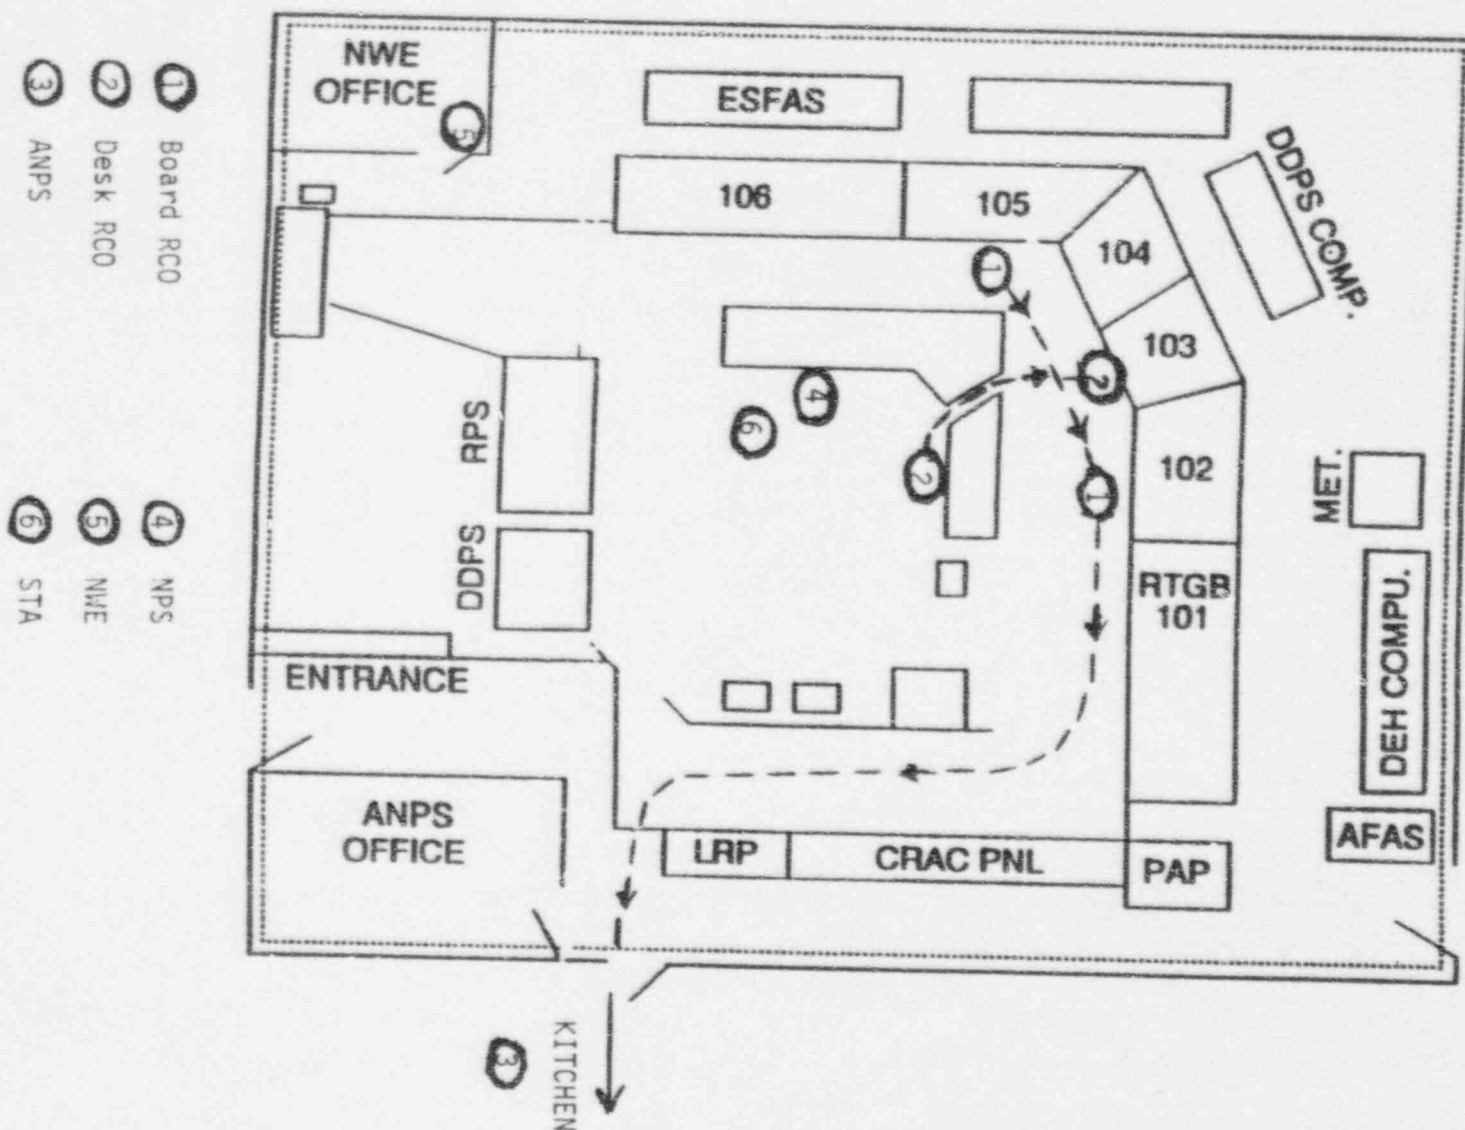
FIGURE 3

The inspectors noted that there was no clearly noticeable indication in the control room of dilution in progress. The dilution water flow totalizer clicker was quiet (and possibly inaudible from the desk area),

sounded identical to the nearby clickers from the waste gas and liquid release totalizers that routinely made noise, and was masked by noise from the control room air conditioning units.

ST LUCIE UNIT 1
CONTROL ROOM ARRANGEMENT

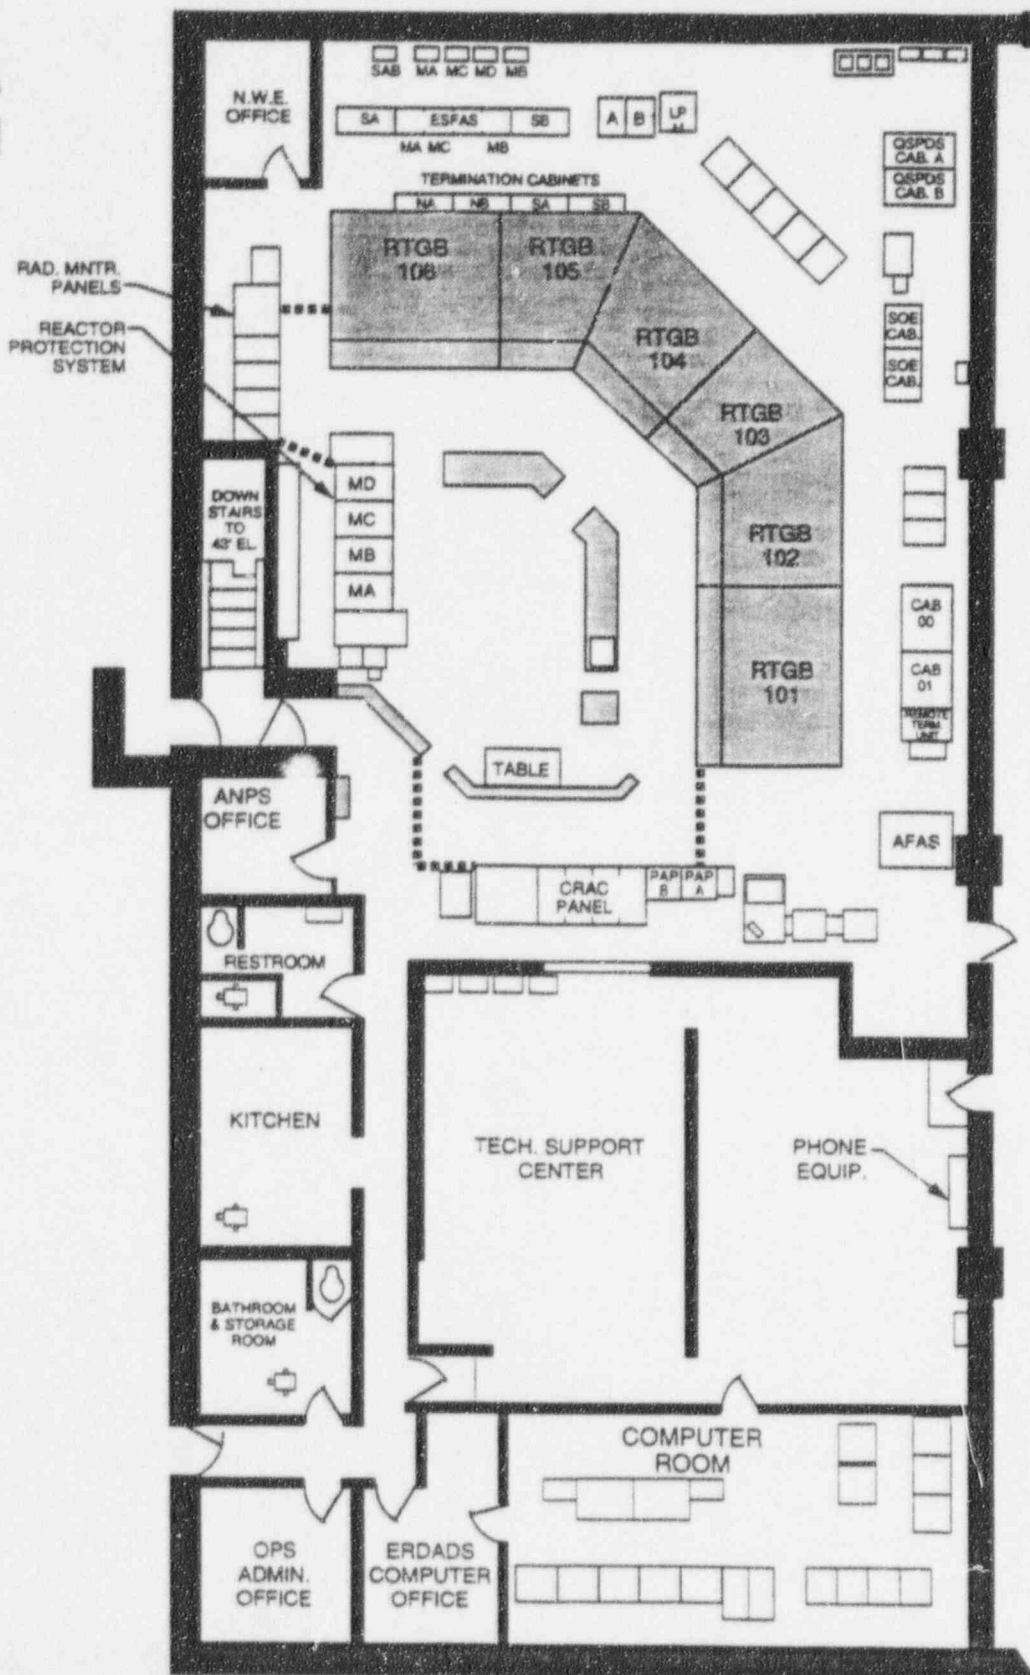
UNIT 1 FLOOR PLAN RAB CONTROL ROOM

ELEVATION 62.00

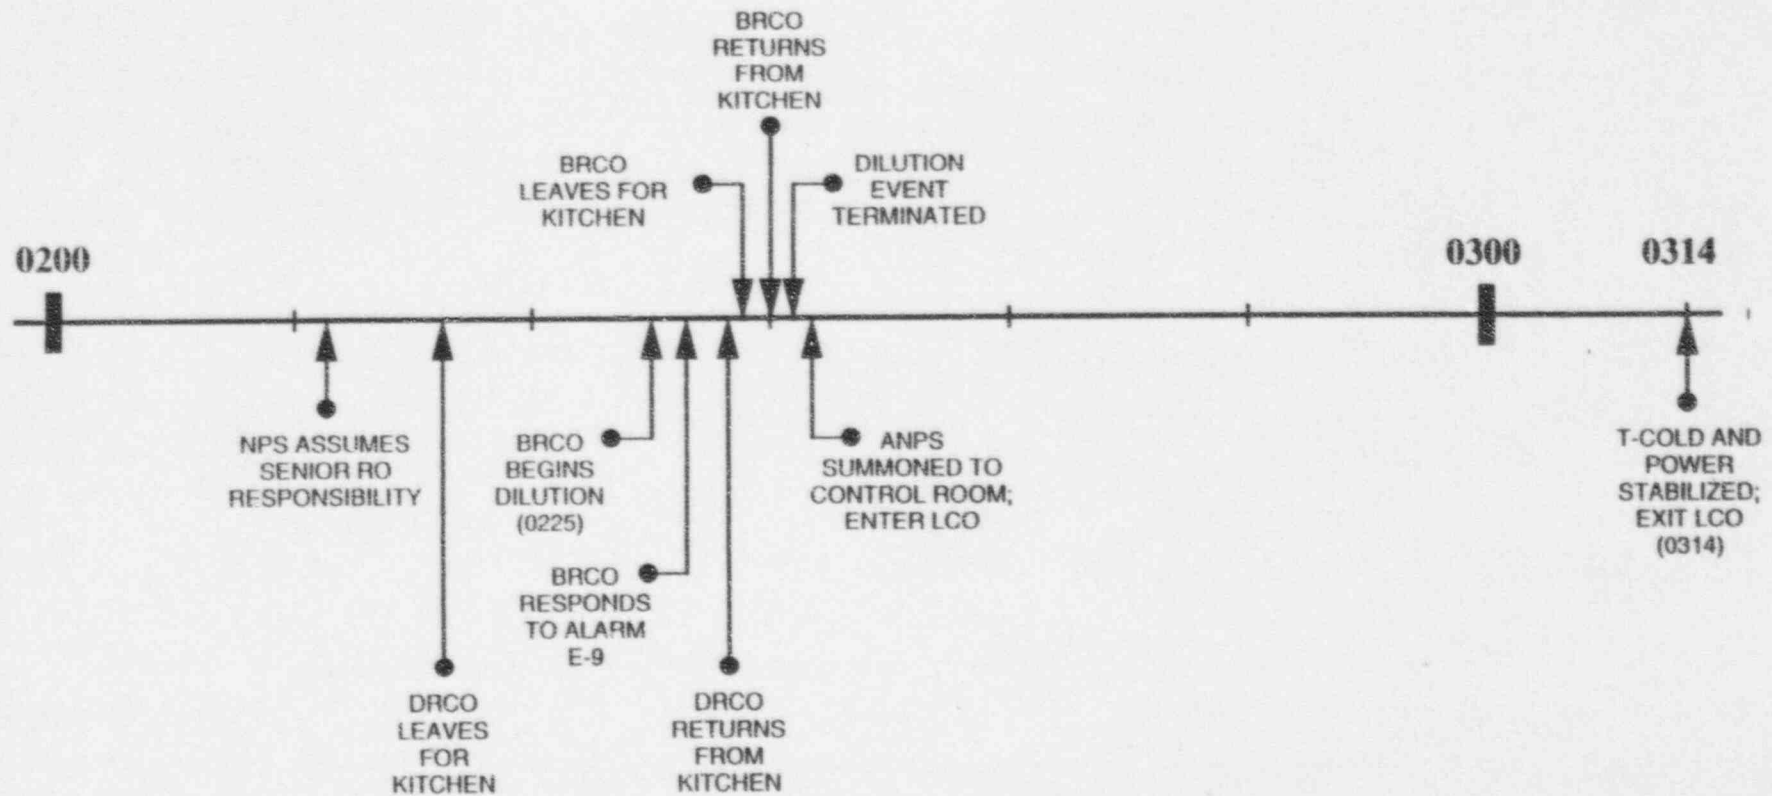
UNIT 1 DILUTION EVENT

JANUARY 22, 1996

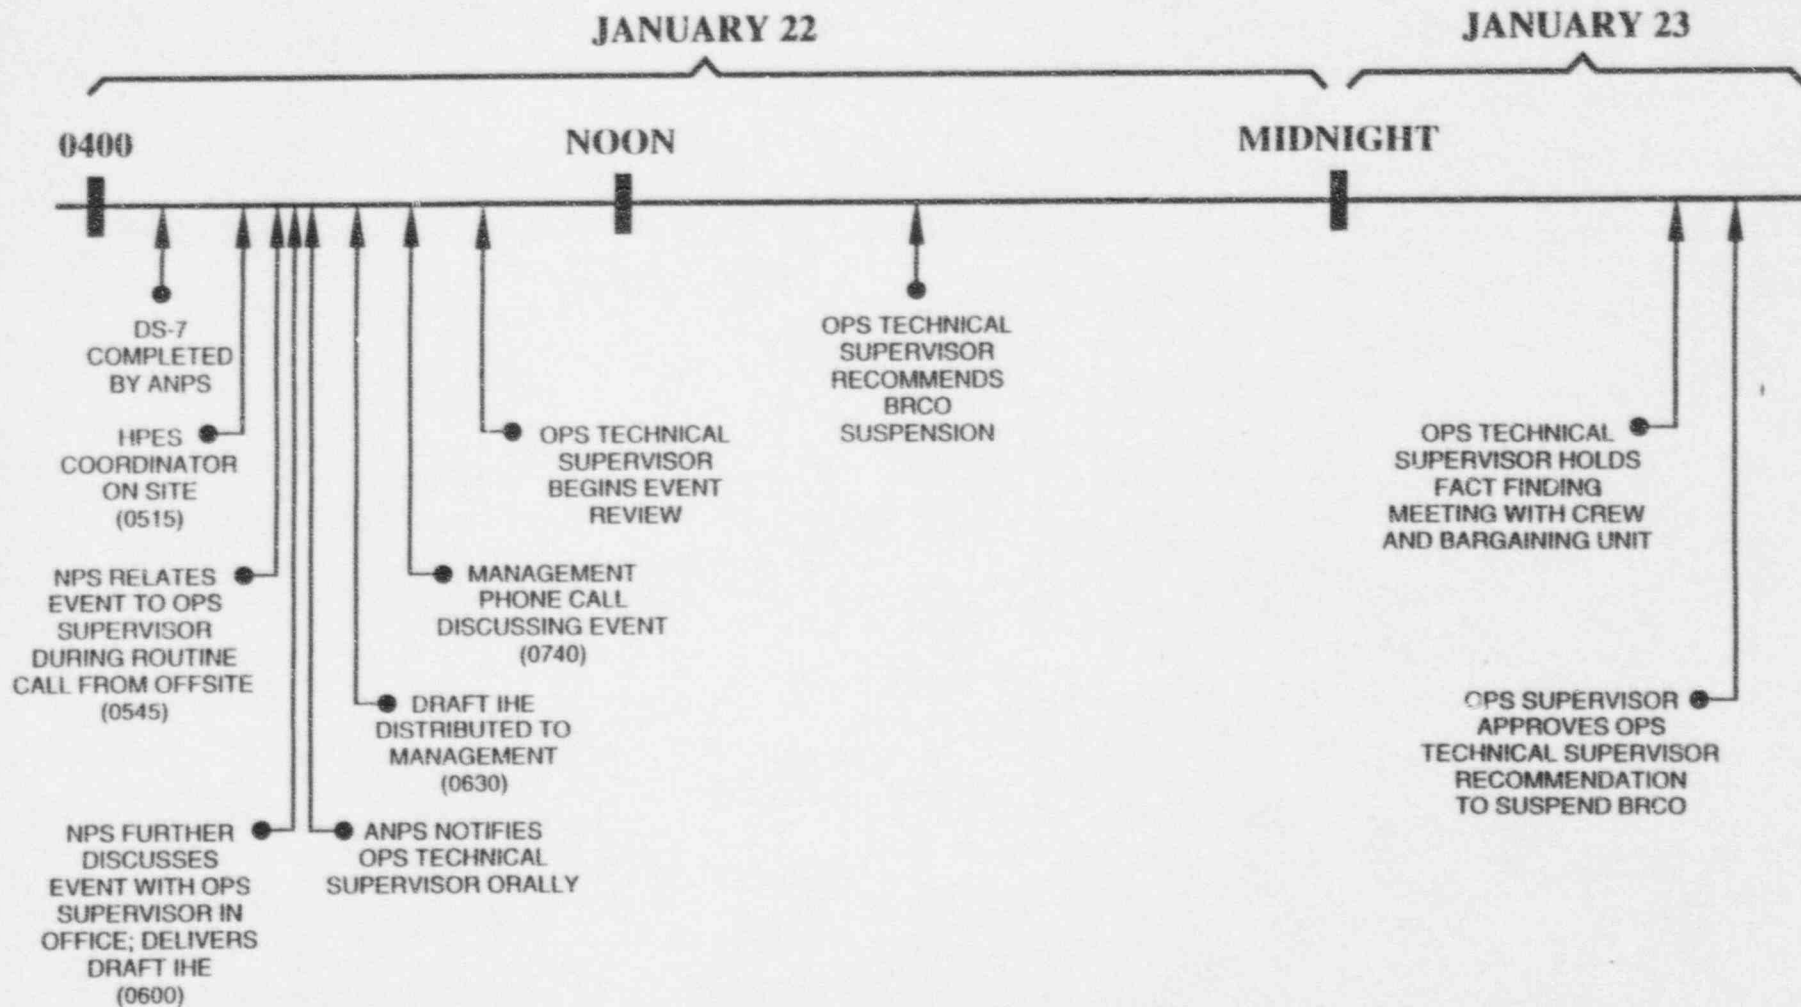
UNIT 1 DILUTION EVENT PROMPT ACTION

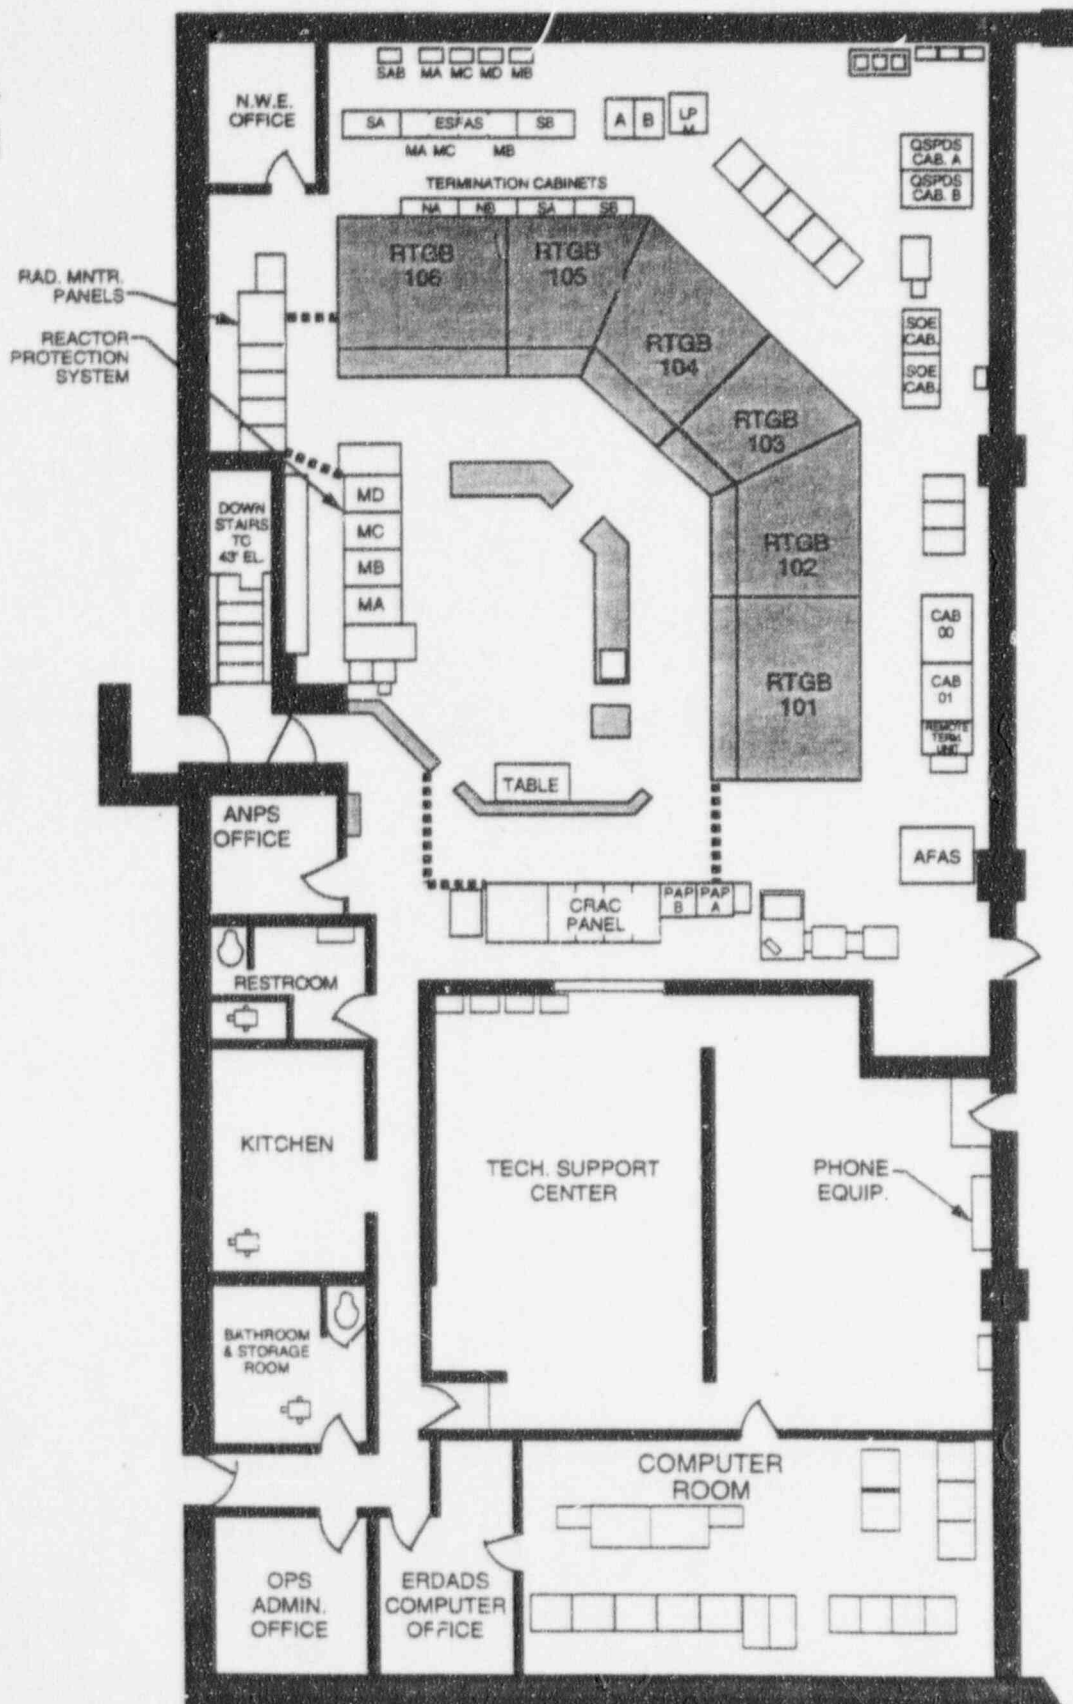
UNIT 1 FLOOR PLAN RAB CONTROL ROOM

ELEVATION 62.00

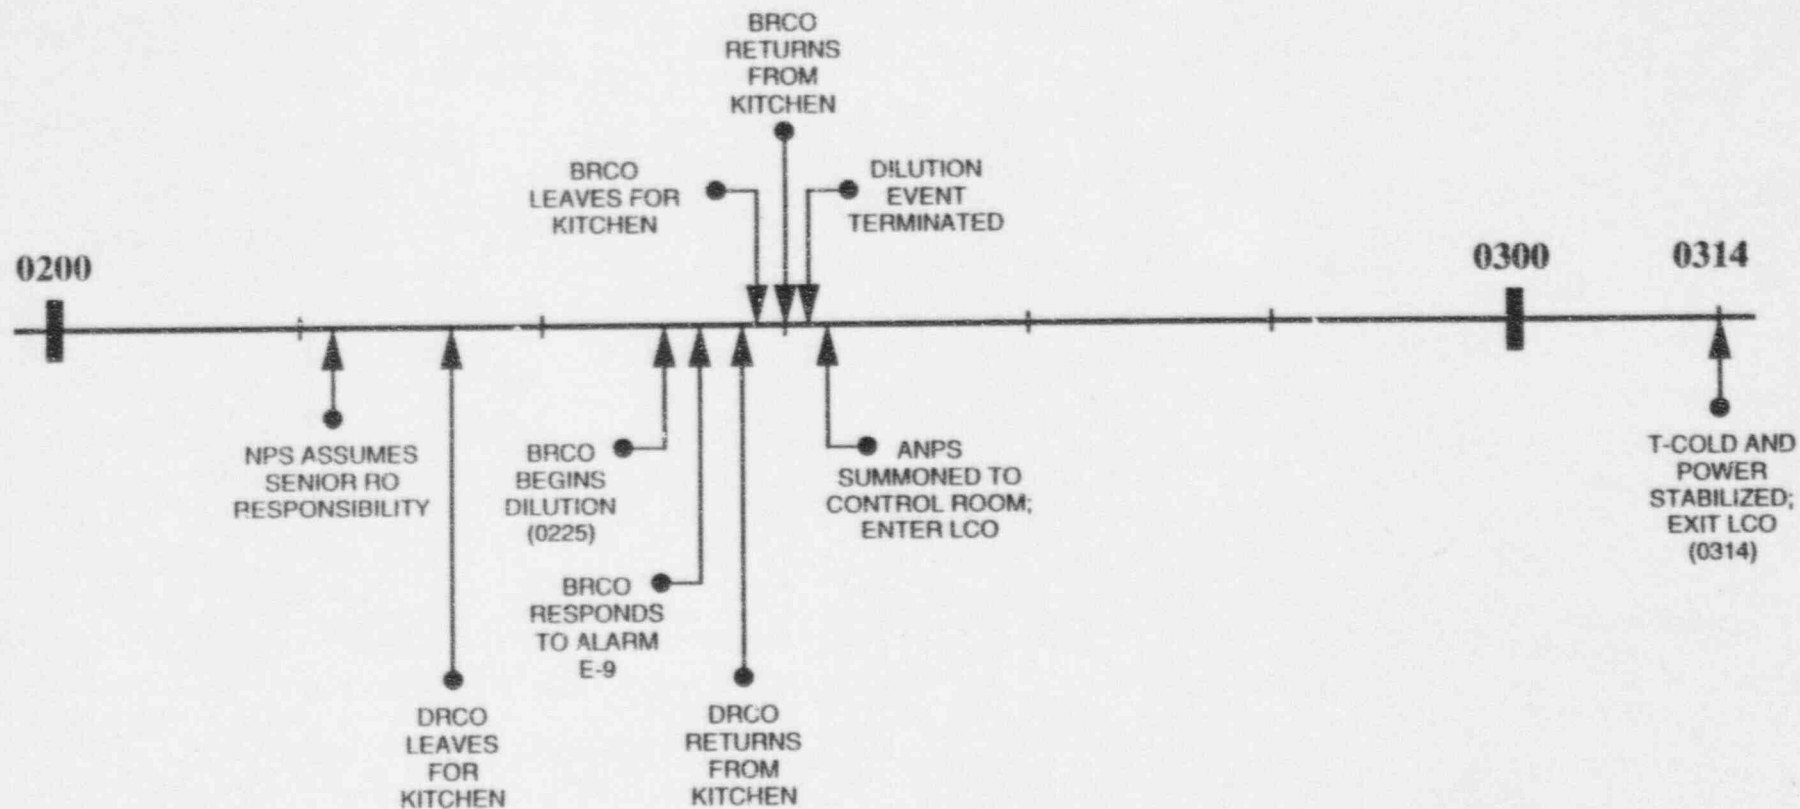
UNIT 1 DILUTION EVENT

JANUARY 22, 1996

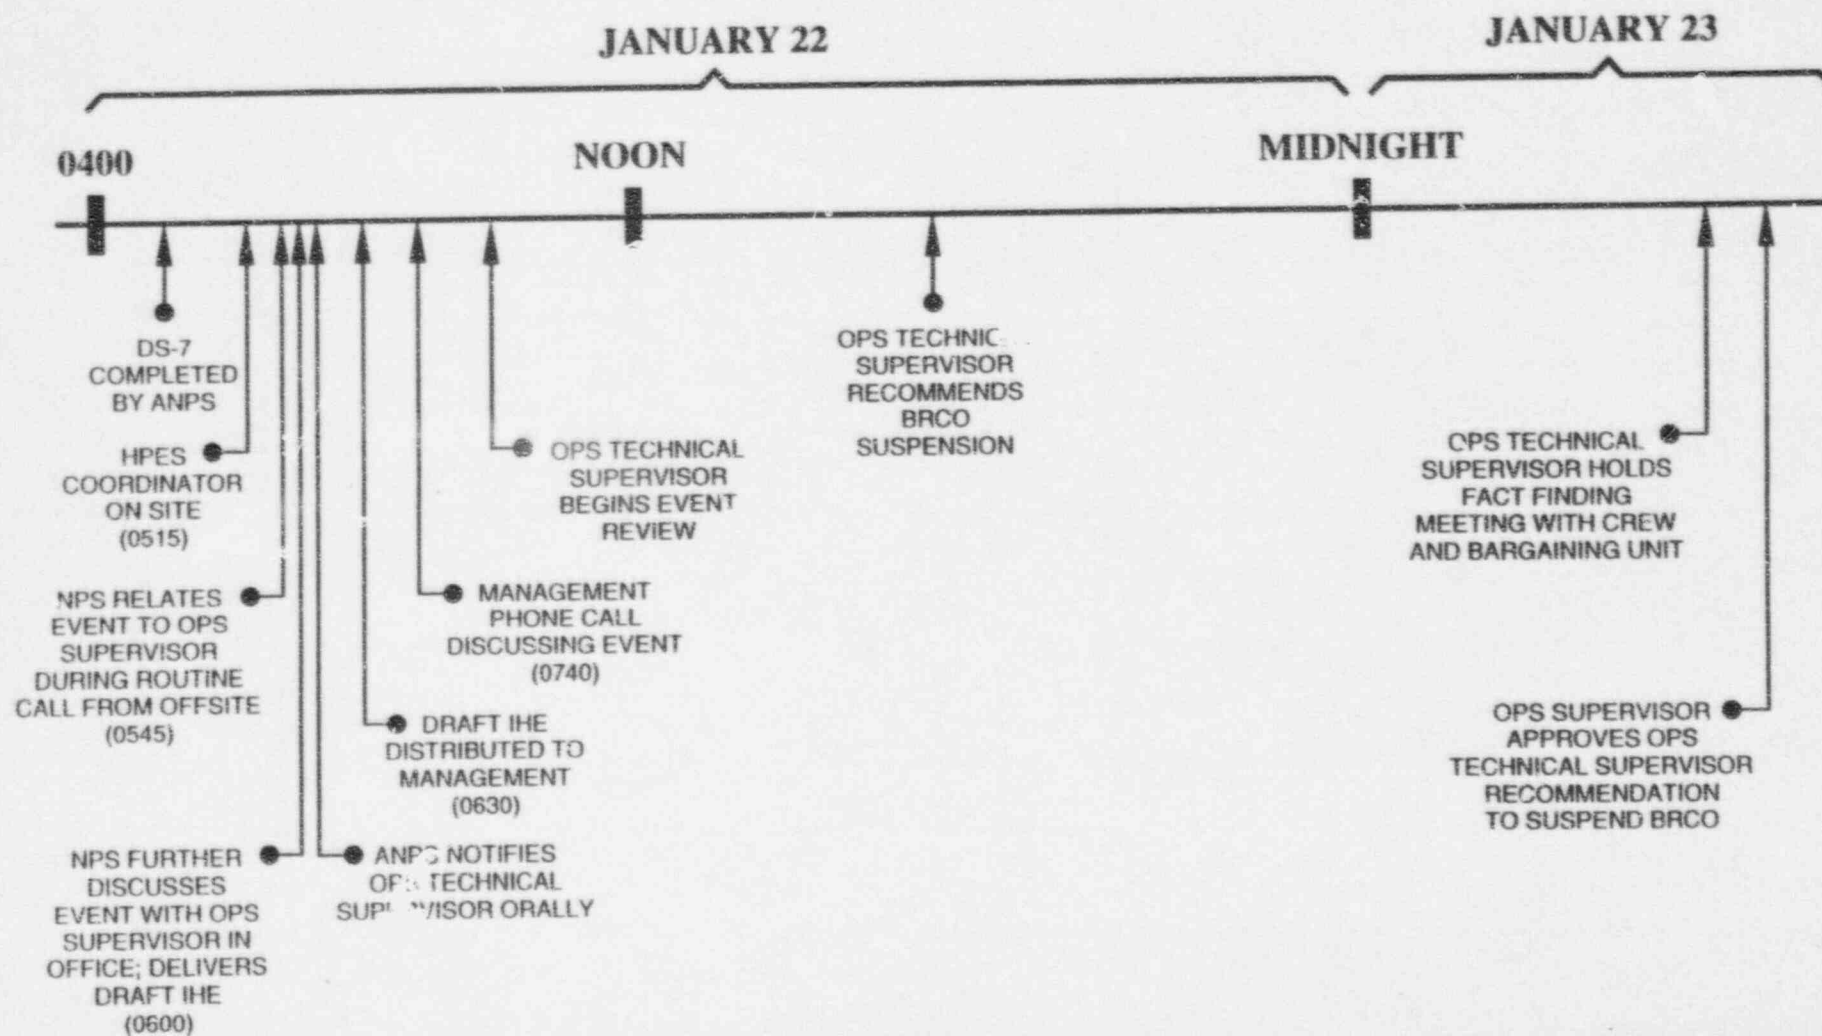
UNIT 1 DILUTION EVENT

PROMPT ACTION
