UNITED STATES
NUCLEAR REGULATORY COMMISSION

AEOD/E97-01

SUBJECT: "REVIEW OF INDUSTRY EFFORTS TO MANAGE PRESSURIZED
WATER REACTOR FEEDWATER NOZZLE, PIPING, AND FEEDRING
CRACKING AND WALL THINNING," NUREG/CR-6456
(INEL 96/0089)

Review of Industry Efforts To Manage Pressurized Water Reactor Feedwater Nozzle, Piping, and Feedring Cracking and Wall Thinning

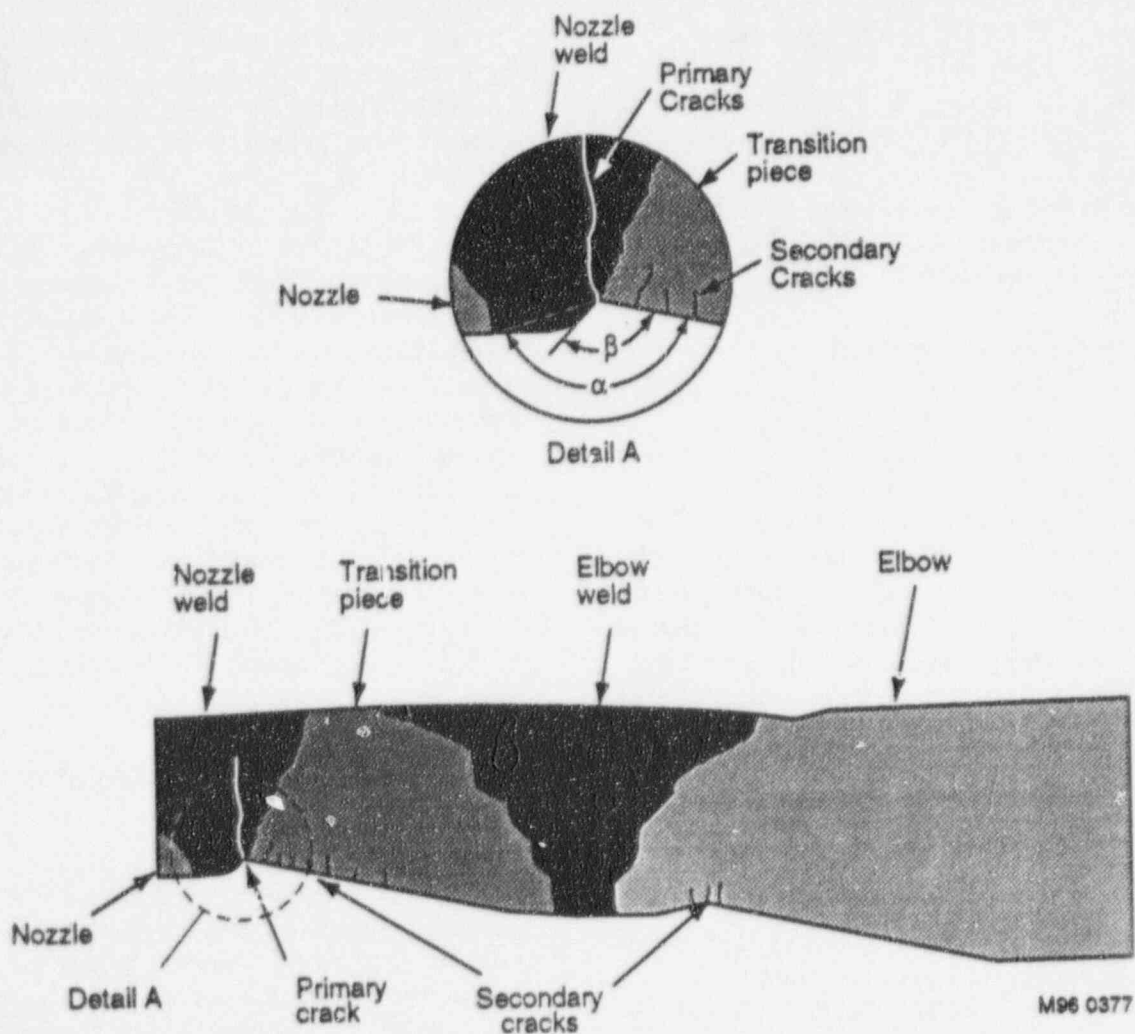
between the nozzle and the transition piece which is smaller than the design angle α ; this causes a stress concentration greater than the design value. This higher stress concentration factor contributed to the initiation of a primary crack at this location (discussed in Section 6.3.1).

Figure 18. Geometric discontinuity introduced by the field welding between the feedwater nozzle and the transition piece (TVA 1992) (modified).

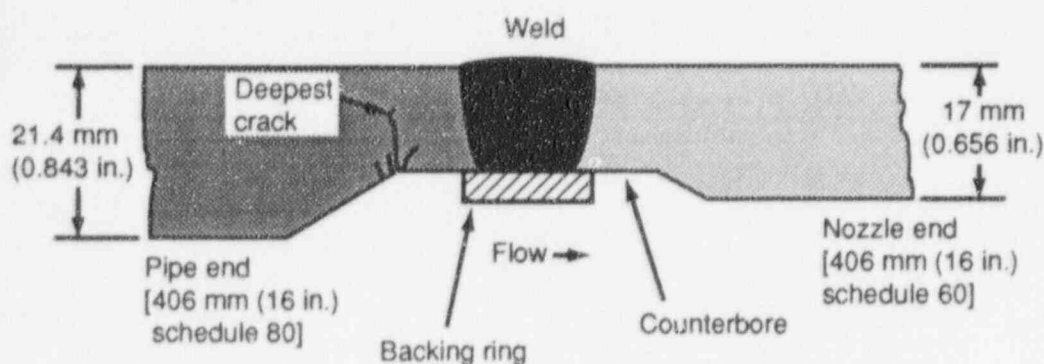
Typical cracks were transgranular, oriented in the circumferential direction and initiated at the inside surface, as shown in Figure 22. In this figure, the primary crack (deepest crack) is a circumferential crack that has grown in the radial direction. There are several shallow secondary cracks adjacent to the primary crack. Whereas the maximum crack depth in some units was less than 2.5 mm (0.100 in), several cracks had propagated 6 to 19 mm (0.250 to 0.750 in.) through the wall. Most of the cracking occurred in the counterbore region of the base metal (see Section 3.3), primarily at the re-

(a) Crack profile in degraded feedwater piping.

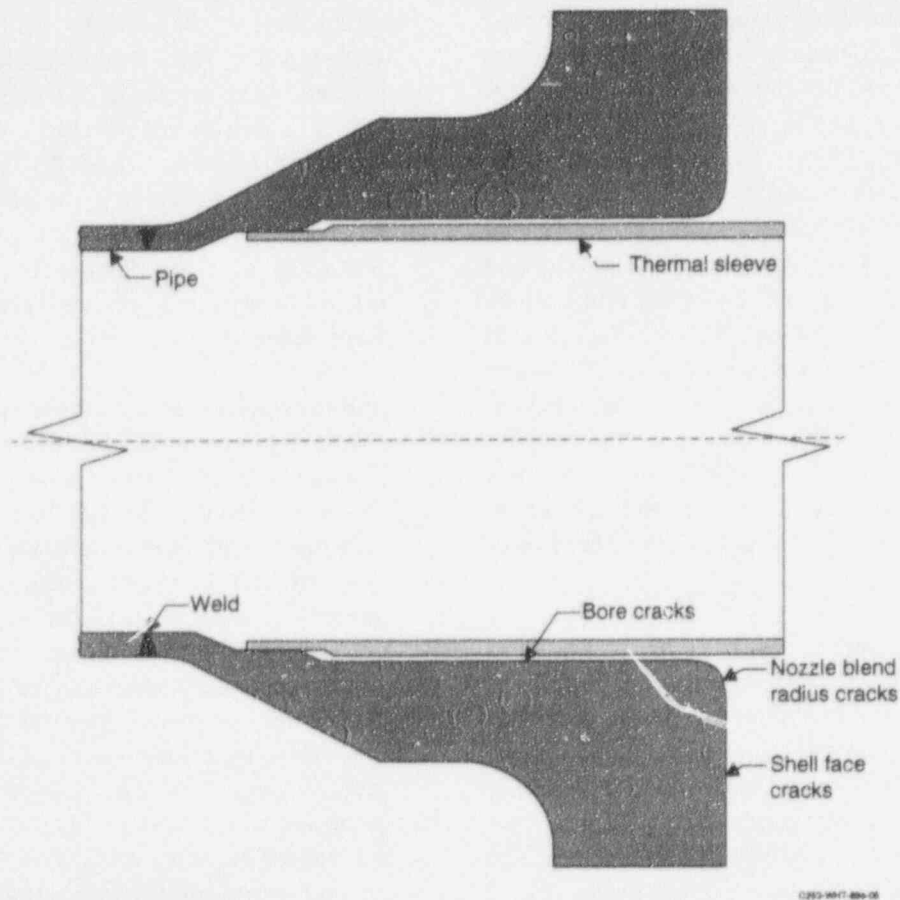
Visual examination detected linear indications on the inner radius section of one of the four feedwater nozzles. These indications were located on the lower 120-degree segment of the nozzle. Liquid penetrant examination confirmed these indications and also found additional indications on the two support brackets welded to the nozzle just below the knuckle. Visual and penetrant examination on the other three nozzles revealed linear indications on the inner radius section of one

Figure 23. Locations of thermal fatigue cracks in an Indian Point Unit 2 feedwater nozzle and steam generator shell caused by bypass leakage of cold feedwater (Westinghouse 1989).

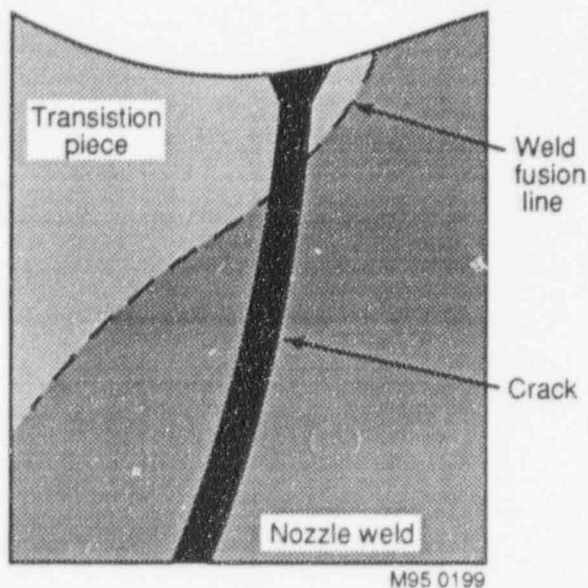
Figure 26. Through-wall crack in the feedwater nozzle weld at Sequoyah Unit 1 (TVA 1992b).

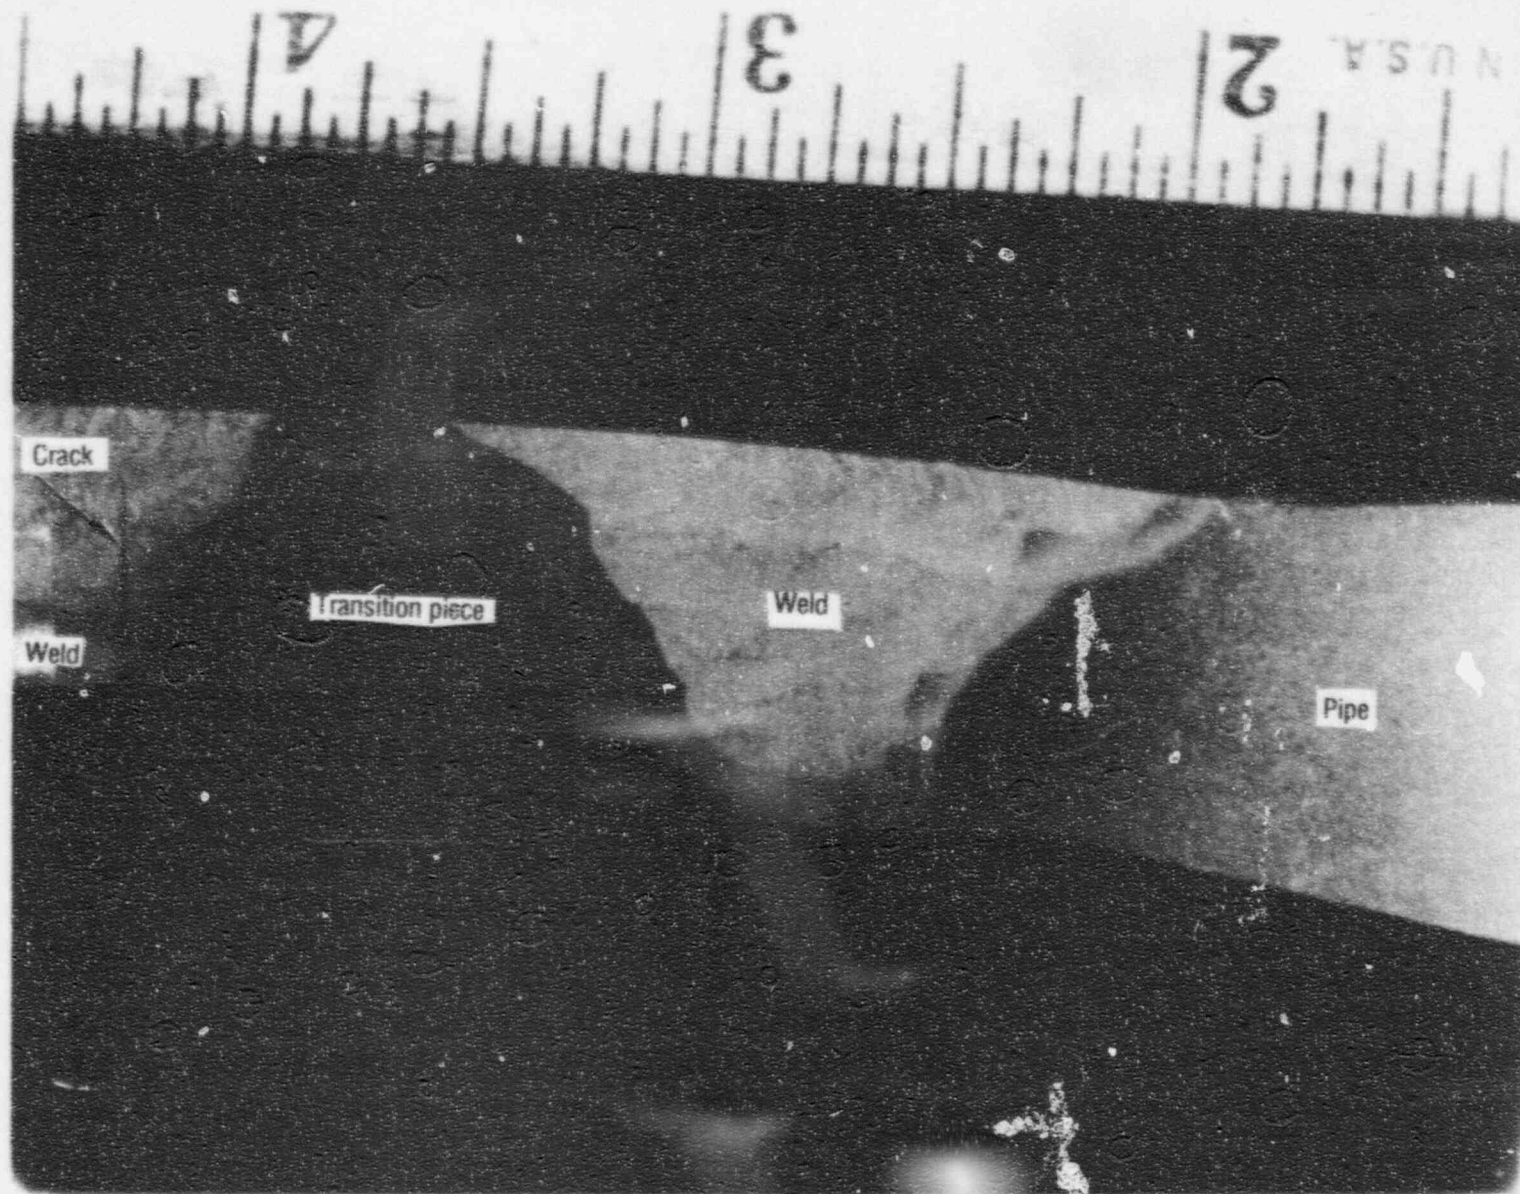
Figure 28. Direction of propagation of a primary crack in Sequoyah Unit 1 (TVA 1992b).

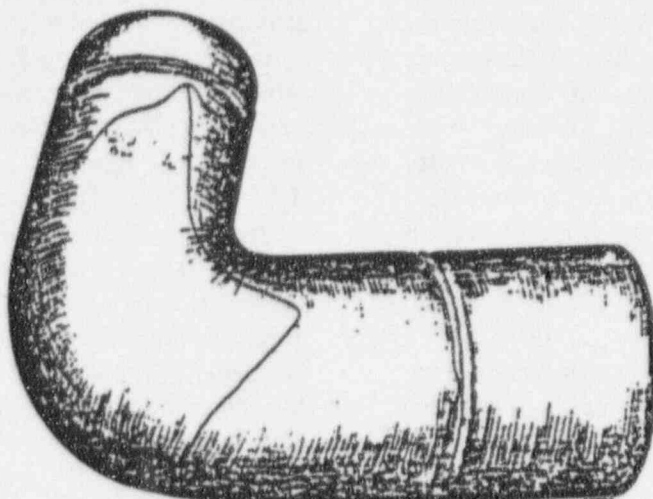
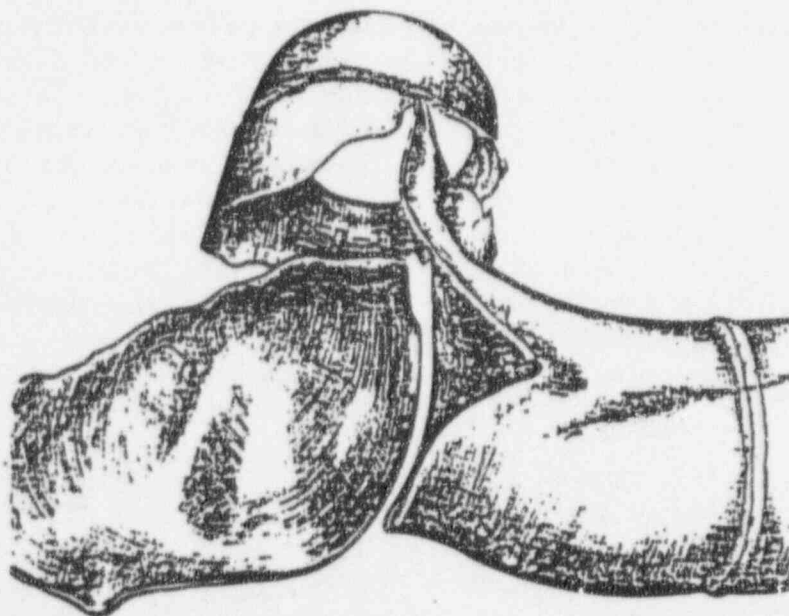
(a) Rupture lines in intact pipe.

(b) Pipe after rupture.
