LICENSEE EVENT REPORT (LER)

FACILITY NAME (1)	DOCKET NUMBER (2)	PAGE (3)
Fort St. Vrain, Unit No. 1	0 5 0 0 0 2 6 1 7	1 OF 0 5

TITLE (4)
"C" Helium Circulator trip on Buffer-Mid-Buffer low

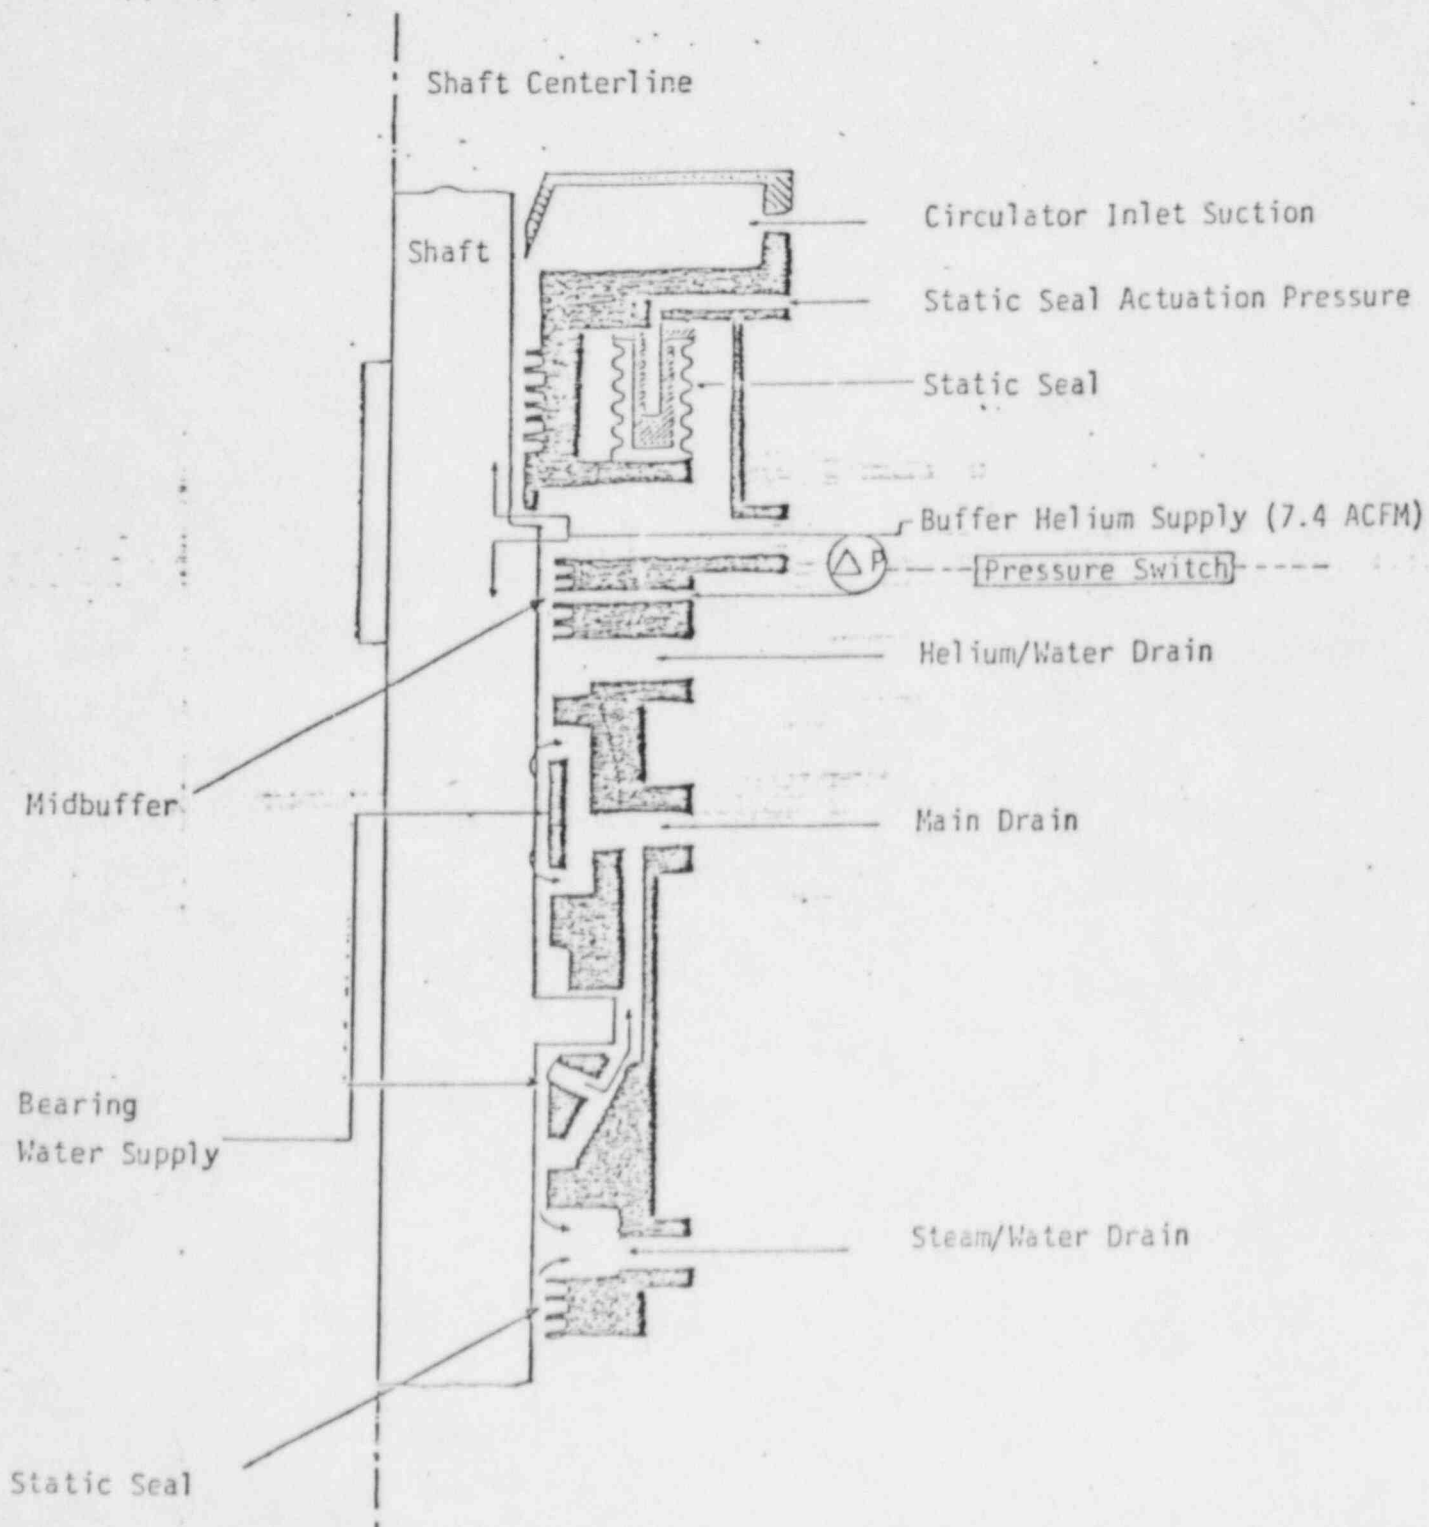
FIGURE 1

A double labyrinth seal with purified helium buffer gas injected between the labyrinths ensures no leakage of primary coolant helium out of the PCRV, or of bearing water leakage into the primary coolant along the helium circulator shaft. The independent helium circulator buffer helium control system maintains the helium water drain pressure such that approximately half of the buffer helium flows upward into the primary coolant system and the remainder flows out through the helium/water drain (Figure 1).

Investigation into the cause of "C" helium circulator trip revealed that bearing water had entered the buffer-mid-buffer differential pressure sensing lines, causing a gradual reduction in indicated differential pressure.

The buffer-mid-buffer differential pressure sensing lines to "C" helium circulator were "blown down" with helium to remove the water. "C" helium circulator was returned to "self turbinng" operation at 1945 hours on January 5, 1986.
