LICENSEE EVENT REPORT (LER)

FACILITY NAME (1)										DOCKET NUMBER (2)										PAGE (3)																																																																																																																																	
Peach Bottom Atomic Power Station - Unit 2										0 5 0 0 0 2 7 7										1 OF 0 4																																																																																																																																	
TITLE (4)																																																																																																																																																					
Containment Isolations Caused by Stray Strands of Wire																																																																																																																																																					
EVENT DATE (5)									LER NUMBER (6)									REPORT DATE (7)									OTHER FACILITIES INVOLVED (8)

Abstract: 2-85-28

SUBJECT: Licensee Event Report
Peach Bottom Atomic Power Station - Unit 2

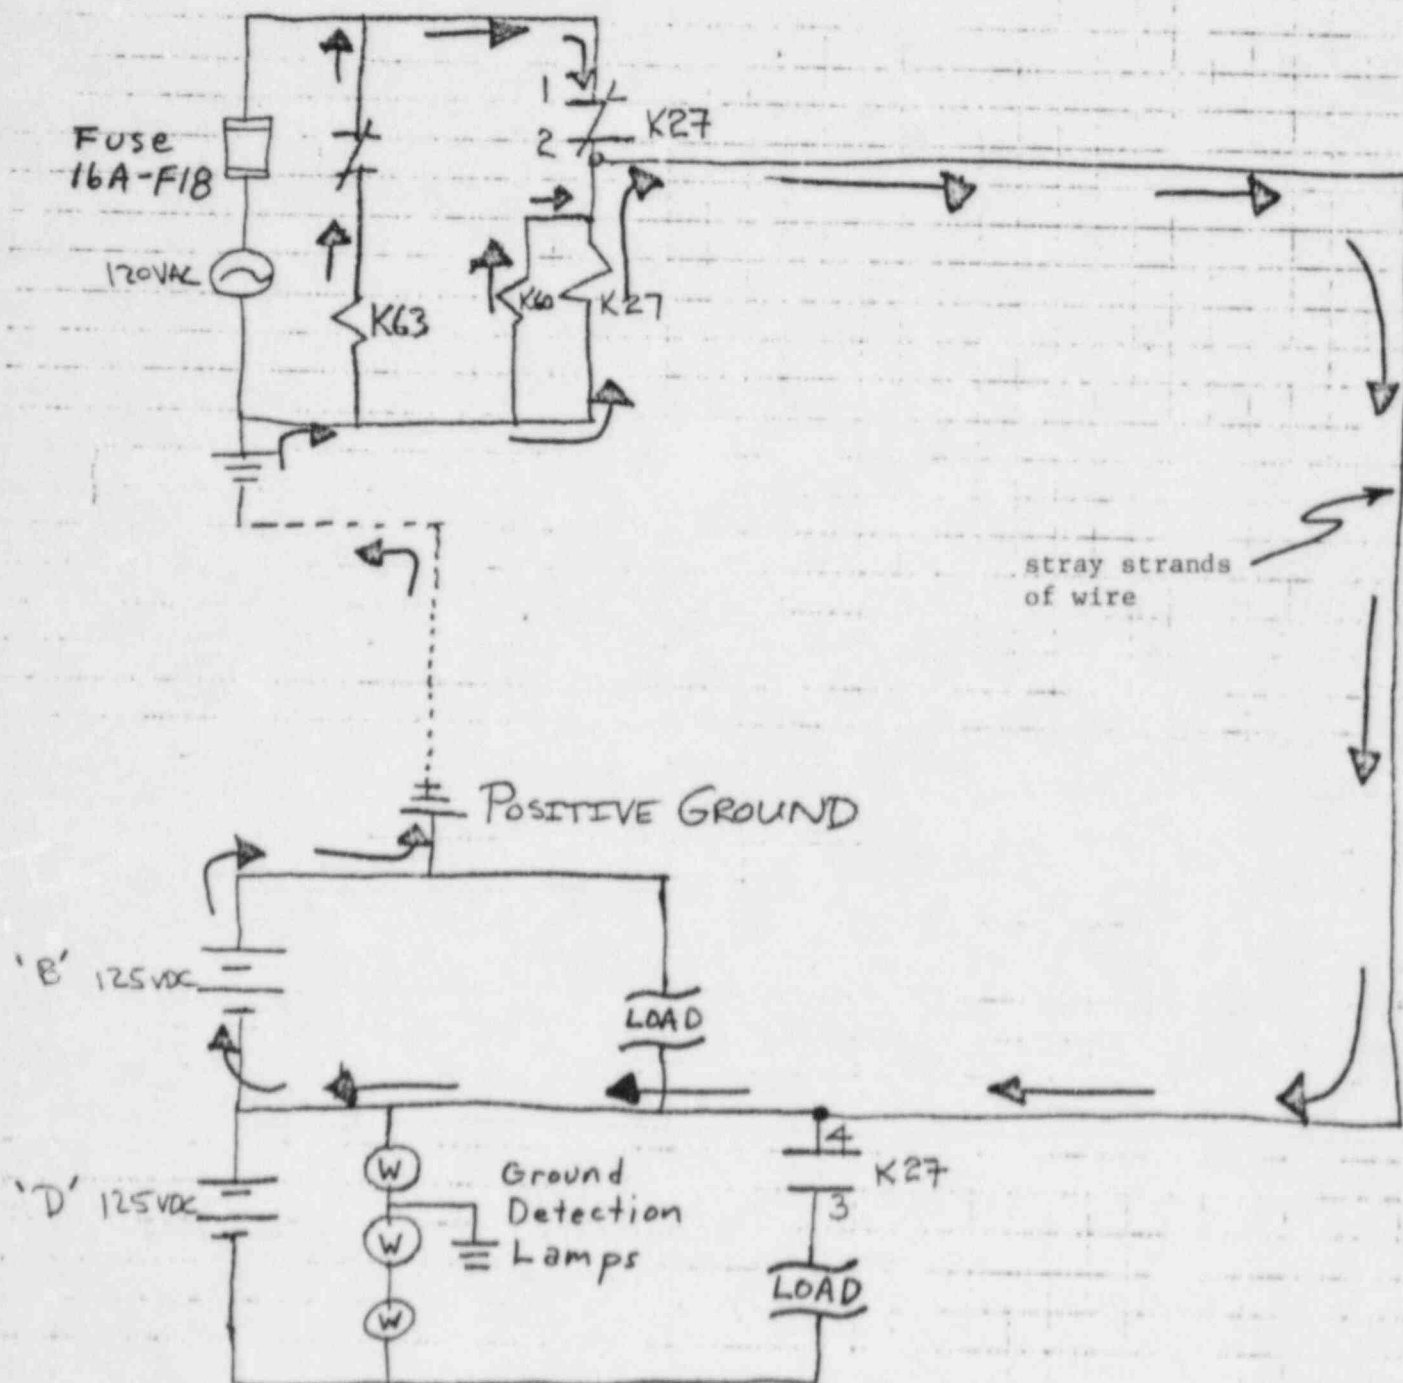
A few stray strands of wire that were supposed to be connected to terminal 2 of relay 16A-K27 (G.E. CR-120) came in contact with, and fused to, terminal 4 of relay 16A-K27. This introduced DC voltage into the AC circuit (see attachment). The DC voltage had a return path when a positive ground occurred on the "B" and "D" batteries. DC current subsequently damaged the AC coils of relays 16A-K60 and 16A-K63 by excessive heat. Relay 16A-K27 was not damaged.

The RWCU isolation did not occur when the fuse blew because relays 16A-K60 and 16A-K63 remained energized with the DC current.

The isolations did not immediately occur when the leads to the coil of relay 16A-K60 were removed because the relay stuck in the energized position due to the damage it experienced. A few minutes later the relay moved to the de-energized position and initiated the isolations.

On December 27, 1985 relays 16A-K60 and 16A-K63, and fuse 16A-F18 were replaced and tested, and the stray strands of wire on the 16A-K27 relay were properly connected. The battery ground was eliminated on December 27, 1985 at approximately 1400 hours.

To avoid recurrence of this problem, all safety-related, feedwater, and ventilation G.E. CR-120 relays were inspected for stray strands of wire in contact with other terminals. No problems were found.
