RADIOLOGIC AND ENGINEERING ASSESSMENT

DOE ID NO.: GJ-03491-RS  
ADDRESS: 2028 LINDA LANE

SEPTEMBER 1985

BENDIX FIELD ENGINEERING CORPORATION  
P.O. Box 1569  
Grand Junction, Colorado 81502

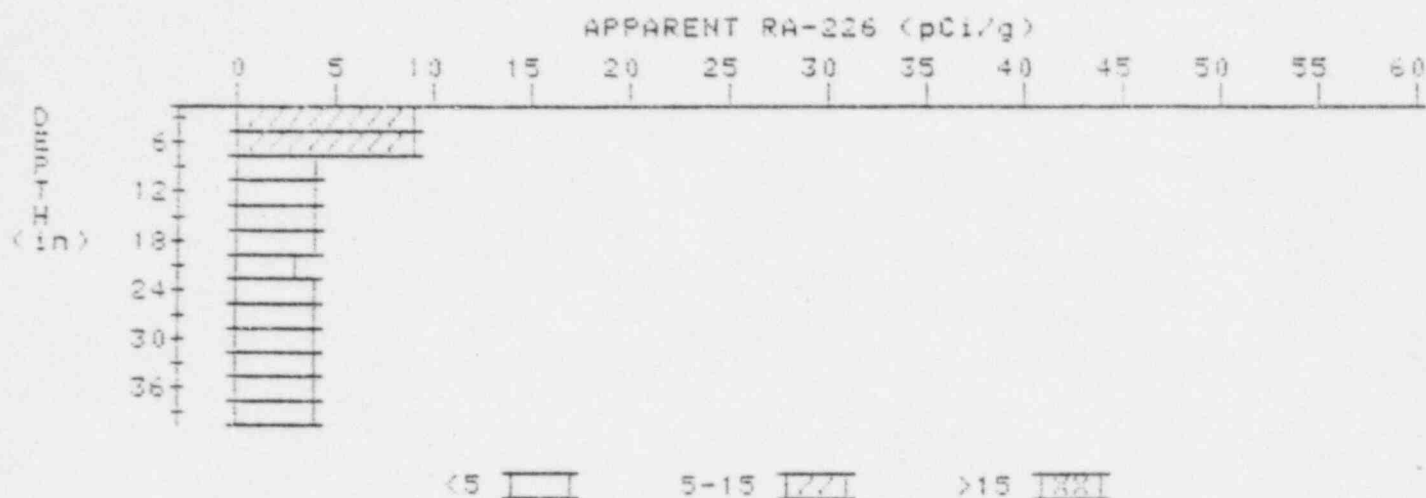
HOLE NUMBER: 3

Loc #	Grid Location	Depth (in.)	Meas. Type	In Situ Ra-226 (pCi/g)		Chem Ra-226 (pCi/g)	Comments
				Tot. Ct	Spectr.		
1	140210	00	DS	5.2		*	Southwest of the primary structure
2	140230	00	DS	6.7		*	Southwest of the primary structure
3	140255	00	DS	12.7		*	Sidewalk
		03	TC	9.2		*	West of primary structure
		06	TC	7.9		*	DC = 9 inches
		09	TC	5.9		*	Based on the deconvolution graph
		12	TC	4.9		*	
		15	TC	4.4		*	
		18	TC	4.2		*	
		21	TC	3.9		*	
		24	TC	3.9		*	
		27	TC	4.0		*	
		30	TC	3.9		*	
		33	TC	3.8		*	
		36	TC	3.8		*	
		39	TC	3.8		*	
4	143212	00	DS	<1.0		*	Southwest of primary structure
		06	DS	<1.0		*	
5	152252	00	DS	1.3		*	West of primary structure
		06	DS	1.4		*	
6	160240	00	DS	3.5		*	West of primary structure
		06	DS	2.0		*	
7	165255	00	DS	11.7		*	West of primary structure
		06	DS	3.4		*	DC = 9 inches
		03	TC	9.0		*	Based on the deconvolution graph
		06	TC	7.4		*	
		09	TC	5.9		*	
		12	TC	5.0		*	
		15	TC	4.7		*	
		18	TC	4.5		*

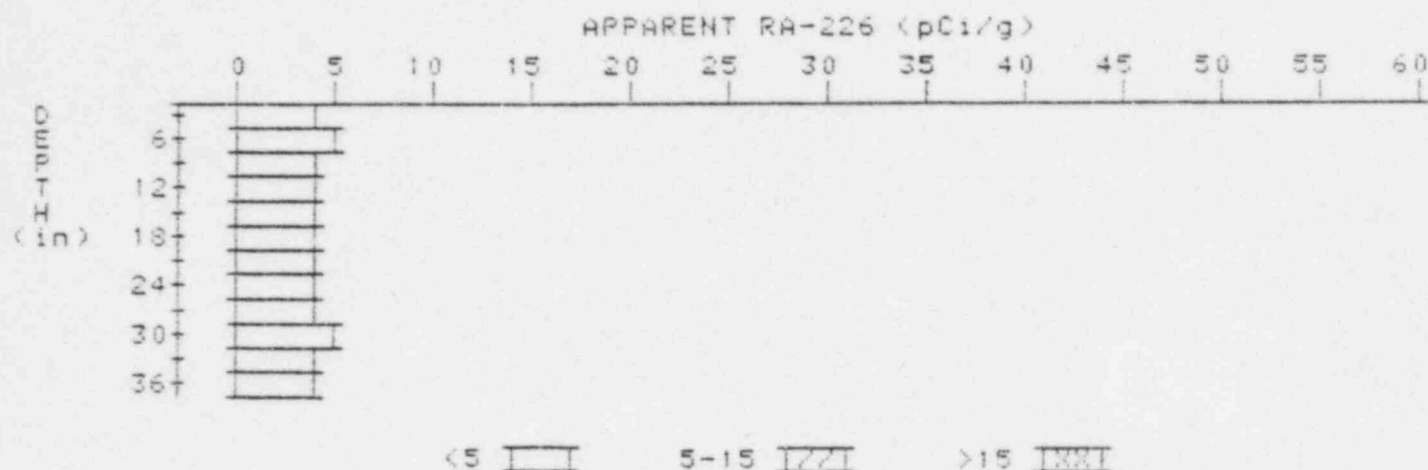
HOLE NUMBER: 3

Loc #	Grid Location	Depth (in.)	Meas. Type	In Situ Ra-226 (pCi/g)		Chem Ra-226 (pCi/g)	Comments
				Tot. Ct	Spectr.		
8	166264	00	DS	3.0		*	Northwest of the primary structure
		03	TC	4.3		*	
		06	TC	4.4		*	DC = 6 inches Based on all available data
		09	TC	4.3		*	
		12	TC	4.2		*	
		15	TC	4.1		*	
		18	TC	4.2		*	
		21	TC	4.2		*	
		24	TC	4.1		*	
		27	TC	4.1		*	
		30	TC	4.2		*	
		33	TC	4.1		*	
		36	TC	4.1		*	
9	171261	00	DS	3.0		*	Gas line
		12	DS	1.7		*	Top of gas line
10	176231	03	TC	3.4		*	Background
		06	TC	3.6		*	West side of
		09	TC	3.7		*	primary structure
		12	TC	3.8		*	DC = 0 inches
		15	TC	3.9		*	
		18	TC	3.9		*	
		21	TC	3.9		*	
		24	TC	4.0		*	
		27	TC	3.9		*	
		30	TC	4.0		*	
		33	TC	3.9		*	
		36	TC	3.7		*	
		39	TC	3.7		*	
		42	TC	3.7		*	
		45	TC	3.8		*	
		48	TC	3.7		*	
		51	TC	3.8		*	
		54	TC	3.8		*	
11	183264	00	DS	1.6		*	North of primary structure
		06	DS	1.1		*	
12	192261	00	DS	10.6		*	North of primary structure
		06	DS	2.1		*
