RADIOLOGIC AND ENGINEERING ASSESSMENT

DOE ID NO.: GJ-12956-RS
ADDRESS: 310 WEST OURAY AVENUE

SEPTEMBER 1985

BENDIX FIELD ENGINEERING CORPORATION
P.O. Box 1569
Grand Junction, Colorado 81502

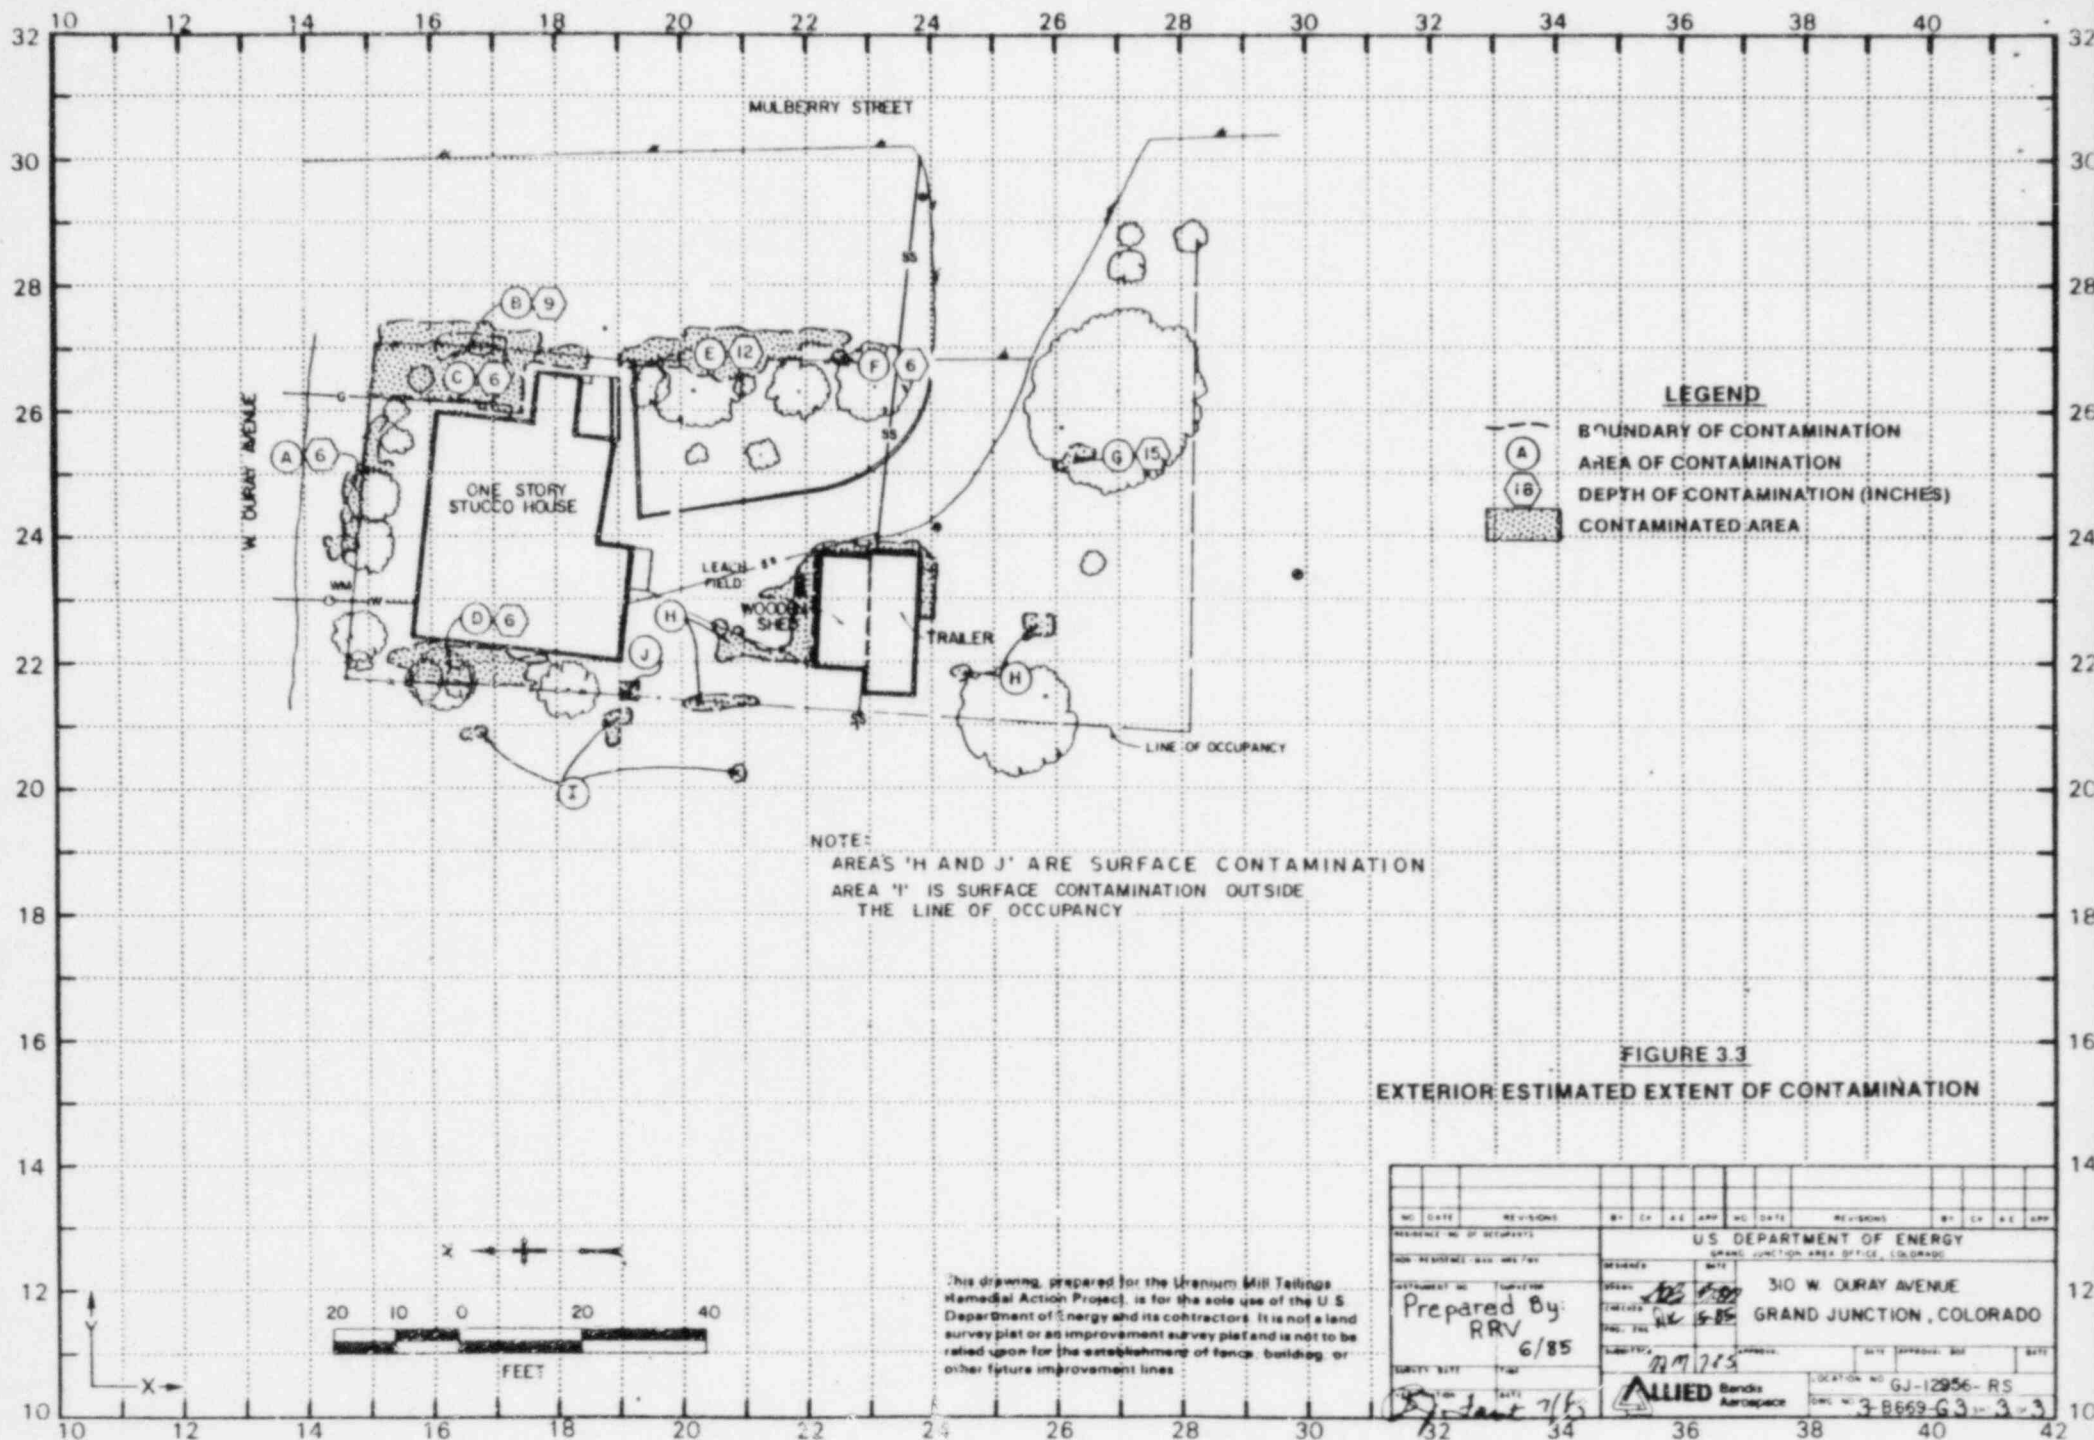
Appendix Figure 3.3 shows identified areas and estimated depths of contamination on this property, based on assessments of all measurements taken. As noted in this figure, areas recommended for remedial action that contain identified residual radioactive materials are:

- (Area A) Surface Material: Soil
Direction From Primary Structure: North
Other Directions: Along the north fence line
Total Depth of Contamination: 6 inches
Approximate Square Footage: 73

- (Area B) Surface Material: Soil
Direction From Primary Structure: East
Other Directions: Along the east fence line
Total Depth of Contamination: 9 inches
Approximate Square Footage: 33

- (Area C) Surface Material: Soil
Direction From Primary Structure: East
Other Directions: East yard
Total Depth of Contamination: 6 inches
Approximate Square Footage: 316

- (Area D) Surface Material: Soil
Direction From Primary Structure: West
Other Directions: Along the west fence line
Total Depth of Contamination: 6 inches
Approximate Square Footage: 128

- (Area E) Surface Material: Soil and sod
Direction From Primary Structure: Southeast
Other Directions: Along the east fence line
Total Depth of Contamination: 12 inches
Approximate Square Footage: 207

- (Area F) Surface Material: Soil
Direction From Primary Structure: Southeast
Other Directions: Along the east fence line
Total Depth of Contamination: 6 inches
Approximate Square Footage: 6

- (Area G) Surface Material: Soil
Direction From Primary Structure: South
Other Directions: South of driveway
Total Depth of Contamination: 15 inches
Approximate Square Footage: 21

- (Area H) Surface Material: Bricks and soil
Direction From Primary Structure: South
Other Directions: Around the trailer and shed
Total Depth of Contamination: Estimated 4", based on site observation.
Other (height or thickness): 4" x 2" x 8" bricks
Comments: This area includes two deposits of contaminated brick.
Approximate Square Footage: 275

- (Area I) Surface Material: Bricks
Direction From Primary Structure: West and southwest
Other Directions: Outside the line of occupancy
Total Depth of Contamination: Surface
Other (height or thickness): 4" x 2" x 8" bricks
Comments: This area includes three deposits of contaminated brick.
Approximate Square Footage: 24

- (Area J) Surface Material: Bricks
Direction From Primary Structure: Southwest
Total Depth of Contamination: Surface
Other (height or thickness): 18" X 18" X 12"
Comments: This deposit is a barbecue pit made up of contaminated brick. It is 18 inches square by 12 inches high.
Approximate Square Footage: 4

The recommended remedial action for this property, DOE ID No. GJ-12956-RS, includes removal of all areas identified as containing radioactive material (as discussed in Section 3.5 and shown in Appendix Figure 3.3) and transport of removed material to the disposal site.

Area I is on an unmaintained site with an abandoned house. Although it falls outside the line of occupancy, Area I is recommended for remedial action in conjunction with remedial action at 310 West Ouray because the contamination is surface brick debris originating from the 310 West Ouray property.

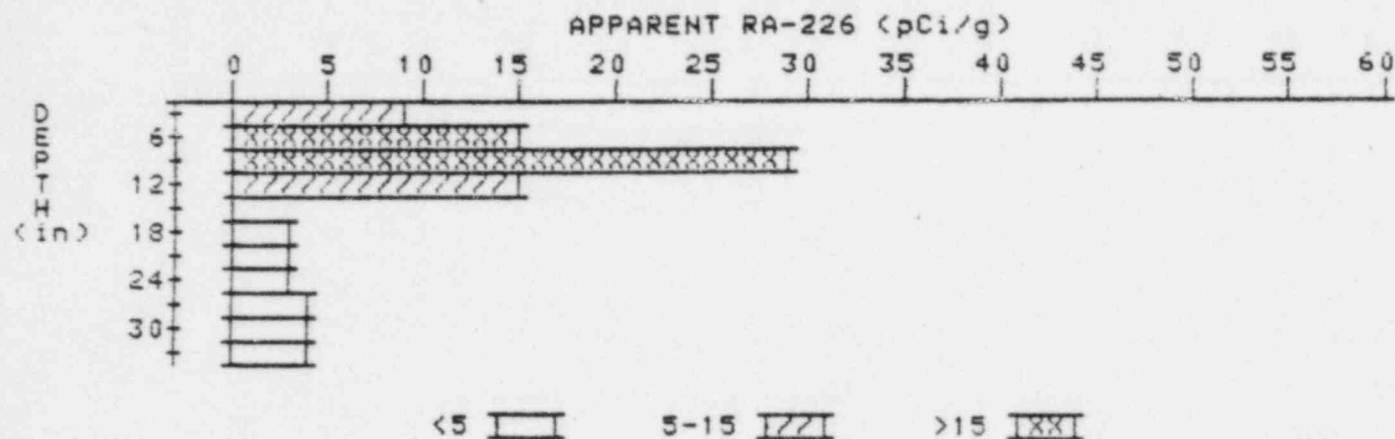
PROPERTY NUMBER: GJ-12956-RS
HOLE NUMBER: 31
LOCATION: 261251

Loc #	Grid Location	Depth (in.)	Meas. Type	In Situ Ra-226 (pCi/g)		Chem Ra-226 (pCi/g)	Comments
				Tot. Ct	Spectr.		
31	261251	03	TC	9.1		*	DC = 15 inches
		06	TC	13.2		*	Based on the
		09	TC	16.2		*	deconvolution graph
		12	TC	12.1		*	
		15	TC	6.6		*	
		18	TC	4.9		*	
		21	TC	4.1		*	
		24	TC	3.7		*	
		27	TC	3.7		*	
		30	TC	3.7		*	
		33	TC	3.7		*

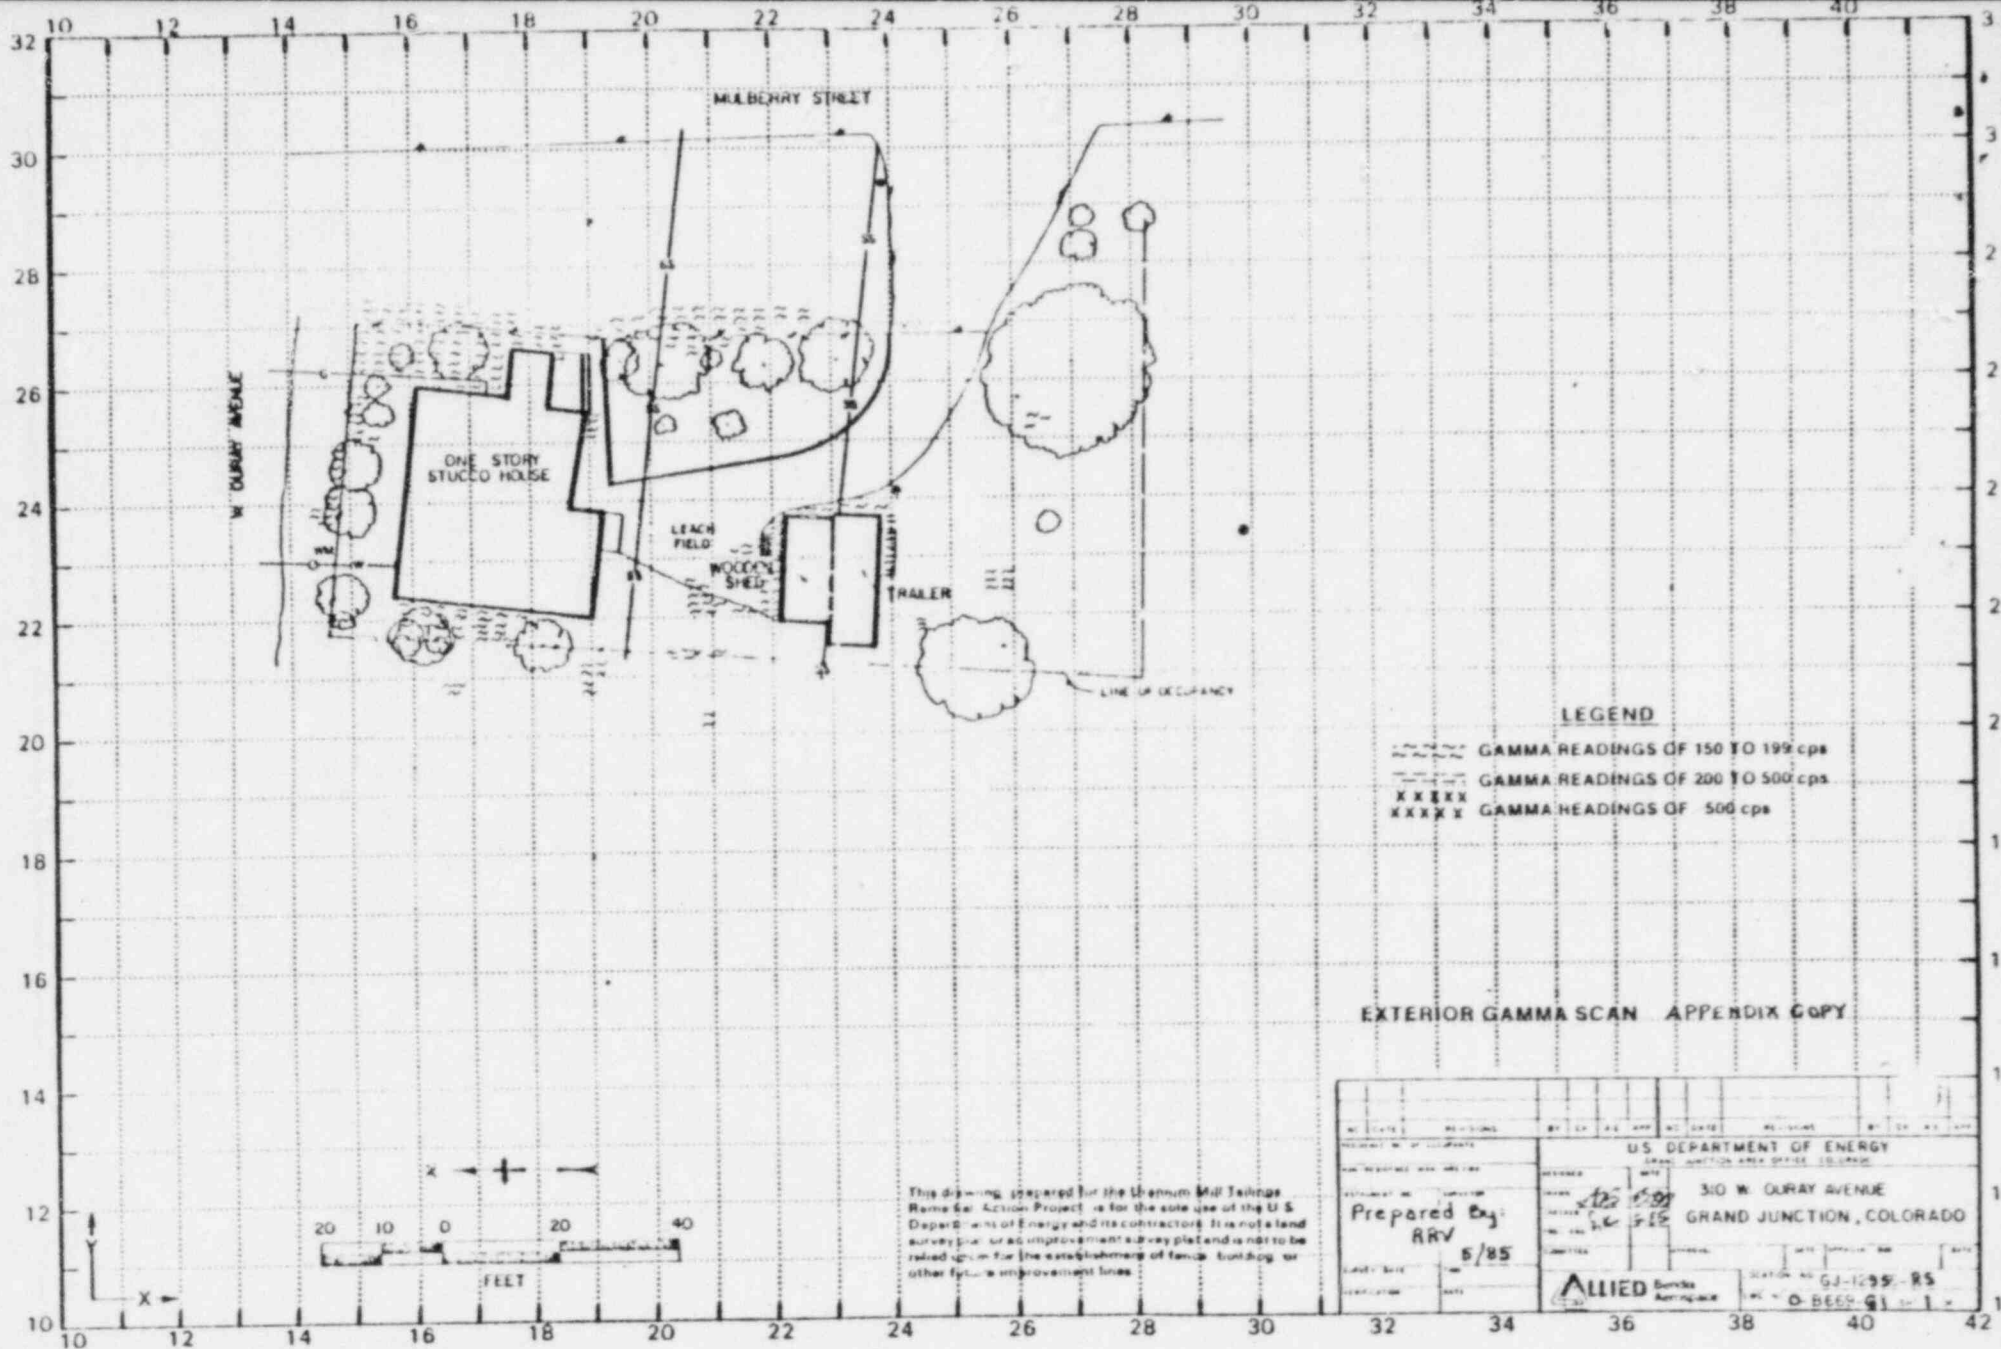
Exterior grid points and gamma survey was conducted. Background range was 80 to 145 cps. Elevated gamma levels were detected in the north, east, south, and west yards. These areas were investigated by taking surface and subsurface delta measurements and borehole logs with the total count meters. The locations that showed elevated gamma levels appeared to be associated with the fire brick, which was scattered throughout the property, since decayed brick was found near or around these areas. No visible evidence of mill tailings material was sighted while augering holes or digging subsurface delta holes, nor when footing/foundation holes were dug.
