RADIOLOGIC AND ENGINEERING ASSESSMENT

DOE ID NO.: GJ-13019-RS  
ADDRESS: 139 NORTH SPRUCE STREET

SEPTEMBER 1985

BENDIX FIELD ENGINEERING CORPORATION  
P.O. Box 1569  
Grand Junction, Colorado 81502

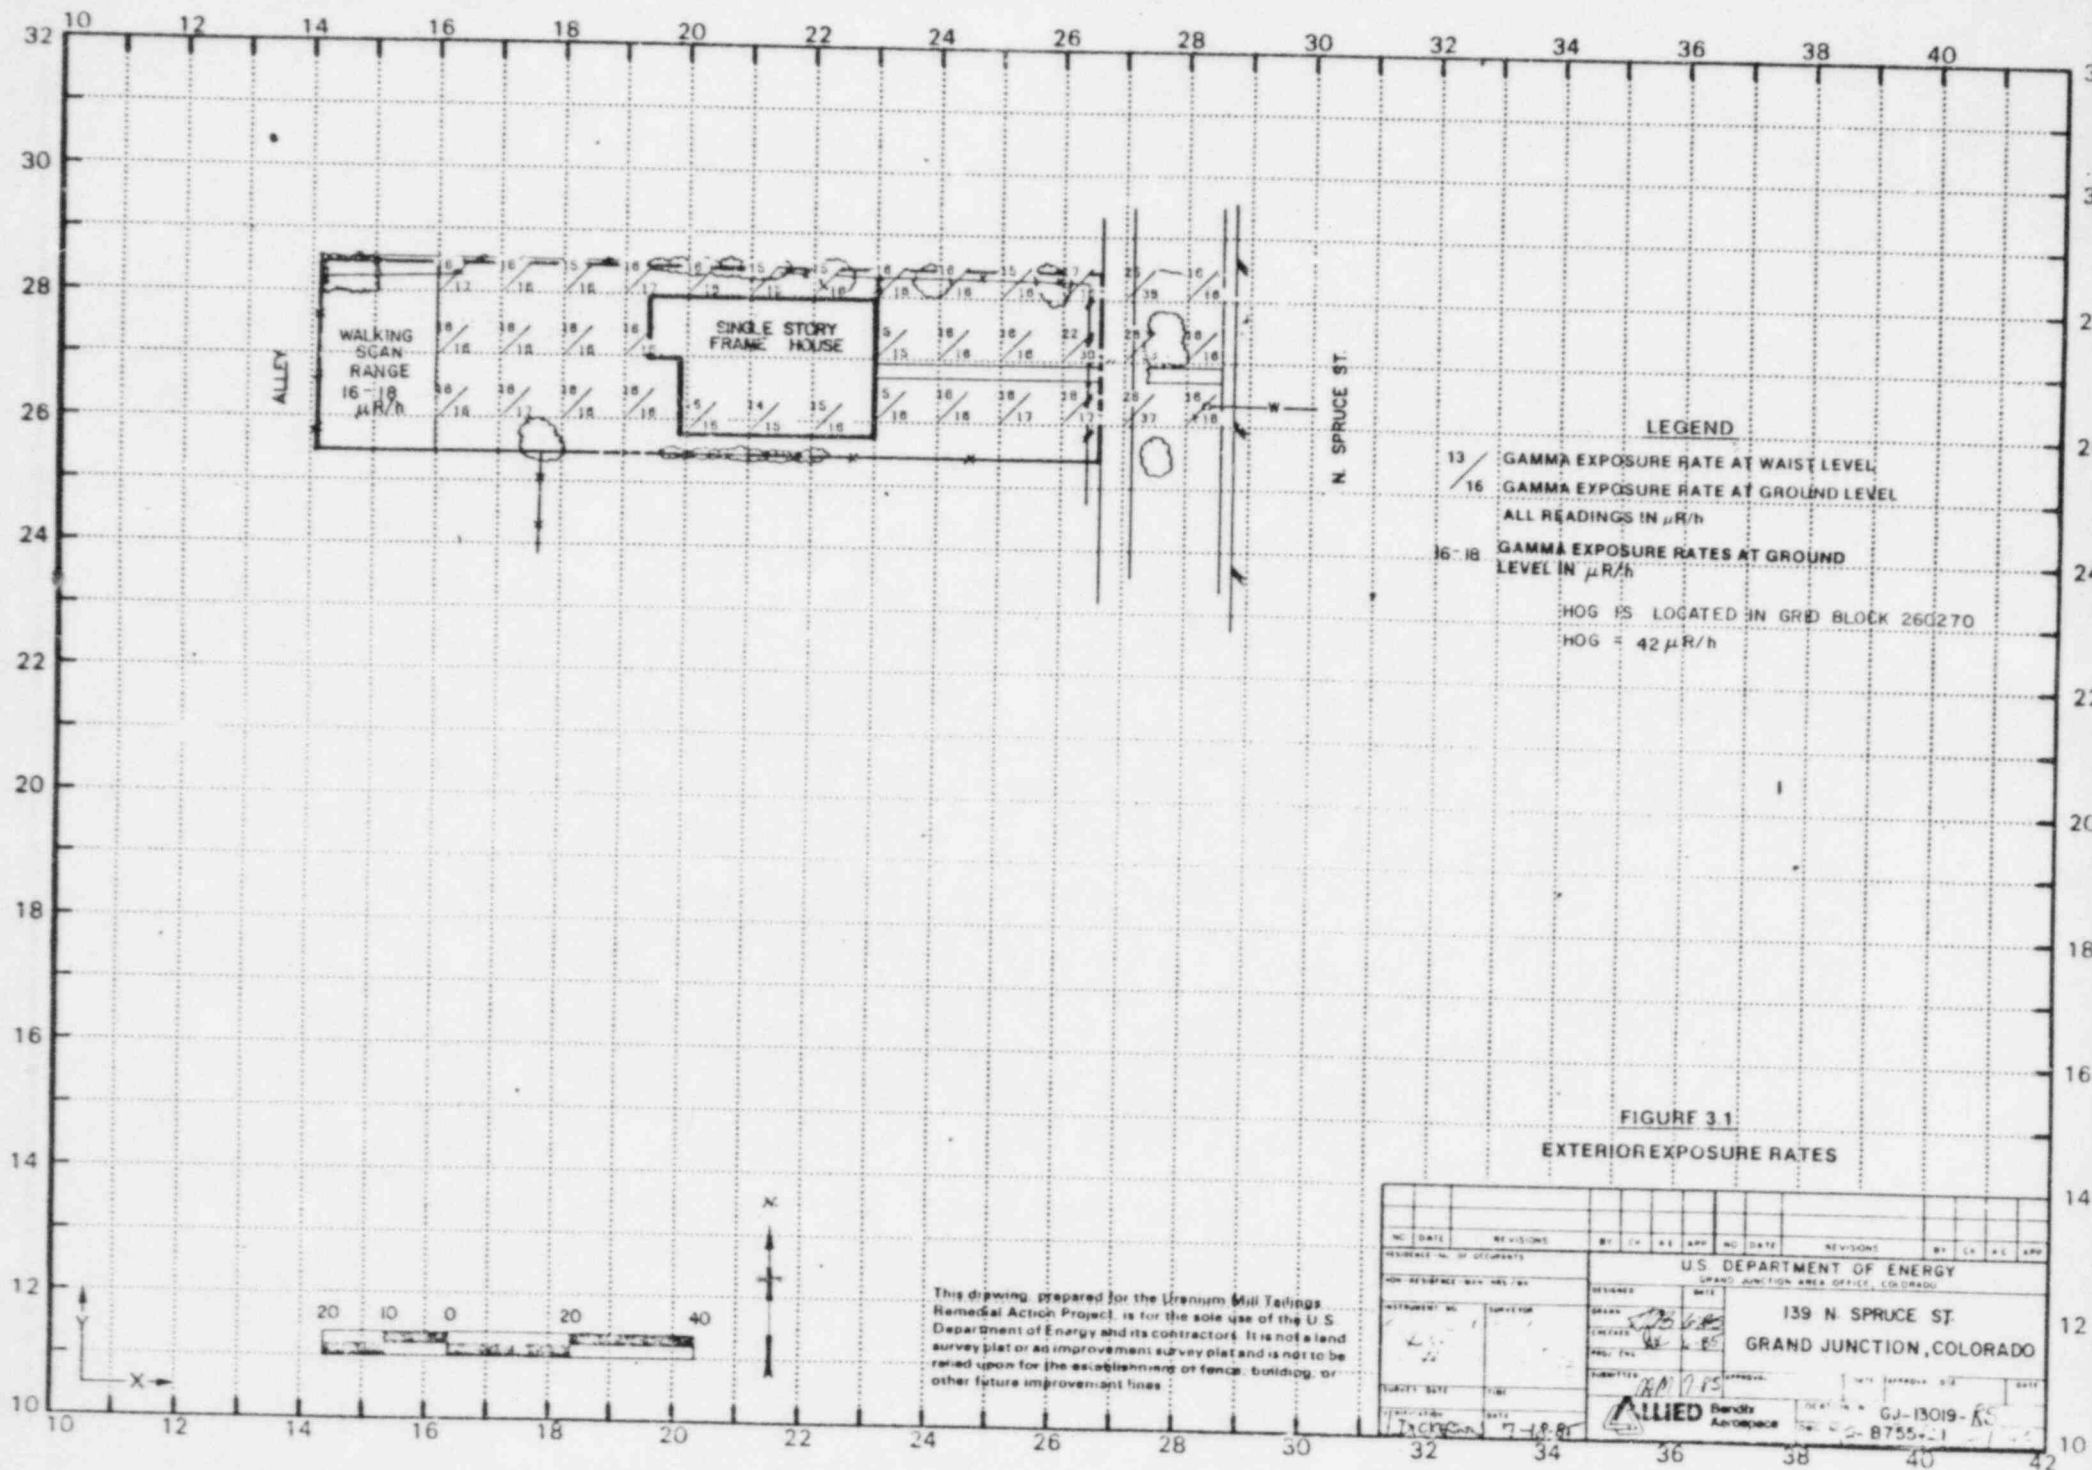
FIGURE 3.1  
EXTERIOREXPOSURE RATES

Background Readings: 15 to 17 uR/h  
Highest Outside Gamma Reading (HOG): 42 uR/h

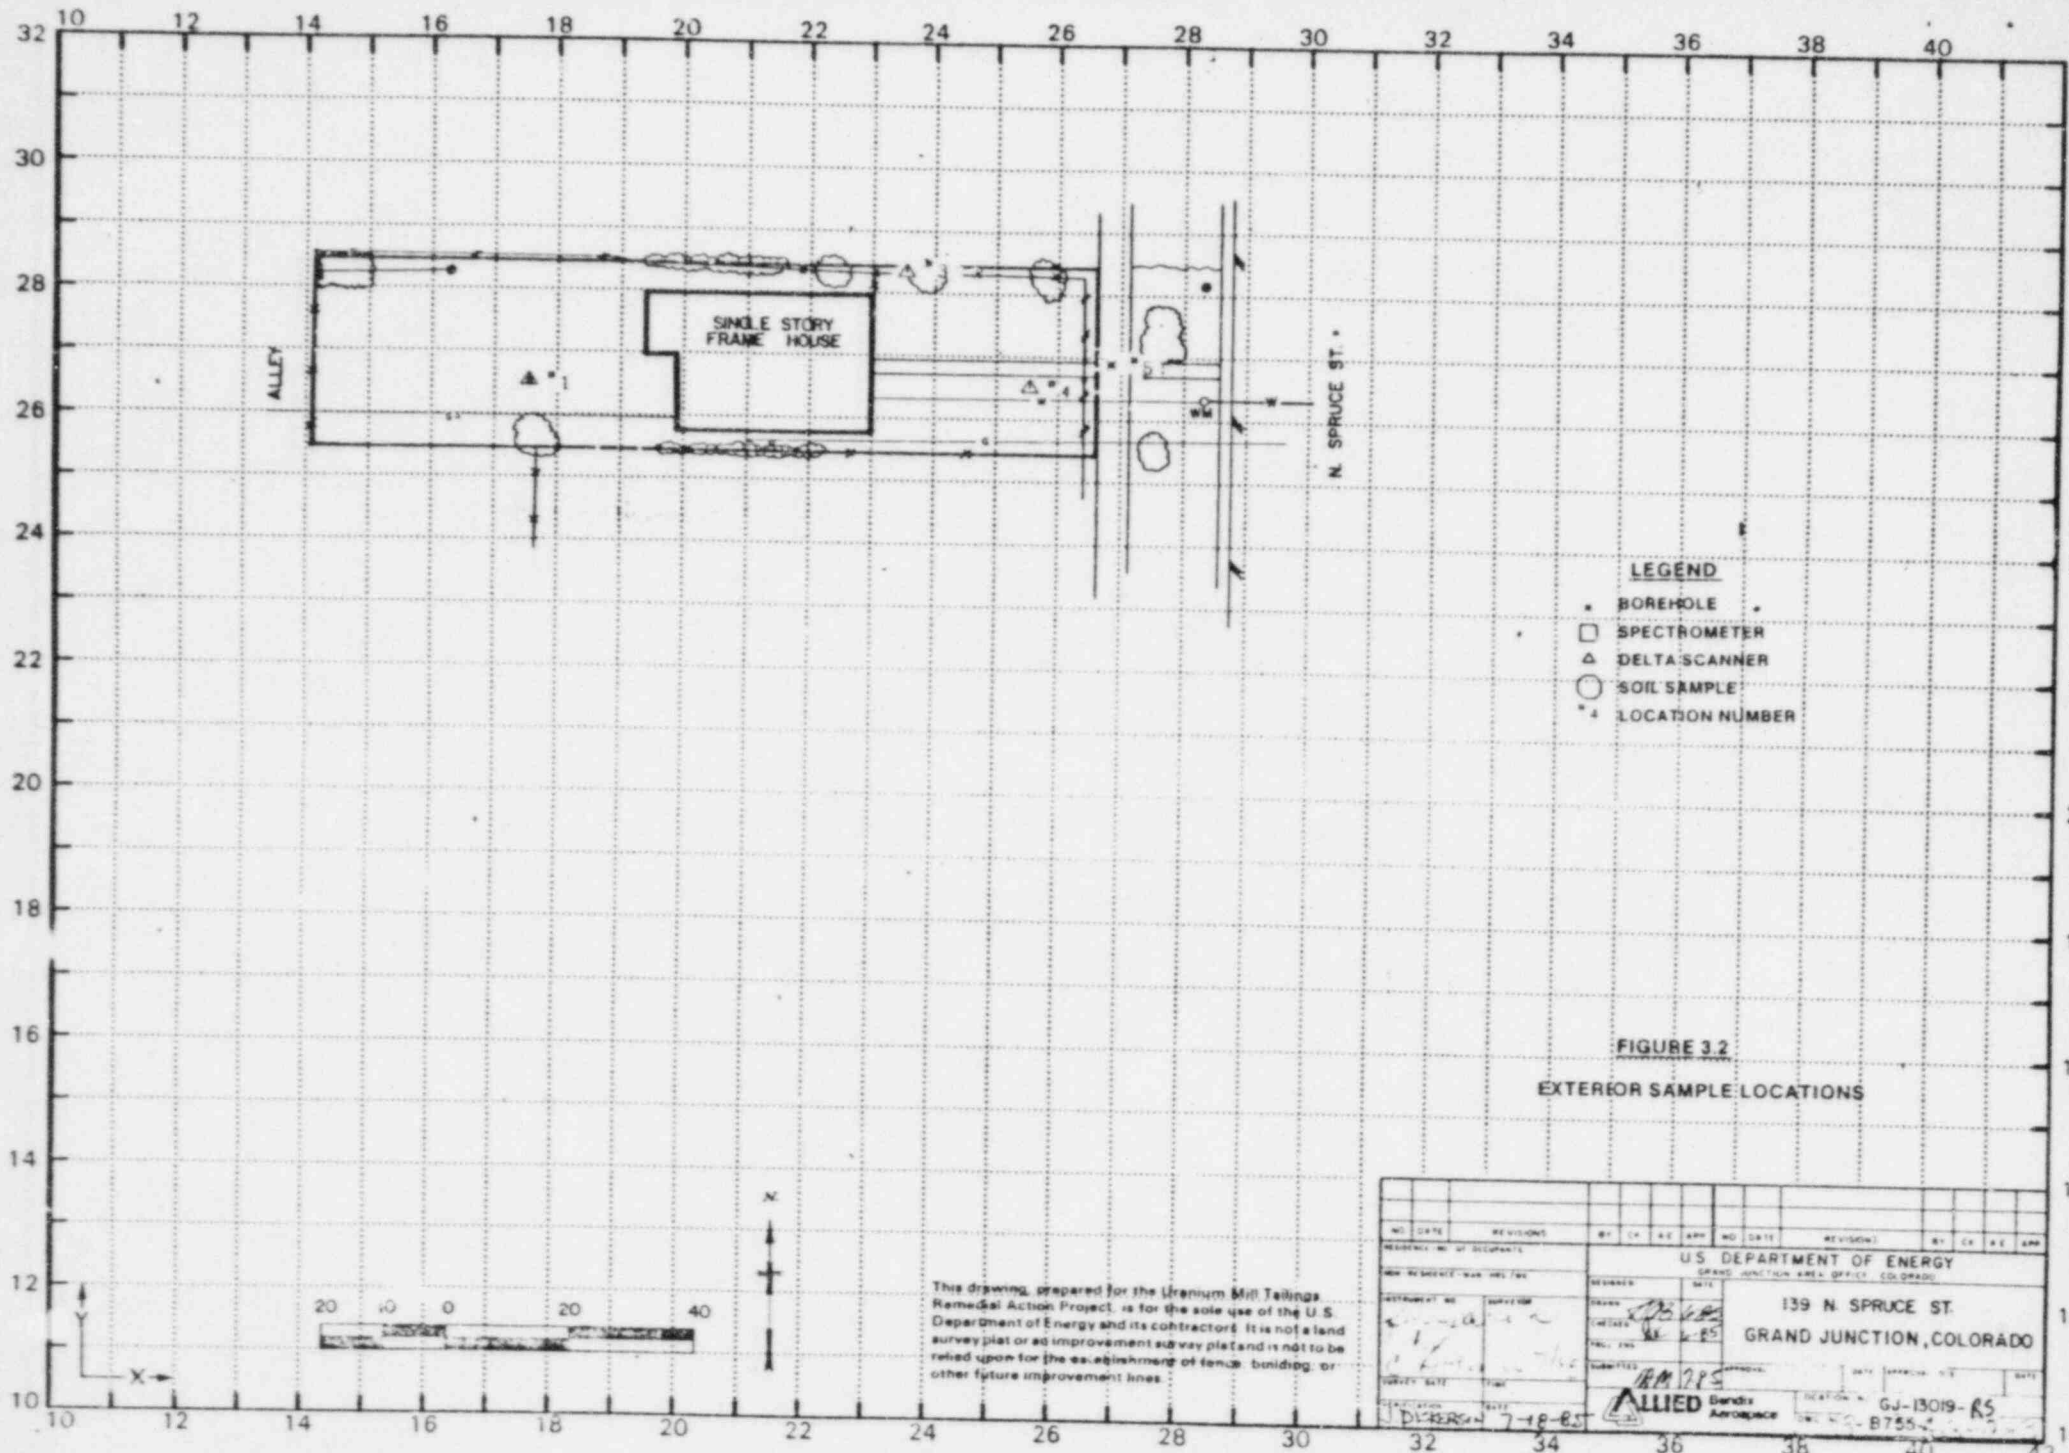
FIGURE 3.2  
EXTERIOR SAMPLE LOCATIONS

Areas which displayed elevated gamma levels were further investigated; these areas are shown in Appendix Figure 3.2. Data from these investigations are included in Appendix Table 3.1.

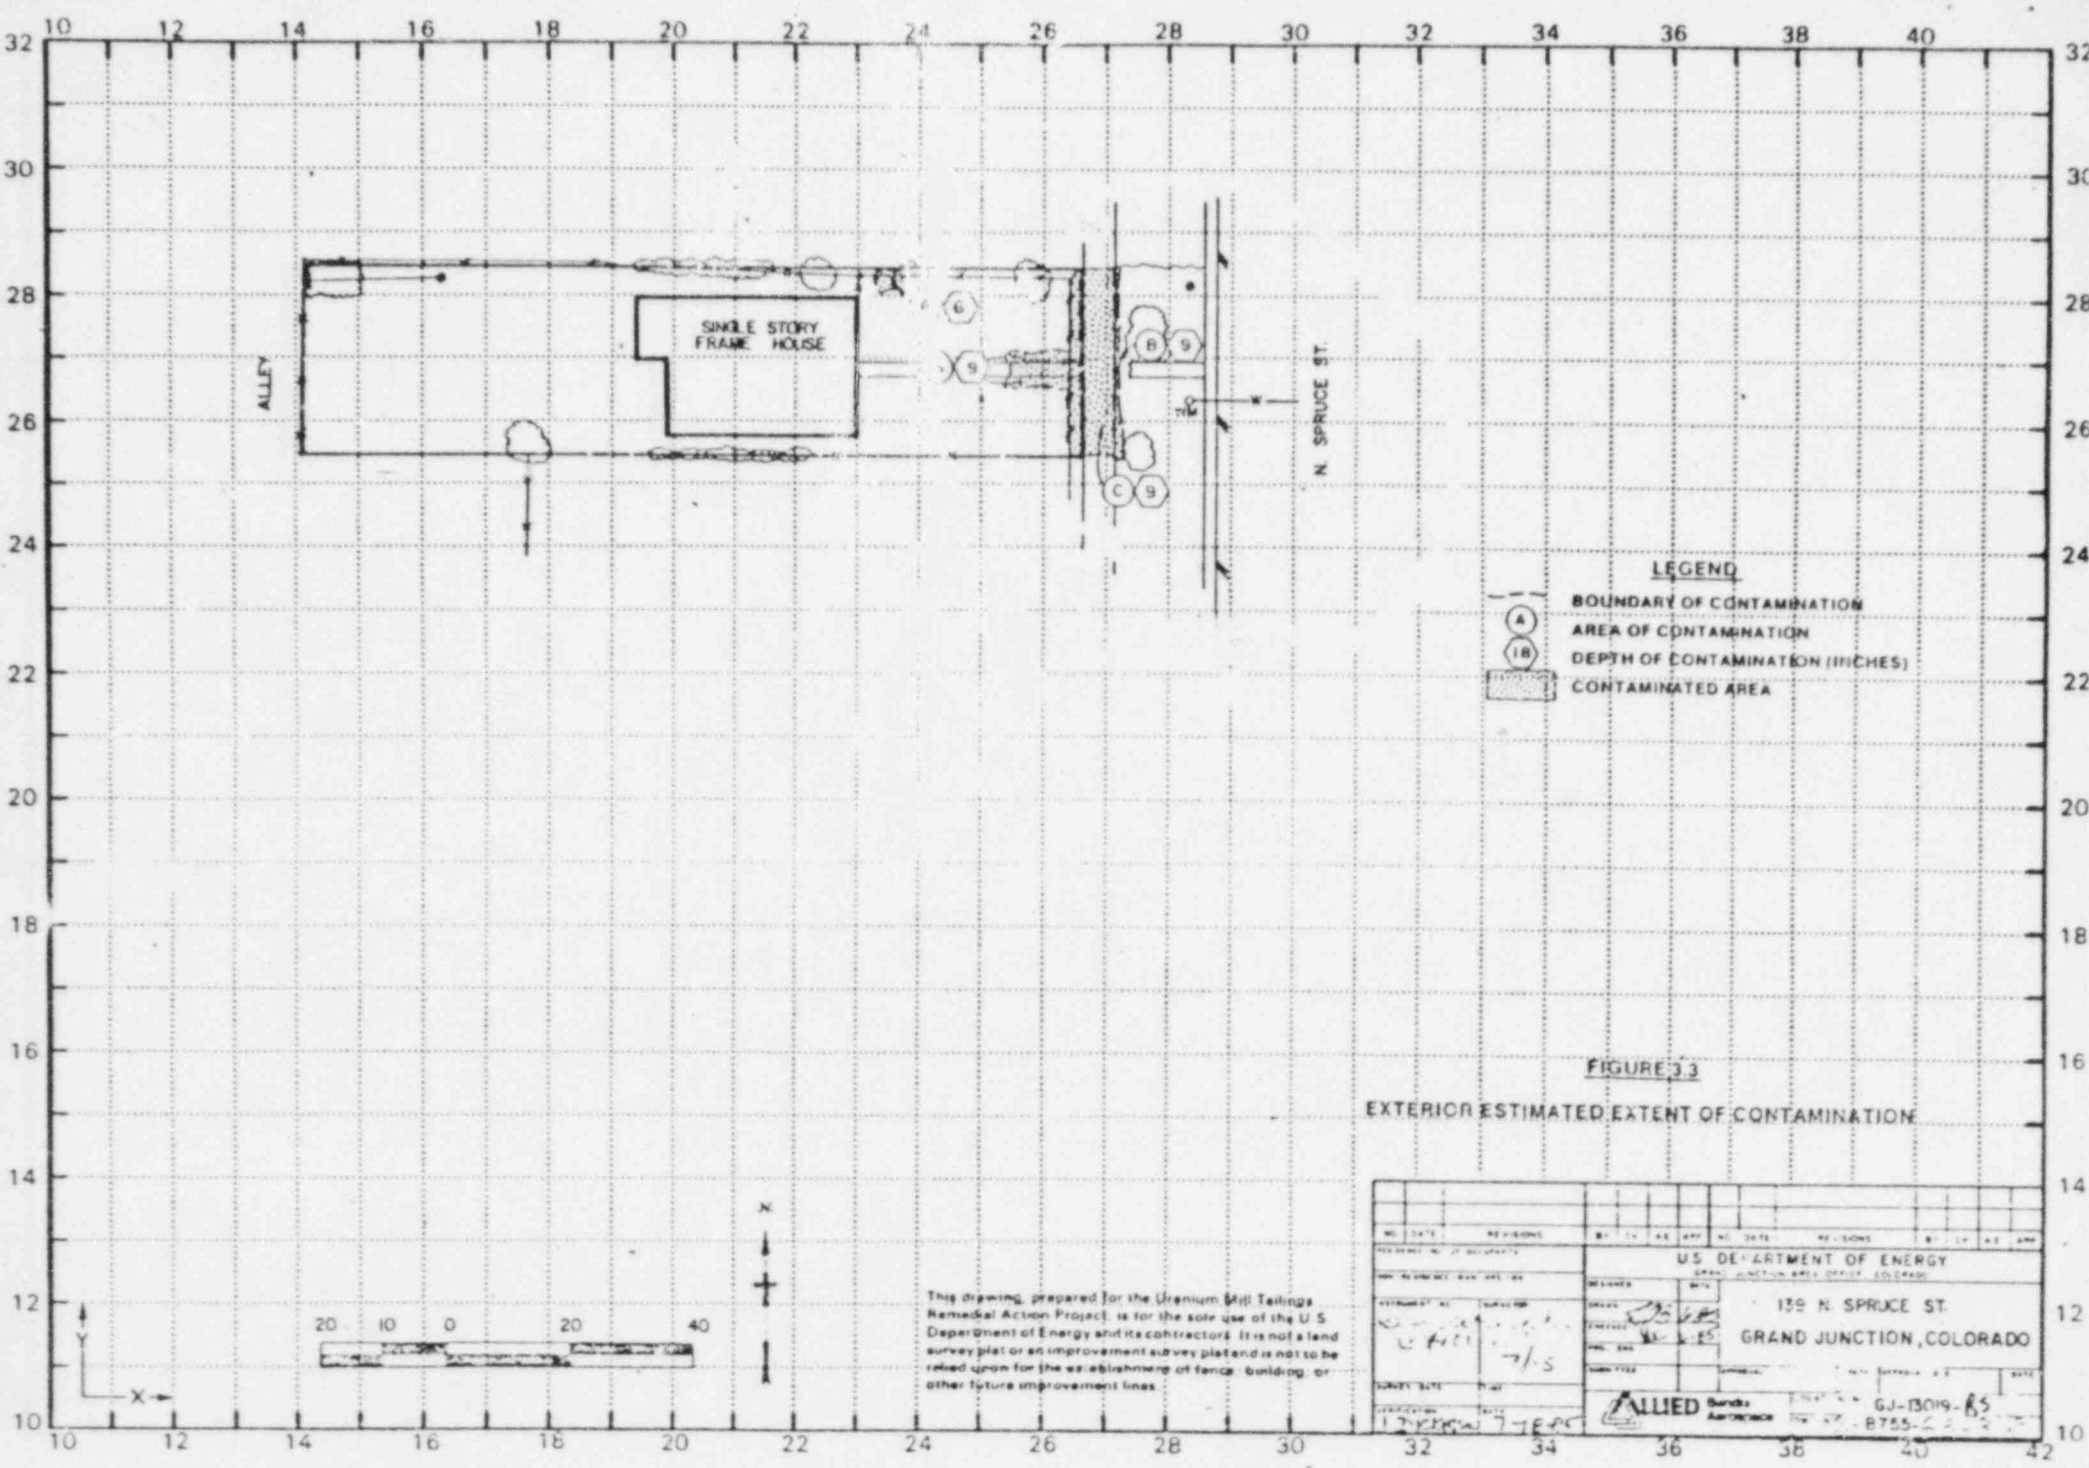
FIGURE 33  
EXTERIOR ESTIMATED EXTENT OF CONTAMINATION

Appendix Figure 3.3 shows identified areas and estimated depths of contamination on this property, based on assessments of all measurements taken. As noted in this figure, areas recommended for remedial action that contain identified residual radioactive materials are:

- (Area A) Surface Material: Soil  
Direction From Primary Structure: Northeast  
Other Directions: Along the north property line  
Total Depth of Contamination: 6 inches  
Comments: This is a small deposit of contamination  
beneath an elm tree.  
Approximate Square Footage: 20
- (Area B) Surface Material: Soil  
Direction From Primary Structure: East  
Other Direction: Along the sidewalk  
Total Depth of Contamination: 9 inches  
Approximate Square Footage: 132
- (Area C) Surface Material: Concrete  
Direction From Primary Structure: East  
Total Depth of Contamination: 9 inches  
Other (height or thickness): 4-inch-thick concrete  
Approximate Square Footage: 189

The recommended remedial action for this property, DOE ID No. GJ-13019-RS, includes removal of all areas identified as containing radioactive material (as discussed in Section 3.5 and shown in Appendix Figure 3.3) and transport of removed material to the disposal site.
