RADIOLOGIC AND ENGINEERING ASSESSMENT

DOE ID NO.: GJ-08843-MR
ADDRESS: 2525 SOUTH BROADWAY

AUGUST 1985

URANIUM MILL TAILINGS REMEDIAL ACTION PROJECT OFFICE

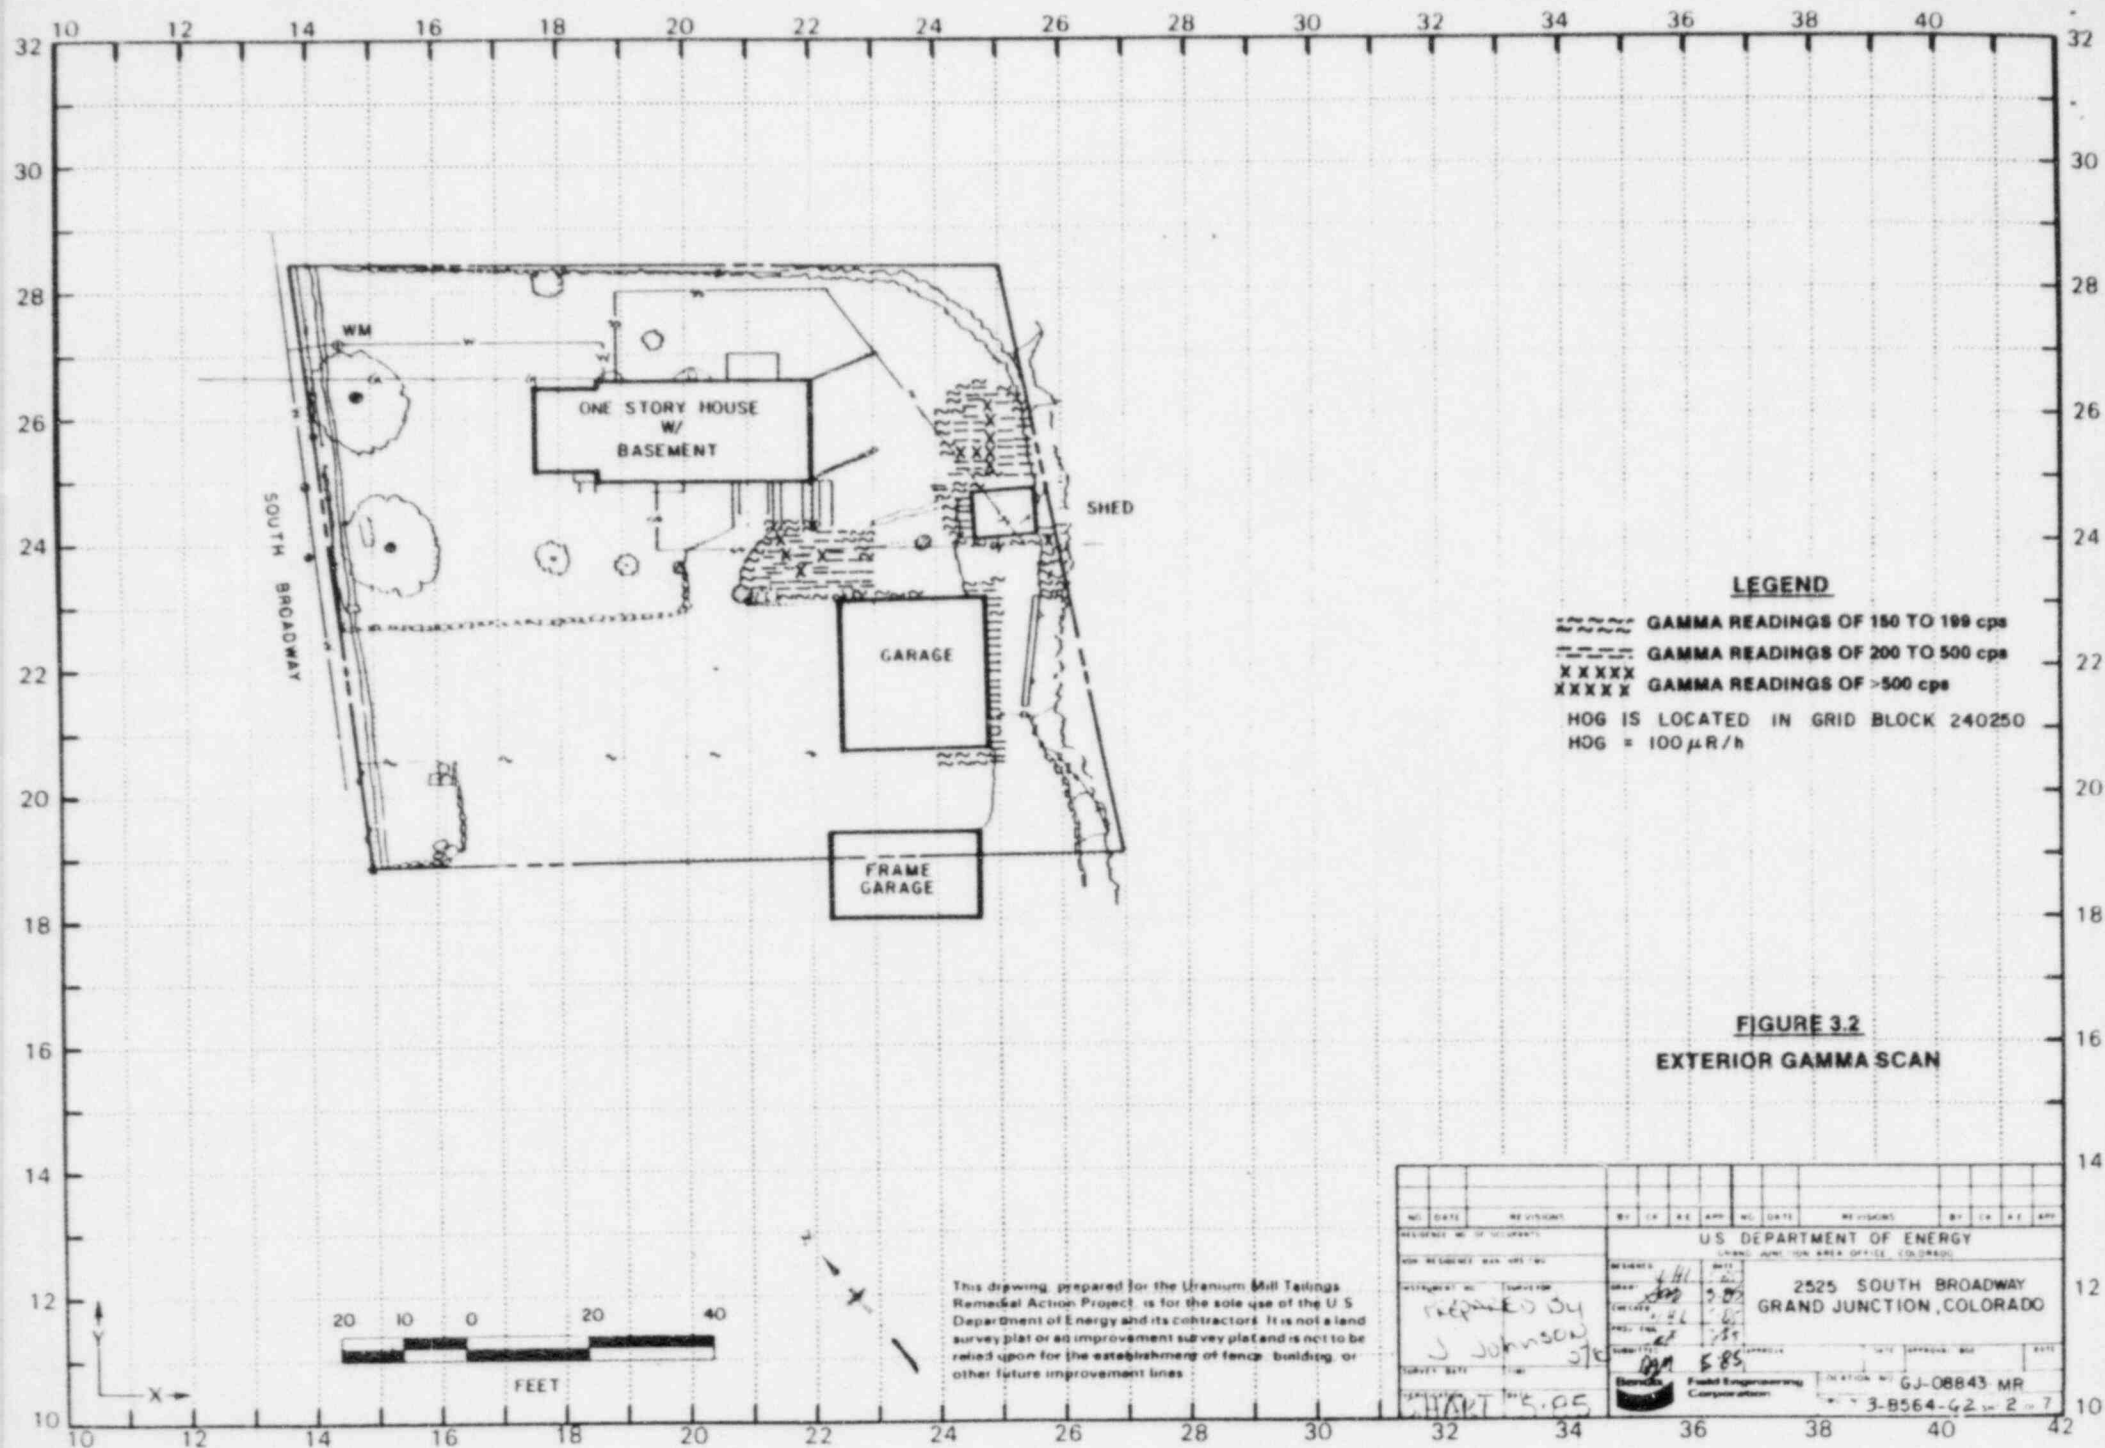
FIGURE 3.2
EXTERIOR GAMMA SCAN

Exterior radium-concentration measurements are presented in Appendix Table 3.1. Grid-point survey results are shown in Appendix Figure 3.1. Appendix Figure 3.2 presents the ranges of elevated gamma readings and indicates areas of possible contamination.

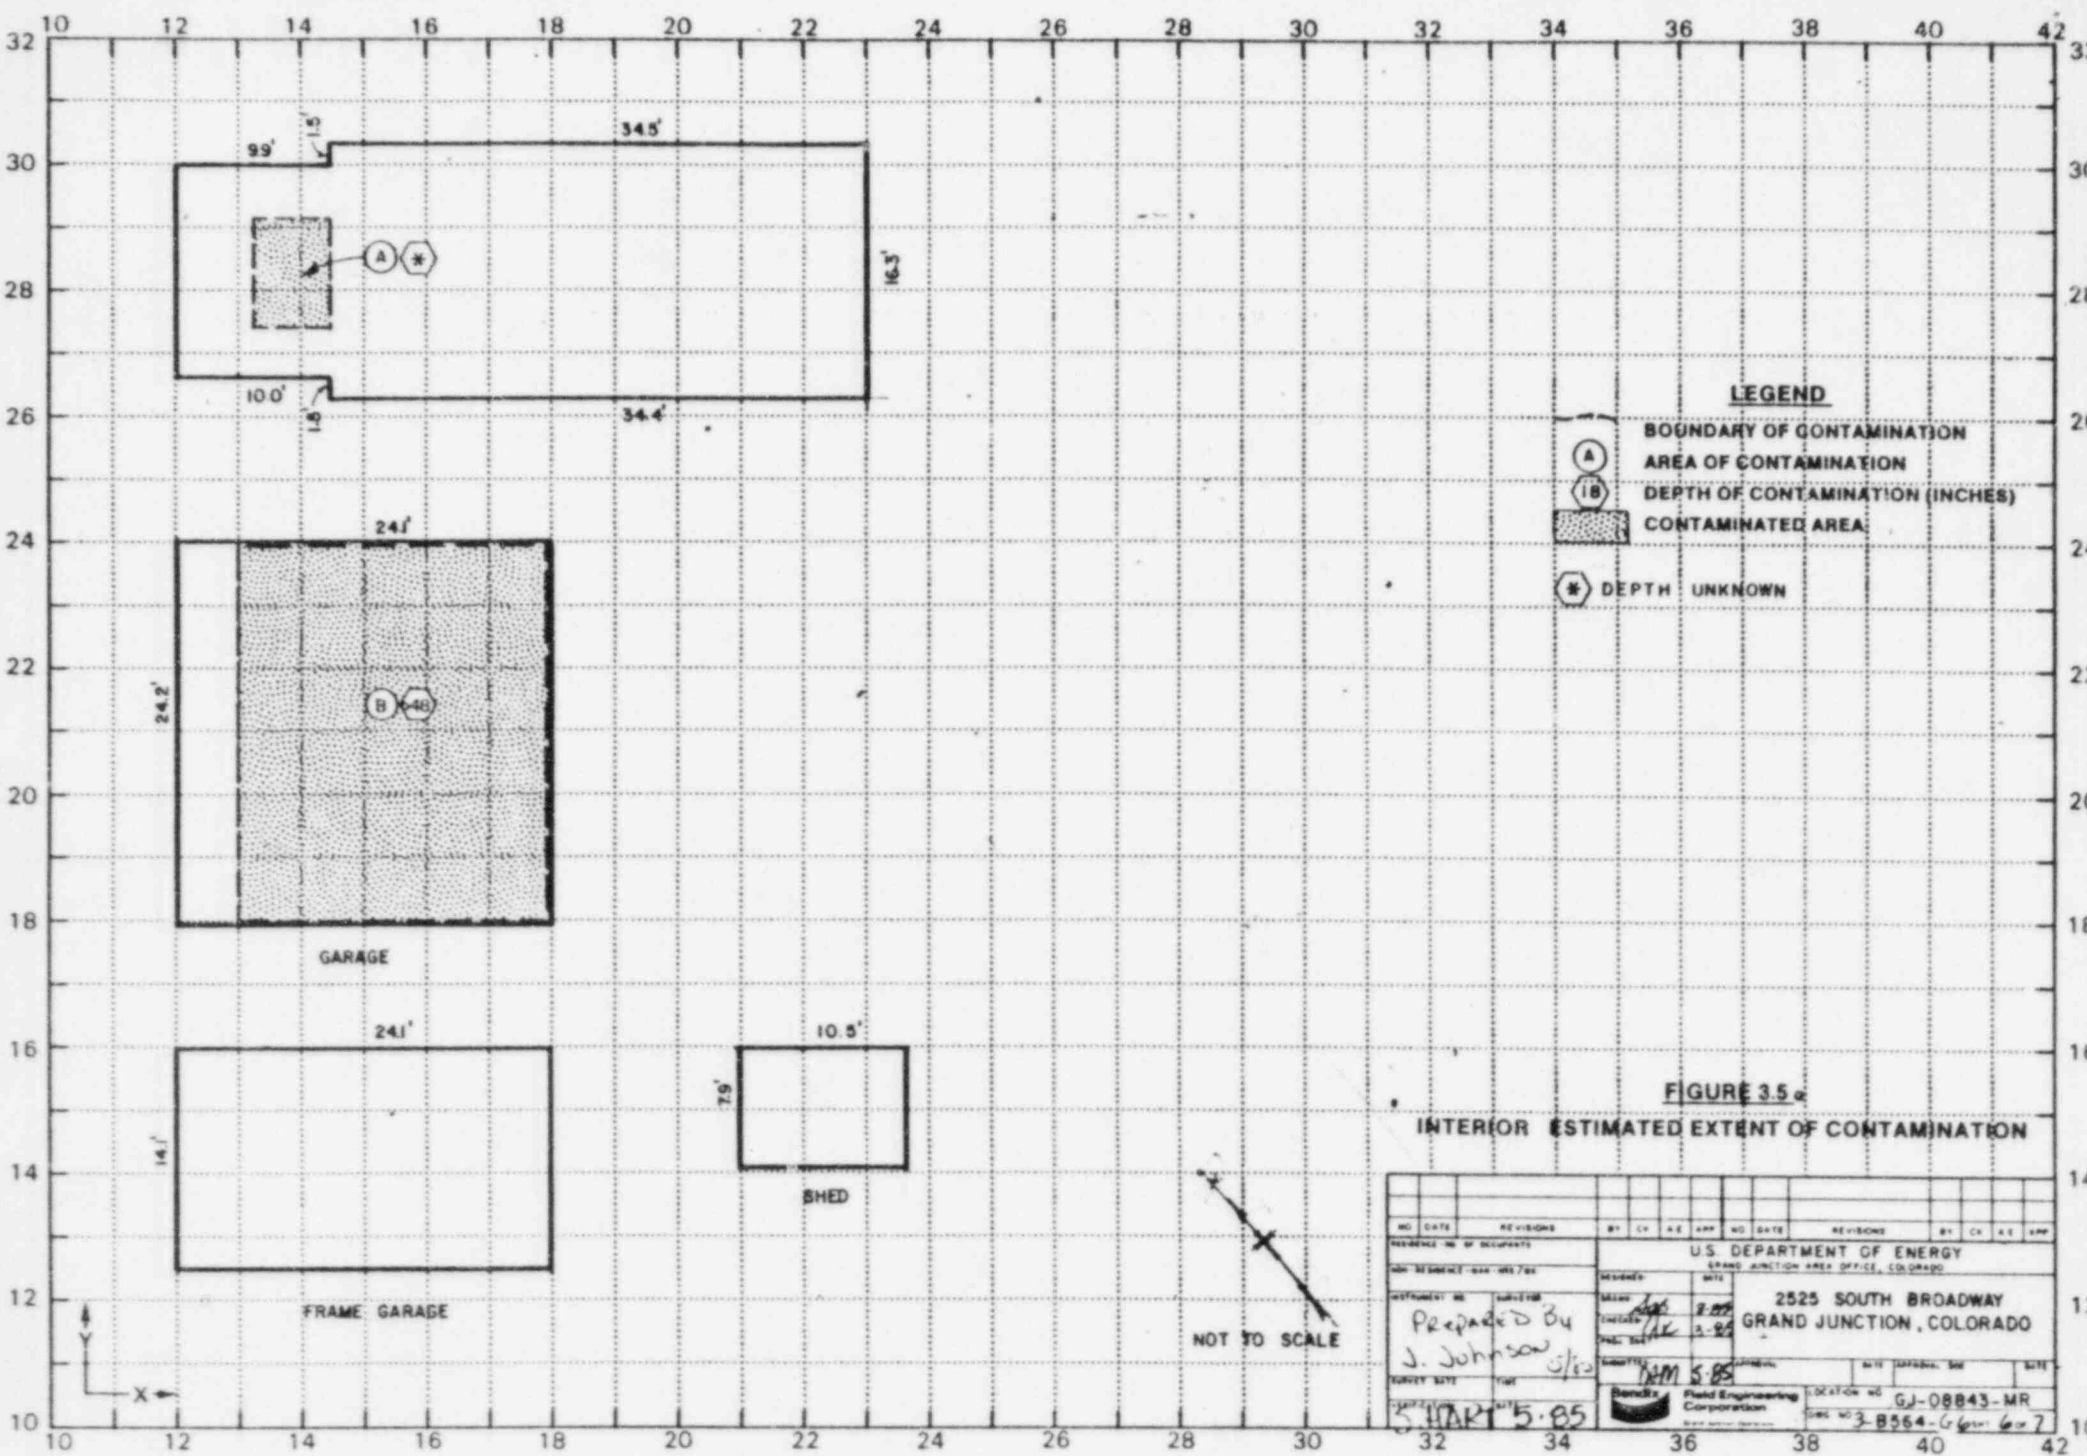
FIGURE 3.5a
INTERIOR ESTIMATED EXTENT OF CONTAMINATION

Appendix Figures 3.5a and 3.5b show identified areas and estimated depths of contamination on this property, based on assessments of all measurements taken. As noted in these figures, areas recommended for remedial action that contain identified residual radioactive materials are:

- (AREA A) A deposit extends under a covered porch on the west side of the primary structure to an unknown depth (approximately 48 sf; this area is excluded from remedial action).
- (AREA B) Contamination in the garage extends to a depth greater than 48 inches (approximately 480 sf).
- (AREA C) Contamination under the 2-inch-thick uncontaminated concrete and sandstone patio, south of the primary structure, is 10 inches deep. The total depth of contamination is 12 inches (approximately 220 sf).
- (AREA D) Southeast of the primary structure contaminated chunks of concrete extend to a depth of 6 inches (approximately 196 sf).
- (AREA E) A deposit on the north, south, and east side of the garage extends to a depth greater than 48 inches (approximately 1,298 sf).

The recommended remedial action for this property, DOE ID No. GJ-08843-MR, includes removal of select areas identified as containing radioactive material (as discussed in Section 3.5 and shown in Appendix Figures 3.5a and 3.5b) and transport of removed material to the disposal site.
