Edwin I. Hatch Nuclear Plant - Unit 2  
Inservice Inspection of Feedwater Sparger

### Edwin I. Hatch Nuclear Plant Inservice Inspection of Feedwater Sparger

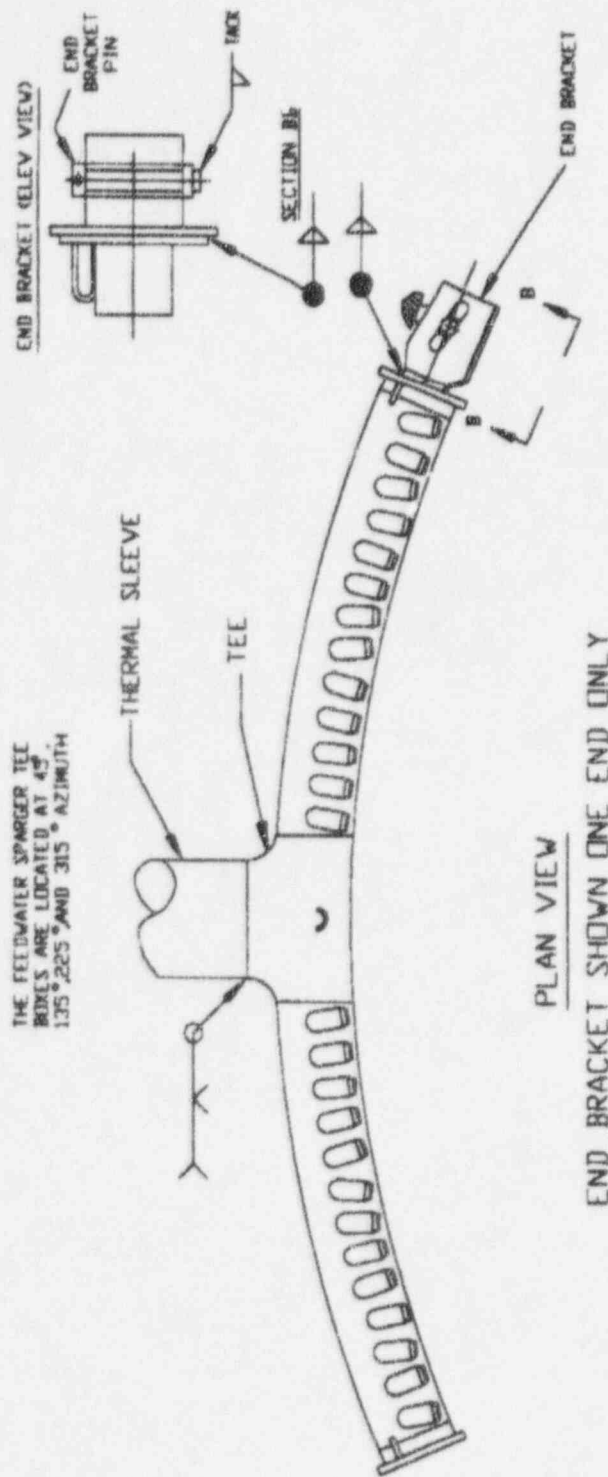
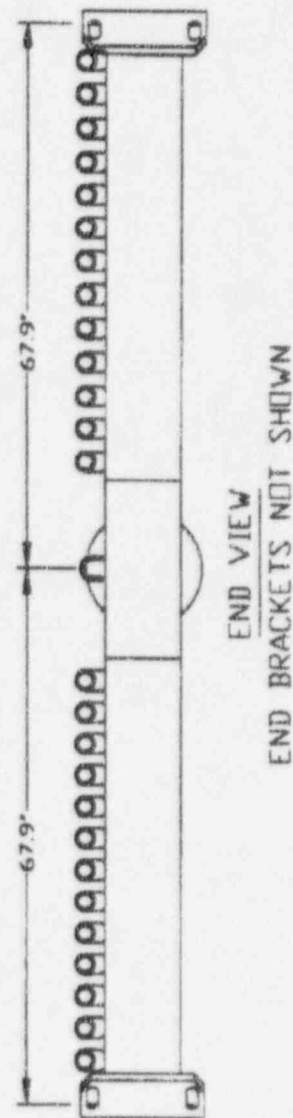
FIGURE 1

Indications were identified on the 'A' feedwater sparger thermal sleeve to the weld and the 'A' feedwater sparger end bracket. The indications on the thermal sleeve to the end bracket are located on the bottom of the pipe and are predominately axial in orientation. One of the indications is approximately four inches long and appears to traverse the sleeve to the tee weld. The indications do not appear to be connected. A UT inspection of the indication was not performed due to the unavailability of a qualified technique and equipment for this application. Figure 1 provides the arrangement of the feedwater sparger and end bracket.

The indication on the sparger end bracket is located on the tack weld of the nut to the end bracket at each of the two bolt locations. The tack welds were cracked through the weld material and some displacement was observed. The tack welds of the nut to the end of the bolt and the tack welds for the bolt head to the end plate showed no indications. No indications on the feedwater sparger thermal sleeve to the tee weld or sparger end bracket were identified at the other three sparger locations.
