RADIOLOGIC AND ENGINEERING ASSESSMENT

DOE ID NO.: GJ-02197-MR
ADDRESS: 1320 NORTH 18TH STREET

AUGUST 1985

BENDIX FIELD ENGINEERING CORPORATION
P.O. Box 1569
Grand Junction, Colorado 81502

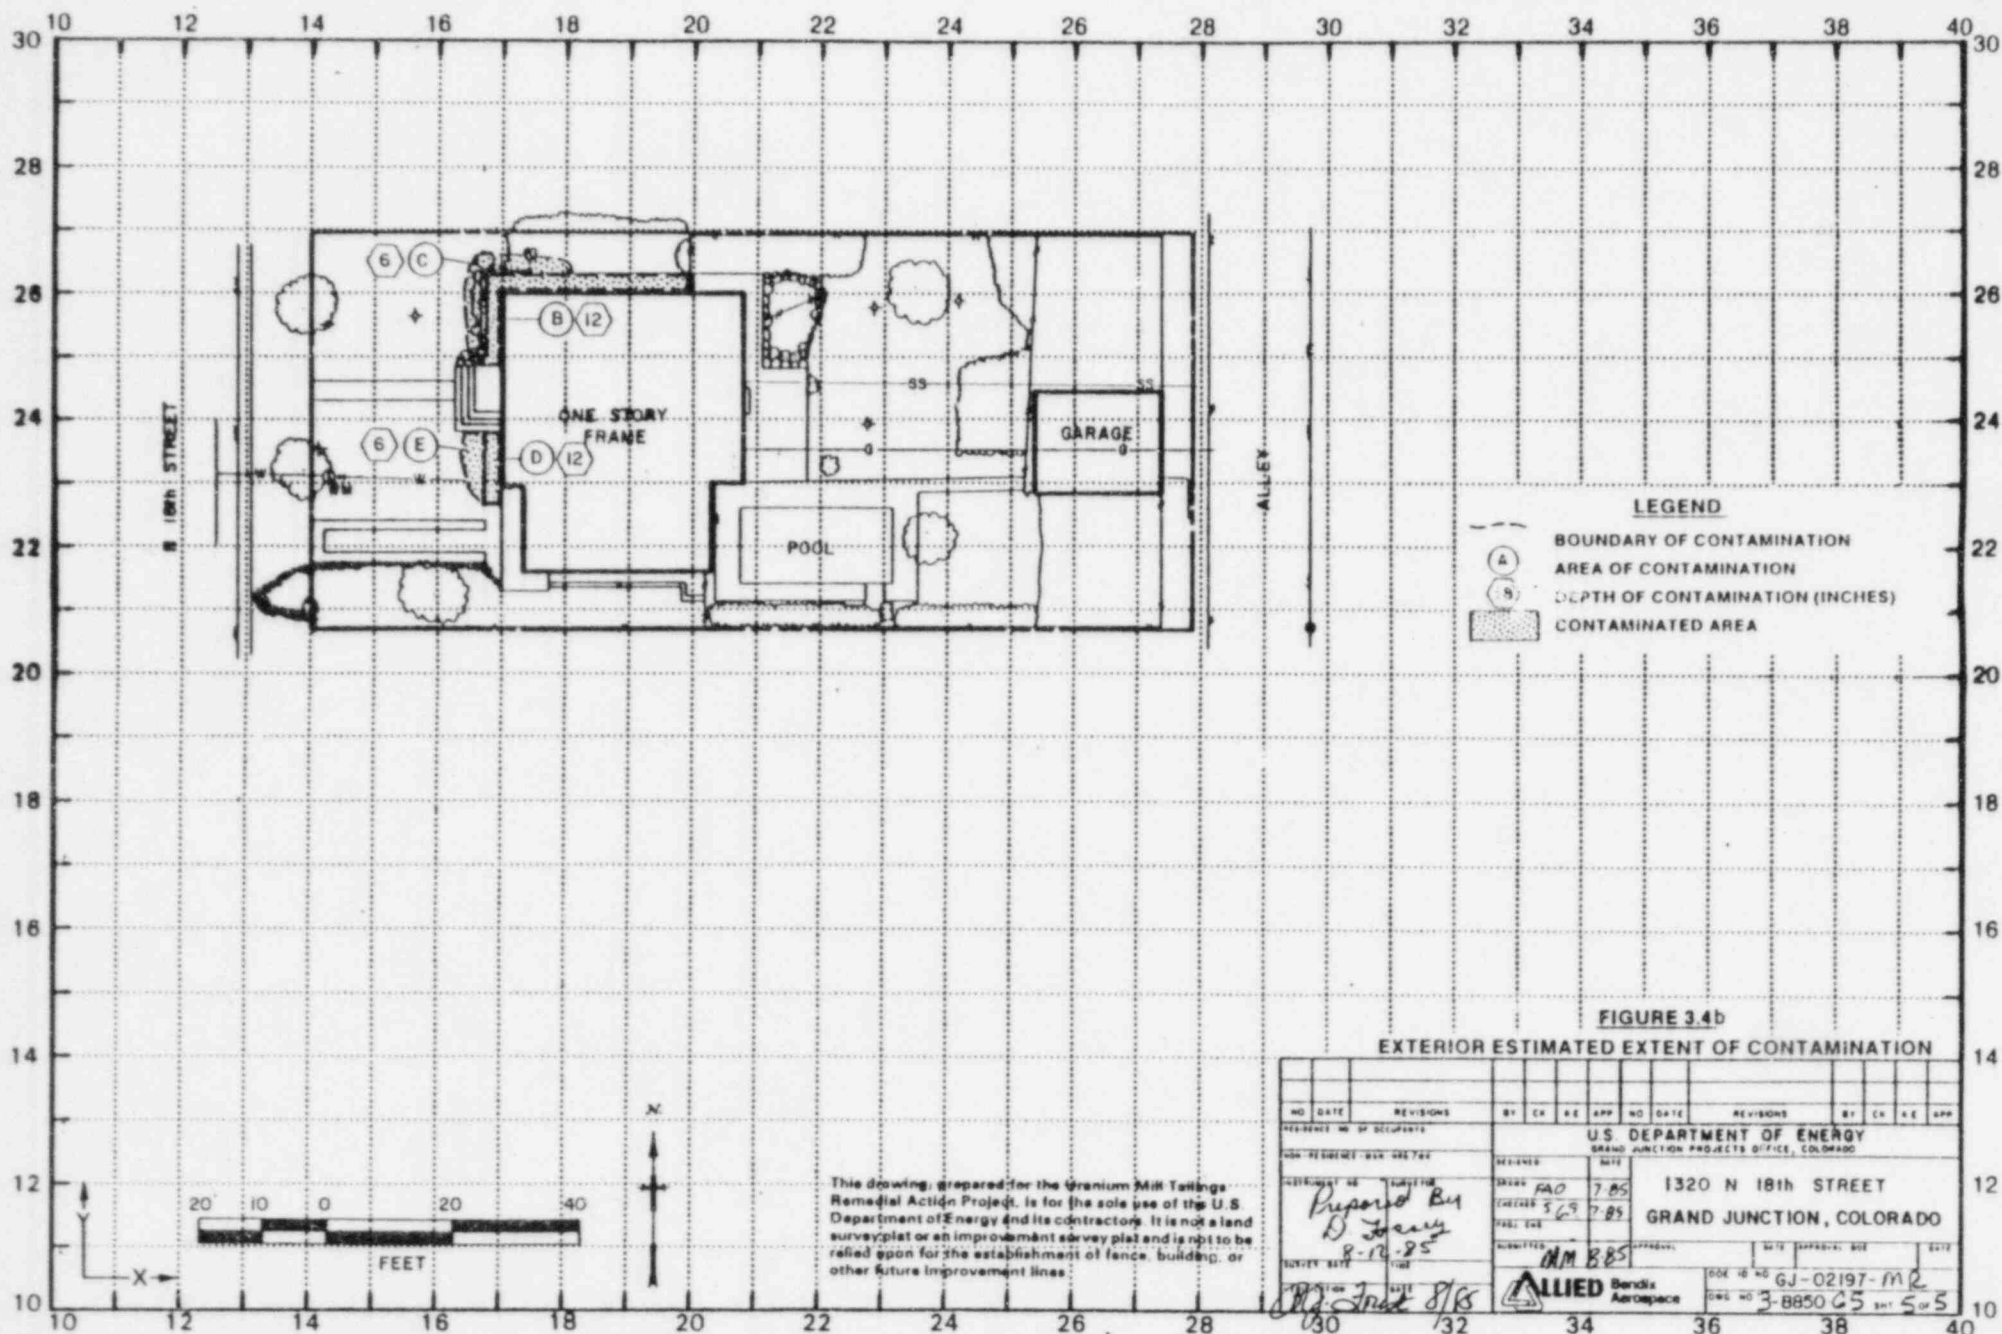
FIGURE 3.4b

- (Area B) Surface Material: Concrete
Direction From Primary Structure: North and west
Total Depth of Contamination: 12 inches
Other (height or thickness): 4-inch-thick concrete
Approximate Square Footage: 132

- (Area C) Surface Material: Soil
Direction From Primary Structure: North and west
Other Directions: Adjacent to Area B
Total Depth of Contamination: 6 inches
Comments: This area contains plants and thick ground cover.
Approximate Square Footage: 90

- (Area D) Surface Material: Concrete
Direction From Primary Structure: West
Total Depth of Contamination: Estimated at 12 inches
Other (height or thickness): 4-inch-thick concrete
Comments: The depth of contamination is based on data collected in Area B.
Approximate Square Footage: 36

(Area E) Surface Material: Lawn
Direction From Primary Structure: West
Other Directions: Adjacent to Area D
Total Depth of Contamination: 6 inches
Approximate Square Footage: 36

EXTERIOR ESTIMATED EXTENT OF CONTAMINATION

The recommended remedial action for this property, DOE ID No. GJ-02197-MR, includes select removal of all areas identified as containing radioactive material (as discussed in Section 3.5 and shown in Appendix Figures 3.4a and 3.4b) and transport of removed material to the disposal site.

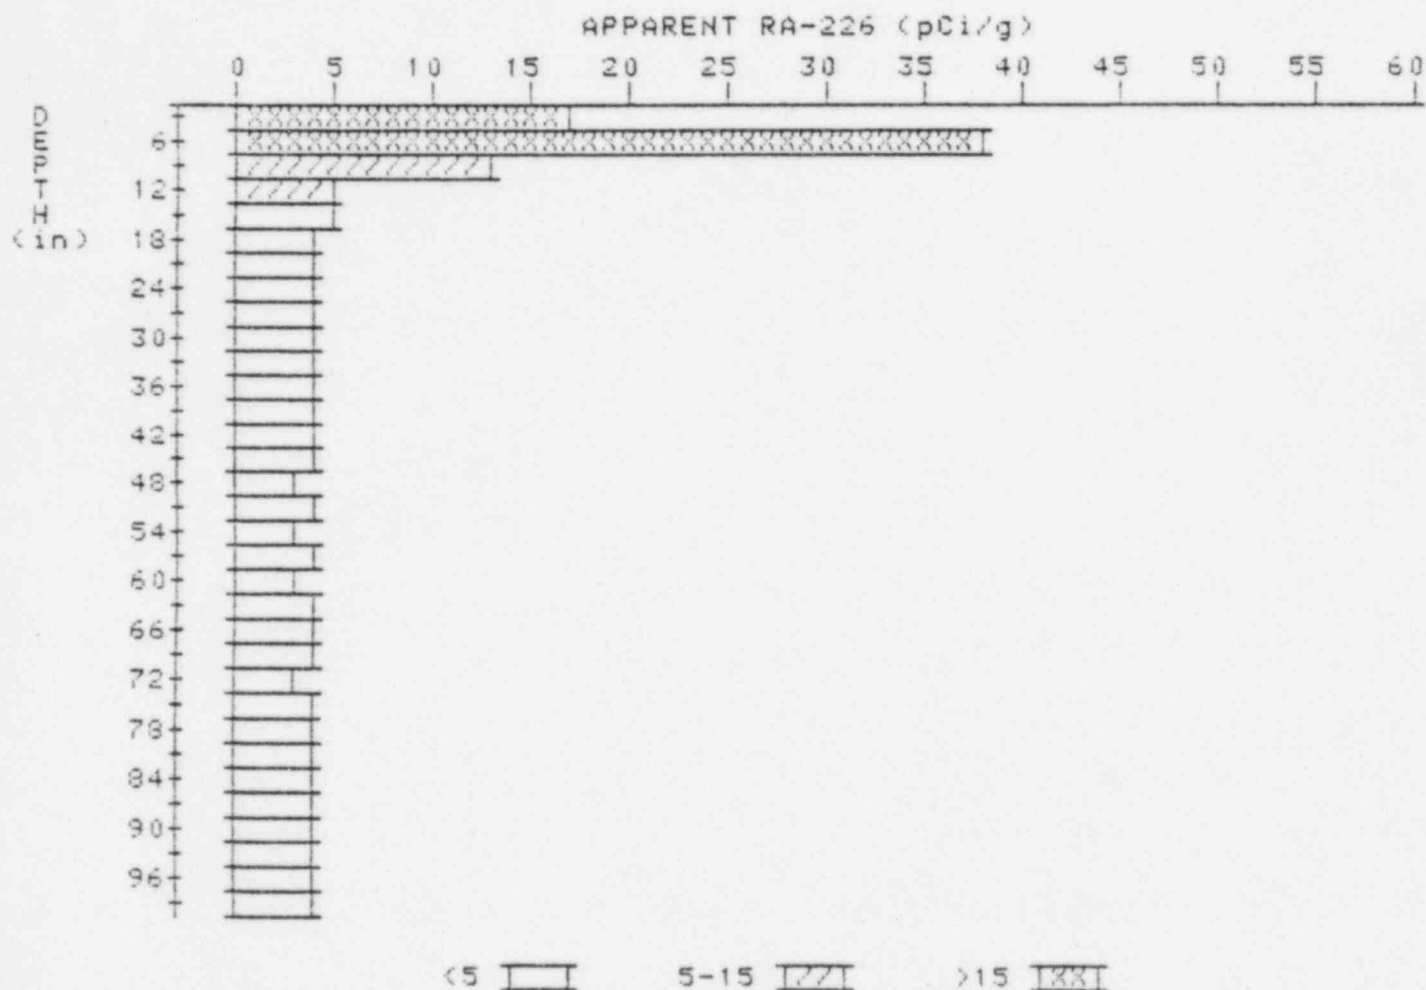
PROPERTY NUMBER: GJ-02197-MR
HOLE NUMBER: 10
LOCATION: 168249

Depth (in)	Apparent Radium-226 (pCi/g) Undeconvolved	Apparent Radium-226 (pCi/g) Deconvolved
3	16.6	16.6
6	20.5	37.9
9	14.6	13.2
12	9.5	5.1
15	6.9	4.8
18	5.3	4.4
21	4.7	4.0
24	4.3	3.9

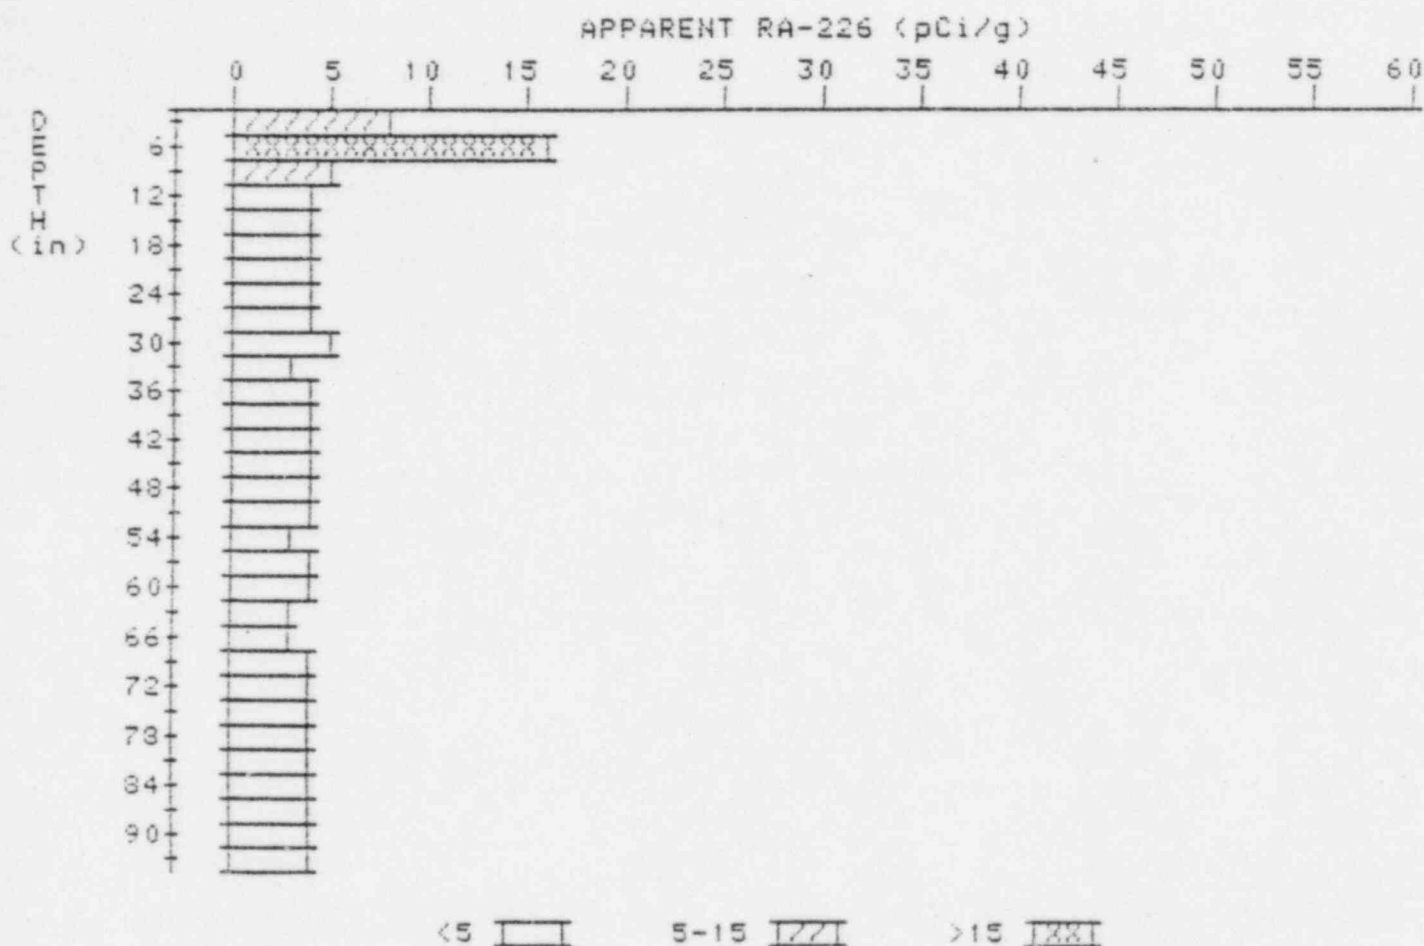
PROPERTY NUMBER: GJ-02197-MR
HOLE NUMBER: 13
LOCATION: 190262

Depth (in)	Apparent Radium-226 (pCi/g) Undeconvolved	Apparent Radium-226 (pCi/g) Deconvolved
3	8.2	8.2
6	9.5	16.3
9	7.0	5.2
12	5.5	4.3
15	4.7	3.8
18	4.4	4.4
21	4.1	3.7
24	4.0	4.0
27	3.9	3.5
