RADIOLOGIC AND ENGINEERING ASSESSMENT

DOE ID NO.: GJ-01358-RS  
ADDRESS: 1644 NORTH 15th STREET

AUGUST 1985

BENDIX FIELD ENGINEERING CORPORATION  
P.O. Box 1569  
Grand Junction, Colorado 81502

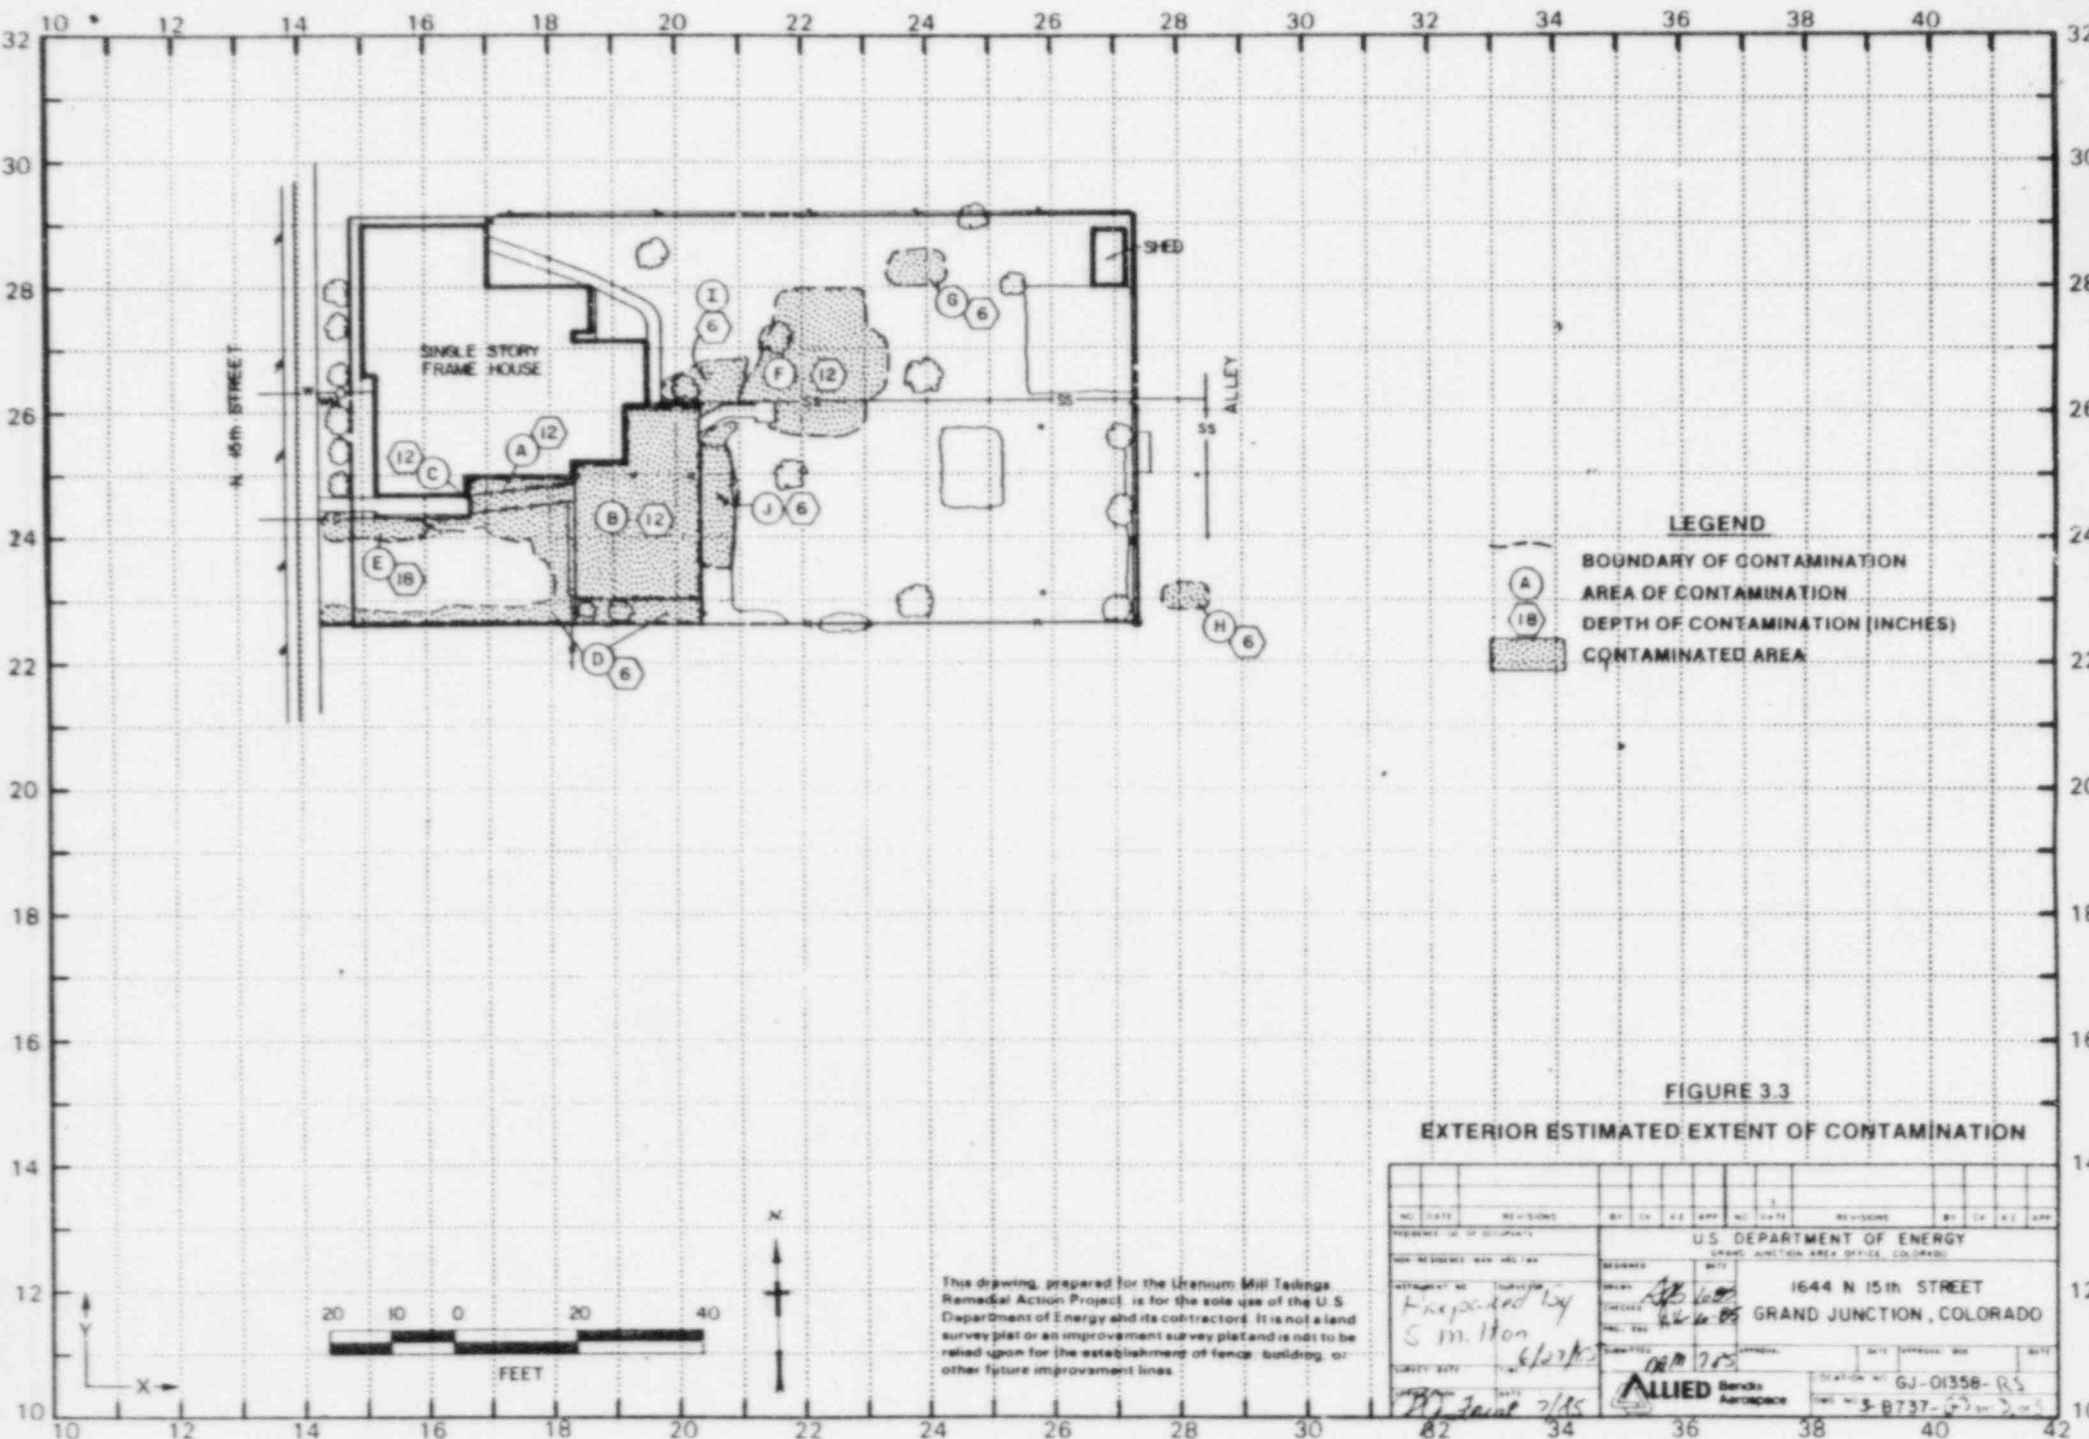
**FIGURE 3.3**

Appendix Figure 3.3 shows identified areas and estimated depths of contamination on this property, based on assessments of all measurements taken. As noted in this figure, areas recommended for remedial action that contain identified residual radioactive materials are:

- (Area A) Surface Material: Soil  
Direction From Primary Structure: South  
Other Directions: Along south foundation  
Total Depth of Contamination: 12 inches  
Approximate Square Footage: 32

- (Area B) Surface Material: Concrete  
Direction From Primary Structure: Southeast  
Total Depth of Contamination: 12 inches  
Other (height or thickness): 4-inch-thick concrete  
Comments: Covered carport  
Approximate Square Footage: 560

- (Area C) Surface Material: Concrete  
Direction From Primary Structure: South  
Total Depth of Contamination: 12 inches  
Other (height or thickness): 4-inch-thick concrete  
Approximate Square Footage: 51

- (Area D) Surface Material: Gravel  
Direction From Primary Structure: South and southeast  
Other Directions: In driveway  
Total Depth of Contamination: 6 inches  
Approximate Square Footage: 328

- (Area E) Surface Material: Gravel  
Direction From Primary Structure: South  
Total Depth of Contamination: 18 inches  
Approximate Square Footage: 64
- (Area F) Surface Material: Lawn  
Direction From Primary Structure: East  
Total Depth of Contamination: 12 inches  
Approximate Square Footage: 414

- (Area G) Surface Material: Lawn  
Direction From Primary Structure: East  
Other Directions: East of area F  
Total Depth of Contamination: 6 inches  
Comments: Small isolated deposit  
Approximate Square Footage: 45

(Area H) Surface Material: Gravel  
Direction From Primary Structure: Southeast  
Other Directions: In alley  
Total Depth of Contamination: 6 inches  
Comments: Small isolated deposit  
Approximate Square Footage: 32

(Area I) Surface Material: Lawn  
Direction From Primary Structure: East  
Other Directions: North of patio  
Total Depth of Contamination: 6 inches  
Approximate Square Footage: 78

(Area J) Surface Material: Soil  
Direction From Primary Structure: Southeast  
Other Directions: East of patio  
Total Depth of Contamination: 6 inches  
Approximate Square Footage: 110

**EXTERIOR ESTIMATED EXTENT OF CONTAMINATION**

The recommended remedial action for this property, DOE ID No. GJ-01358-RS, includes removal of all areas identified as containing radioactive material (as discussed in Section 3.5 and shown in Appendix Figure 3.3) and transport of removed material to the disposal site.
