RADIOLOGIC AND ENGINEERING ASSESSMENT

DOE ID NO.: GJ-00055-MR  
ADDRESS: 2530 MESA AVENUE

AUGUST 1985

BENDIX FIELD ENGINEERING CORPORATION  
P.O. Box 1569  
Grand Junction, Colorado 81502

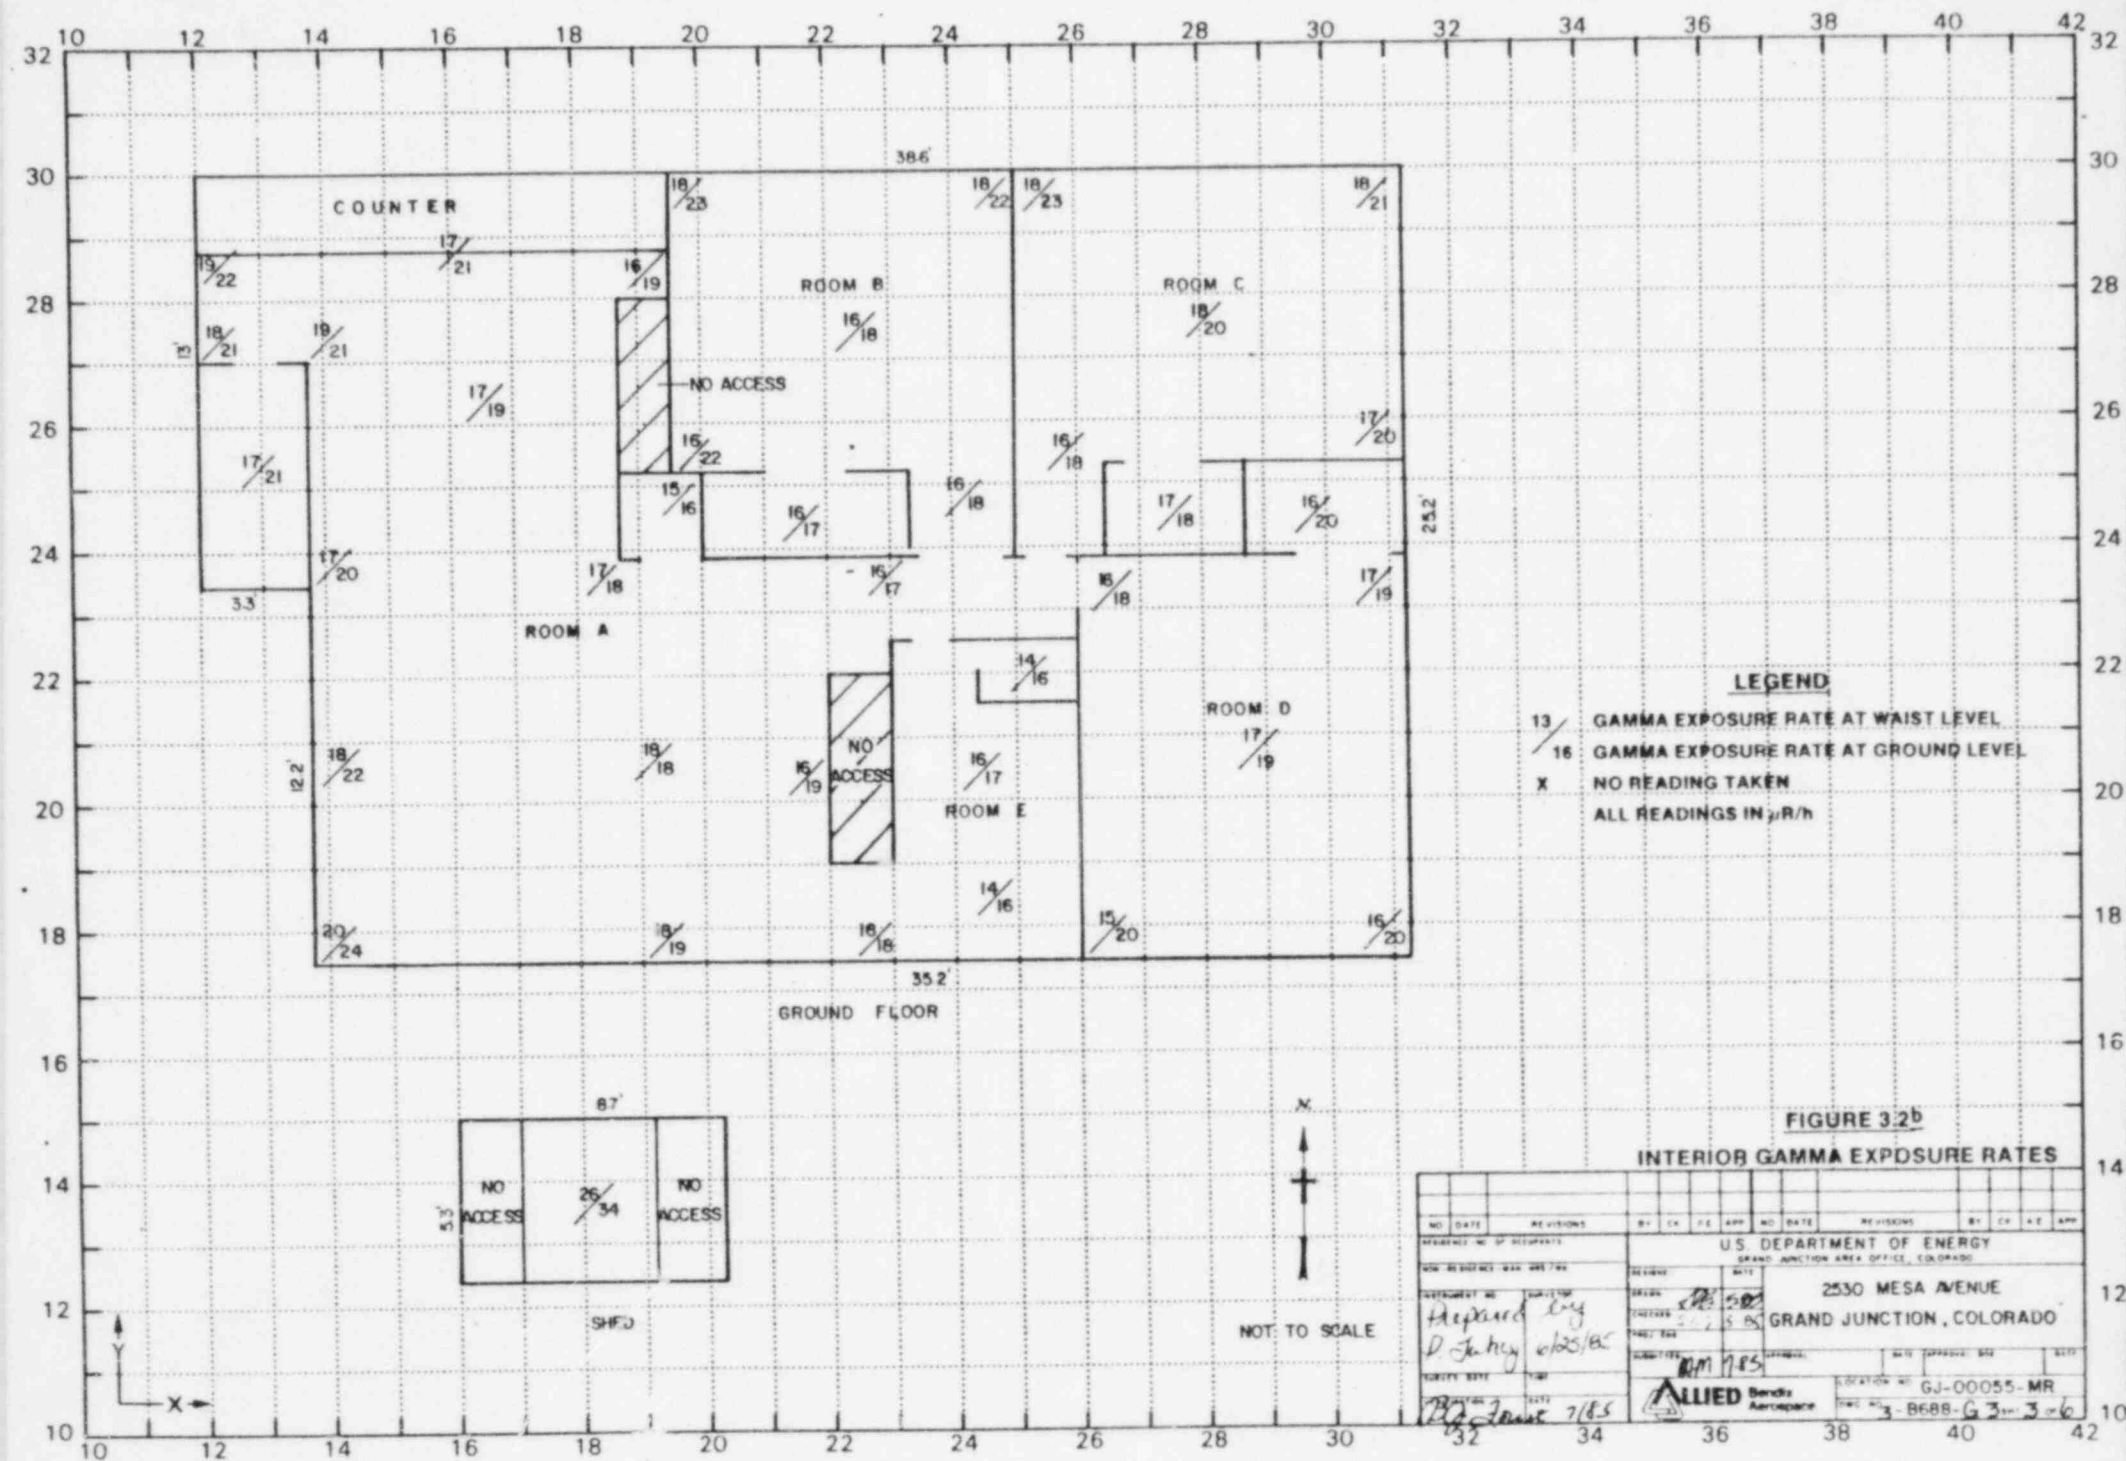
**FIGURE 3.2b**

Background Readings: 14 to 18 uR/h  
Highest Inside Gamma Reading (HIG): 24 uR/h

Interior radium-concentration measurements are presented in Appendix Table 3.2. Interior gamma exposure-rate measurements are summarized in Appendix Table 3.3. Appendix Figures 3.2a and 3.2b show interior exposure rates and locations of these measurements.
