TITLE POST IRRADIATION EXAMINATION OF FORT ST. VRAIN  
CRACKED FUEL ELEMENT SN1-2415

Post Irradiation Examination  
of Fort St. Vrain  
Cracked Fuel Element SN 1-2415

NRC Fin No. A-7258  
October, 1984

Los Alamos National Laboratory

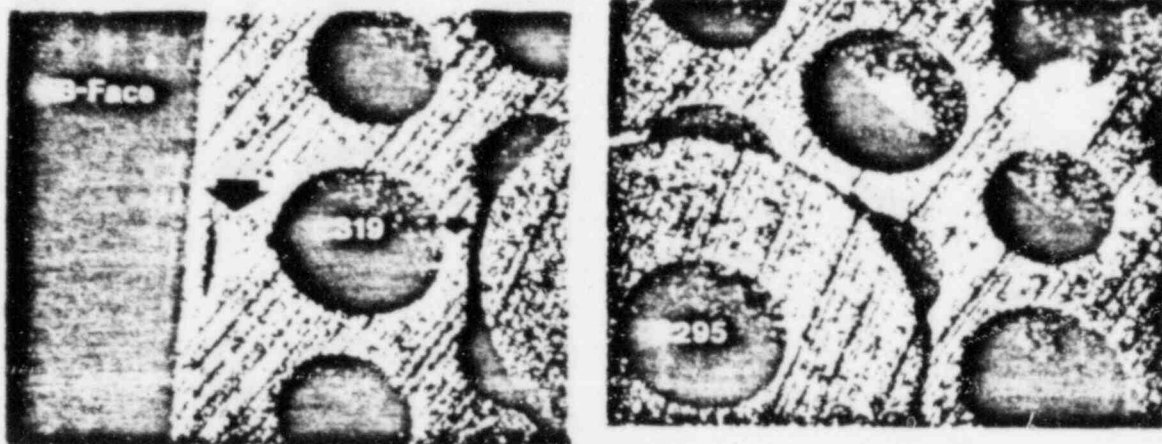
Initially, the extent of cracking in SN 1-2415 was confirmed by removing approximately a 1/4" slice from the top of the element, thereby effectively removing the cemented B-dowel from the element socket, without interfering with the fuel stacks. Photo 1 shows the top of SN 1-2415 after the removal of the first slice with the remainder of the B-dowel still in the socket. In this photo, the crack radially extends from the B face, across coolant channel 319, and disappears under the B-dowel. Photo 2, taken after the B-dowel section was removed, shows how the crack extended from coolant channel 319 to fuel channel 307, and on to coolant channel 295 under the B-dowel.

SN 1-2415 Element - - Slice  
removed showing B dowel

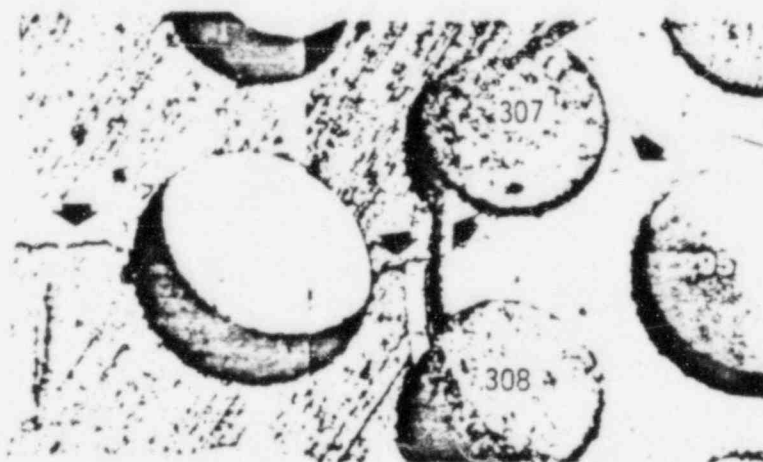
Photo 2

Top of GAT Slice, showing  
crack in dowel socket

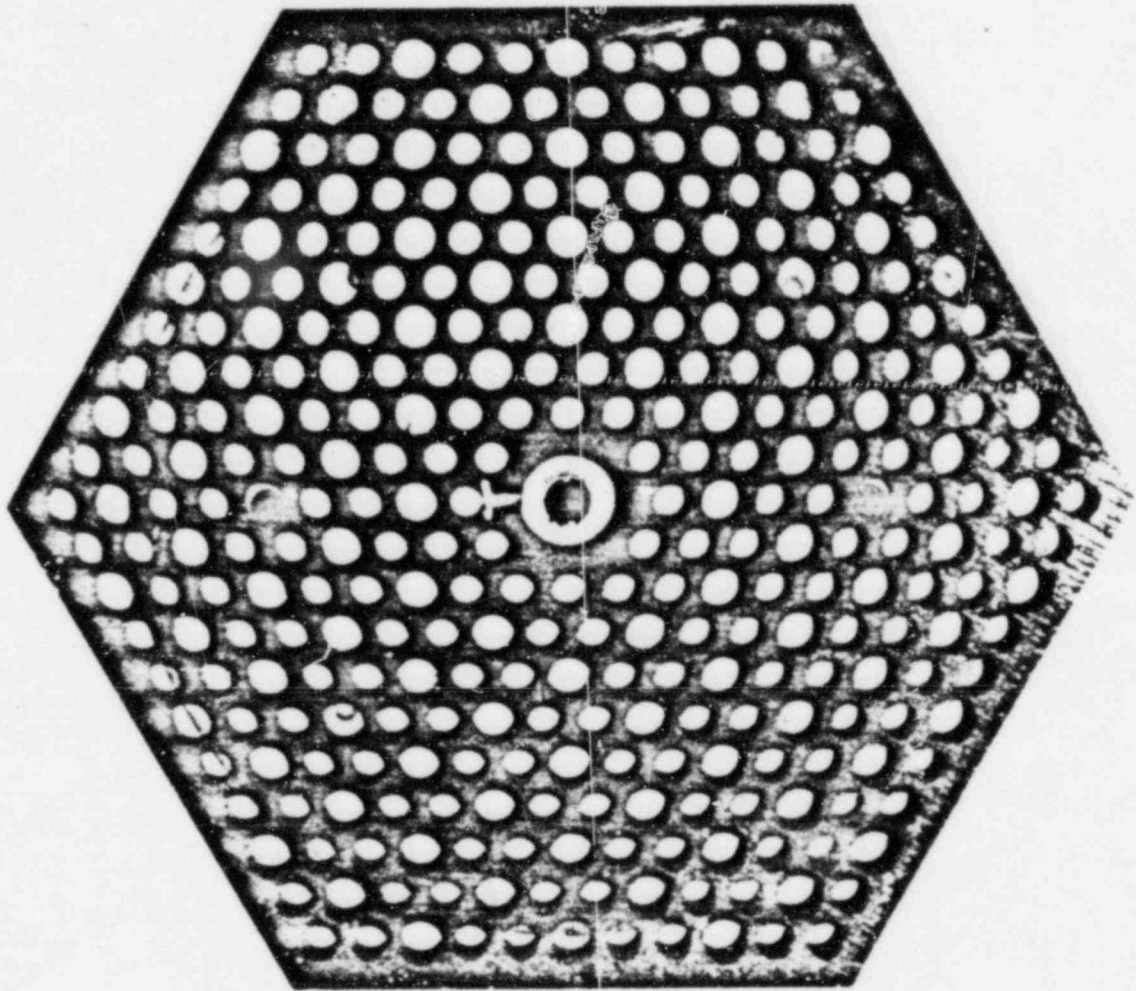
Photo 3

A broad array of general and detailed photographs was taken of the three cracked regions, and provided a permanent record of the crack characteristics on each slab prior to sectioning for other examinations. Photo 3. shows Slab 1, as seen in the Los Alamos hot cell facility, mounted on the rotatable jig used for positioning the slabs. Photographs 4 a, b and c show the crack definitely running from the B-face surface to coolant channel 319, over to fuel hole 307, and apparently traversing the graphite web over to coolant channel 295, for Slabs 1, 2 and 4, respectively. It was noted that the crack width seemed to narrow for each successive slab approaching the core midplane. A tabulation of the crack widths is available in Table 2.

FT ST. URAIN  
FUEL BLOCK S/N 1-2415  
SECTION 1-TOP

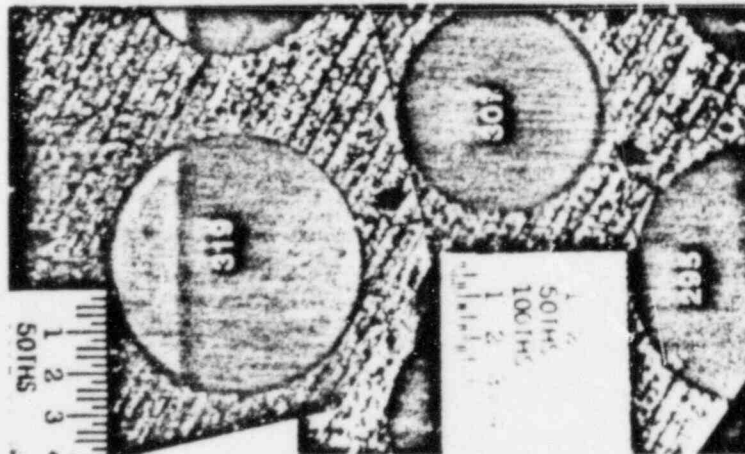
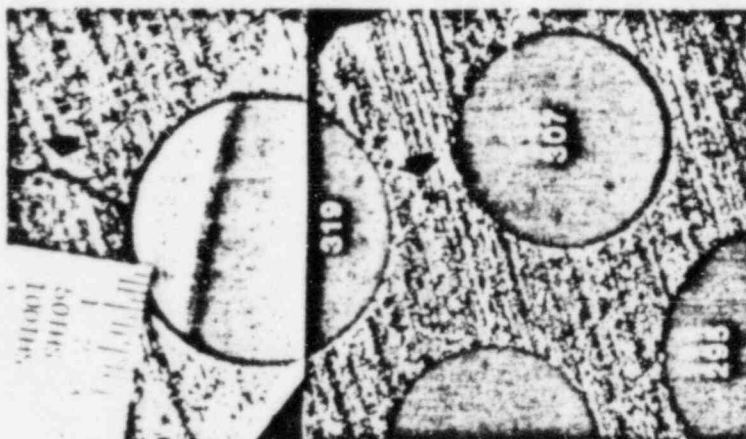
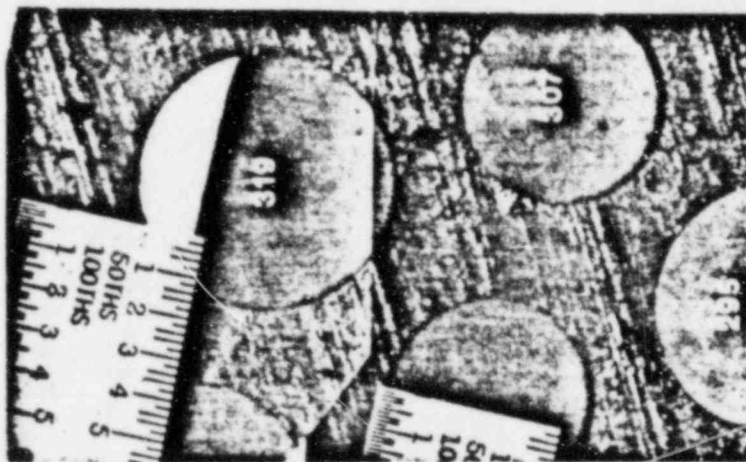
Photo 4

<u>Slab</u>	<u>Approximate Crack Widths, inches x 10<sup>-3</sup></u>		
	<u>B-face to 319</u>	<u>319 to 307</u>	<u>307 to 295</u>
1	10-15	10-15	10-15
2	5-7	4-6	4-6
4	3-5	2-4	*

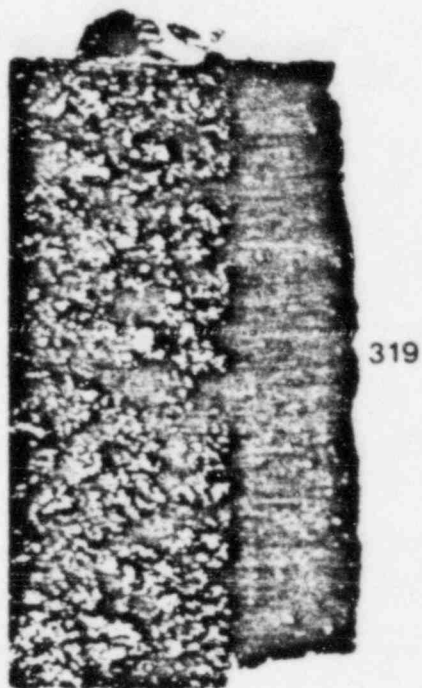
Photo 5(a)

Fracture surface between  
B-Face and 319. Slab 4  
4x

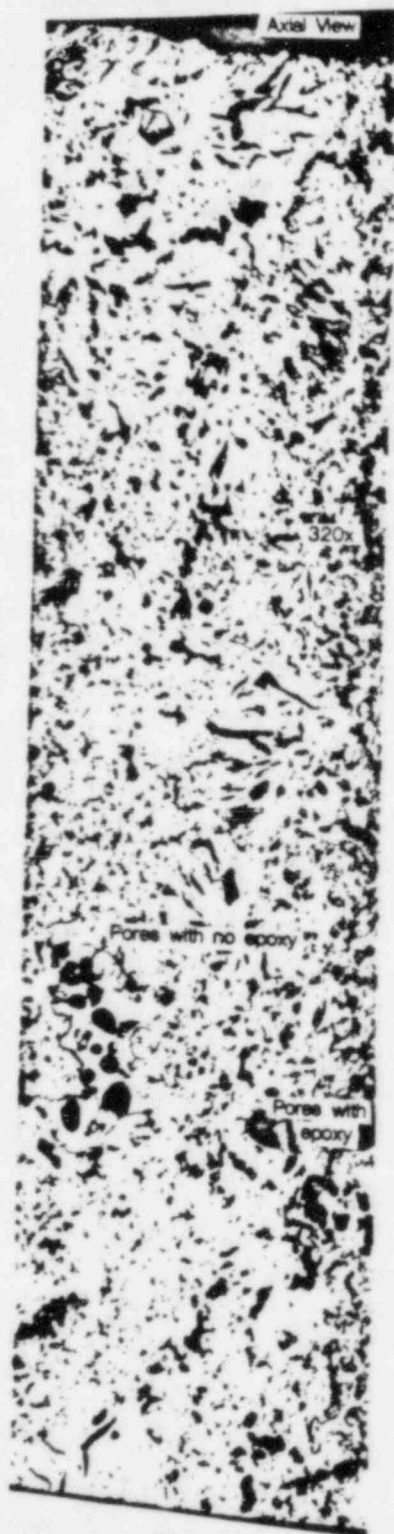
Photo 6(a)

The H-327 graphite, as an anisotropic material, has distinctly different material property characteristics in the longitudinal (extrusion) and transverse directions, although this is not readily apparent in Photos 6(a) and 6(b) (32x original magnification, but photographically reduced 50%). This set of samples was taken from the web between the B-face and coolant channel 319, Slab 4, but is also typical of the longitudinal and transverse microstructure observed at several other locations in the slab.

Photomicrograph of Longitudinal  
cross section between B-Face  
and 319, Slab 4

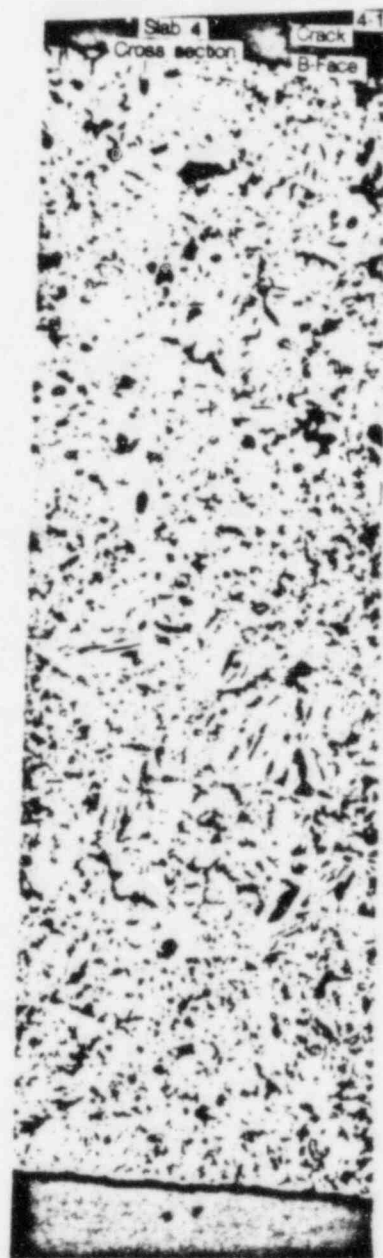
Photo 6(b)

Photomicrograph of Transverse  
cross section between B-Face  
and 319, Slab 4

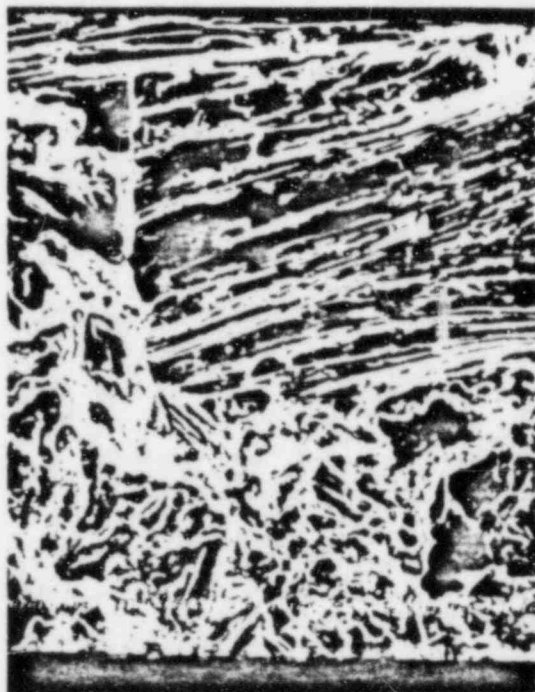
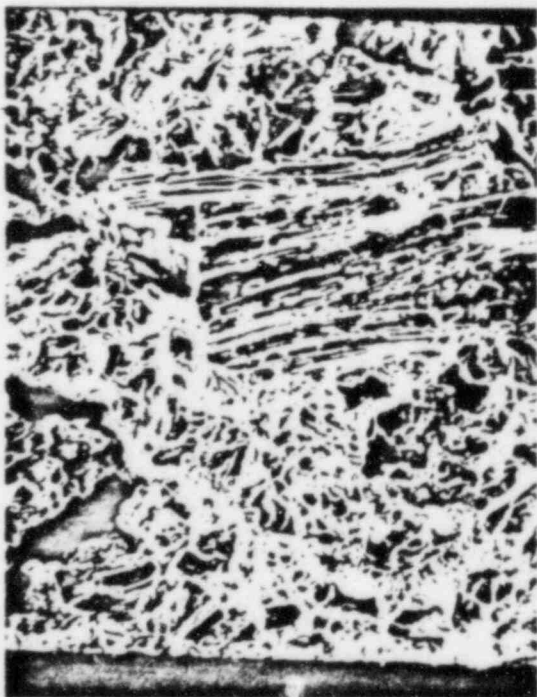
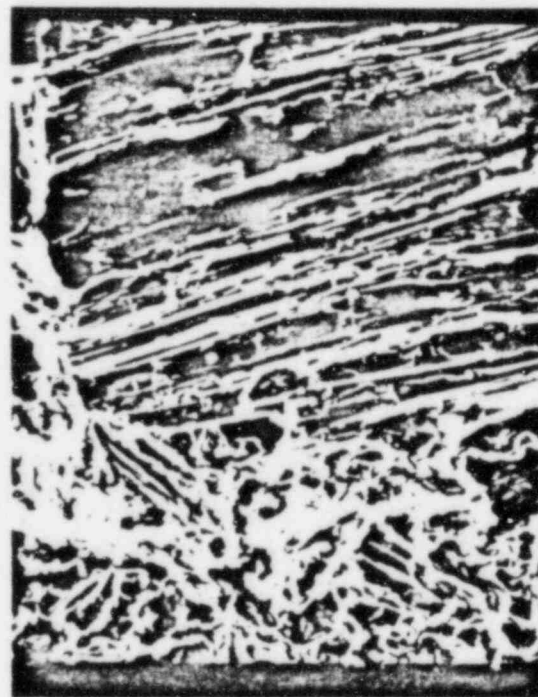
The SEM (Scanning Electron Microscope) photomicrograph in Photo 7 (original magnification as noted, but photographically reduced 4%) was taken on a sample of the fracture surface between the B-face and coolant channel 319, Slab 4, and shows how the graphite microstructure is a composite of dense, ordered coke filler particles, and unordered binder with porosity. With increasing magnification (50x, 100x, 200x), the greater long-range order of the coke filler particle relative to the surrounding material becomes more distinct--and it is that long-range order that allows basal-plane cleavage to take place within the particle. Assuming the needle-like coke filler particles are basically aligned in a given direction, it is not difficult to imagine a stress field operating to fracture the material preferentially in that direction.

SEM (Scanning Electron  
Microscope) Photomicrograph  
showing cleavage, Slab 4

Cleavage in dense area

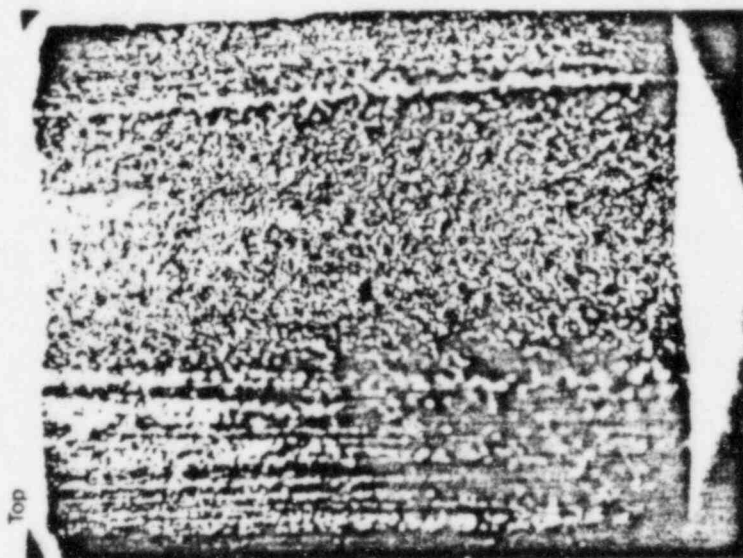
The final examination on Slab 4 verified that no crack actually existed between fuel hole 307 and coolant channel 295. In Photo 8(a) (original magnification as noted, but photographically reduced 51%), the presence of a crack can not be directly identified because of the saw striation marks. Again, in Photo 8(b), no cracking could be found on the axial projection of fuel hole 307 or coolant channel 295 (not shown). But the photomicrograph of the web, shown in Photo 8(c), displays a string of pores between 307 and 295. Such a string is a good candidate path for crack propagation.

Photo 8(b)  
Looking at side edge of 307.  
Towards 295, shows no sign of  
axial cracking at 8x

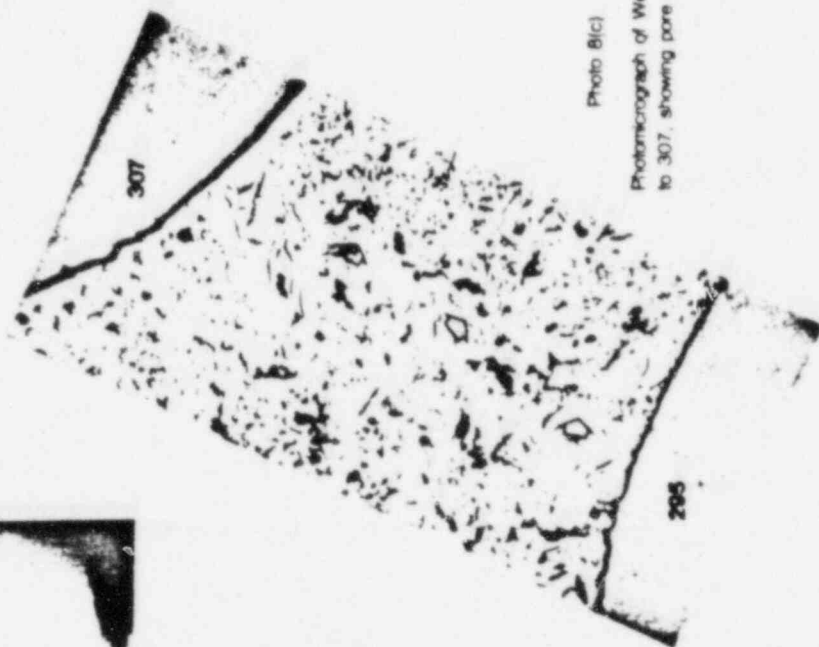
Photo 8(c)  
Photomicrograph of Web 295  
to 307, showing pore alignment

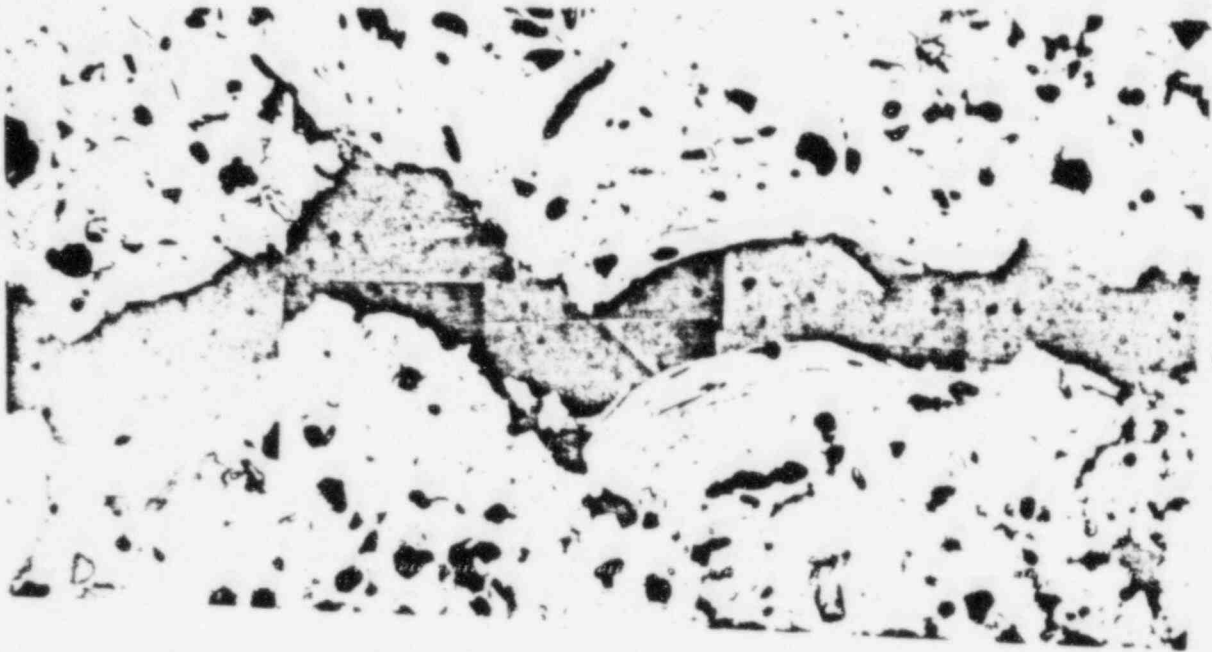
Photo 9(b)

9(b) the crack can be seen to follow a path of easy cleavage along the grain of a coke filler particle. Photo 10(a) illustrates another energetically-favorable crack path, in which the crack tends to propagate so as to link up pores. Interestingly, no crack was found in the web between fuel hole 307 and coolant channel 295 in Slab 2.

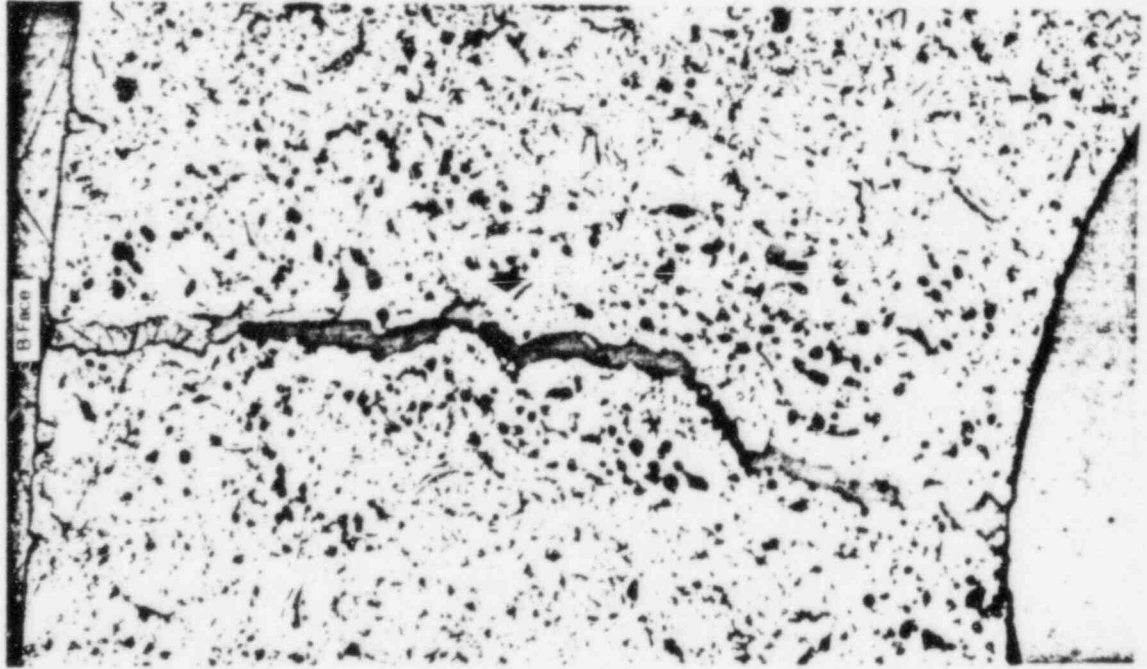
Slabs 2 and 1 were also used in verifying the localized crack morphology. Photo 9(a) (32x original magnification, but photographically reduced 49%) is a photomicrograph of the crack between the B-face and coolant channel 319, and 9(b) shows the central part at higher magnification (128x). At the center of

Photomicrograph of crack  
between B Face and 319  
Slab 2

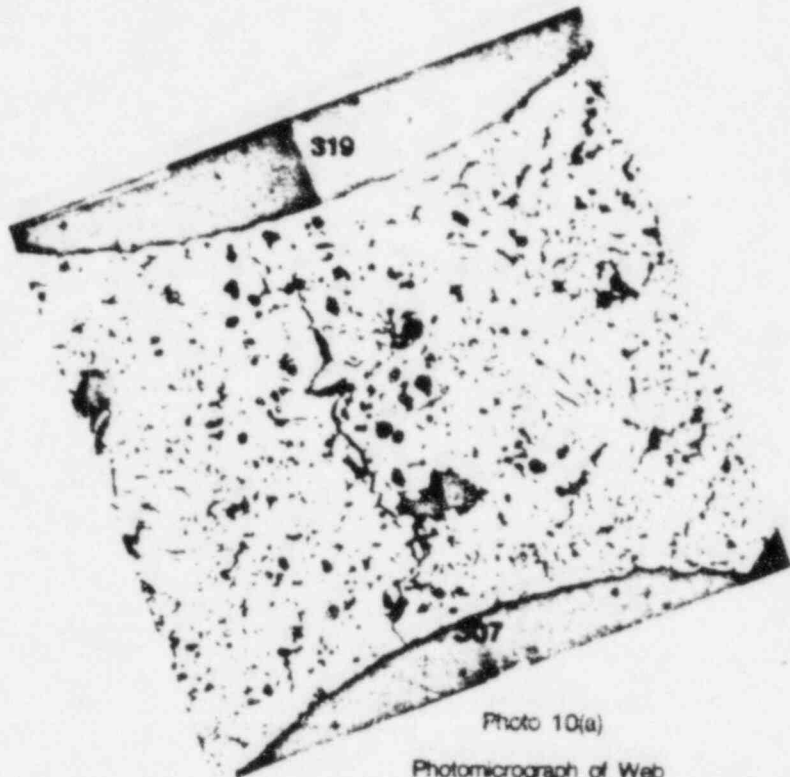
Photo 10(a)

Photomicrograph of Web  
319 and 307,  
Slab 2

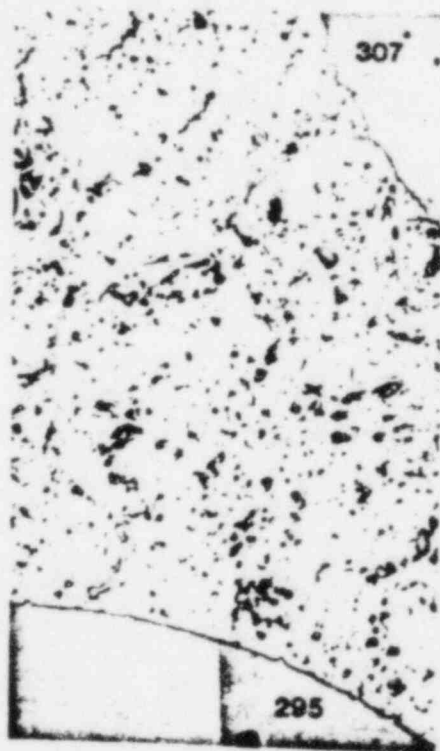
Photo 10(b)

Photomicrograph of Un-cracked  
Web between 307 and 295,  
Slab 2

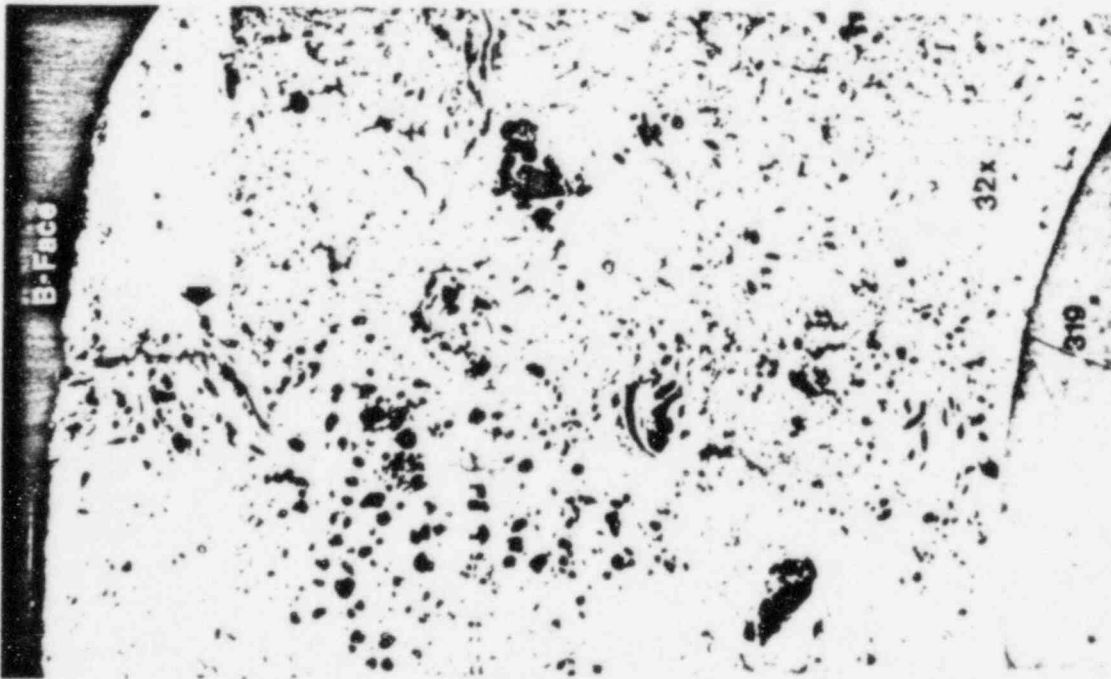
Slab 1 was the only one of the three slabs to have cracks in the first three webs from the B-face, as shown in the sequence of Photos 11 and 12. Again, the general crack microstructure in Slab 1 echoed the patterns already observed in Slabs 2 and 4. Cleavage along the grain of filler particles and crack propagation between aligned, or even semi-aligned pores, seems to be the preferred mode of crack propagation in all slabs examined. This is consistent with what would be expected from the standpoint of lowest energy of formation, and is the crack mode usually found in artificial graphites.

Photo 11(a)  
 Photomicrograph of Web  
 between B-Face and 319  
 Slab 1, 32x

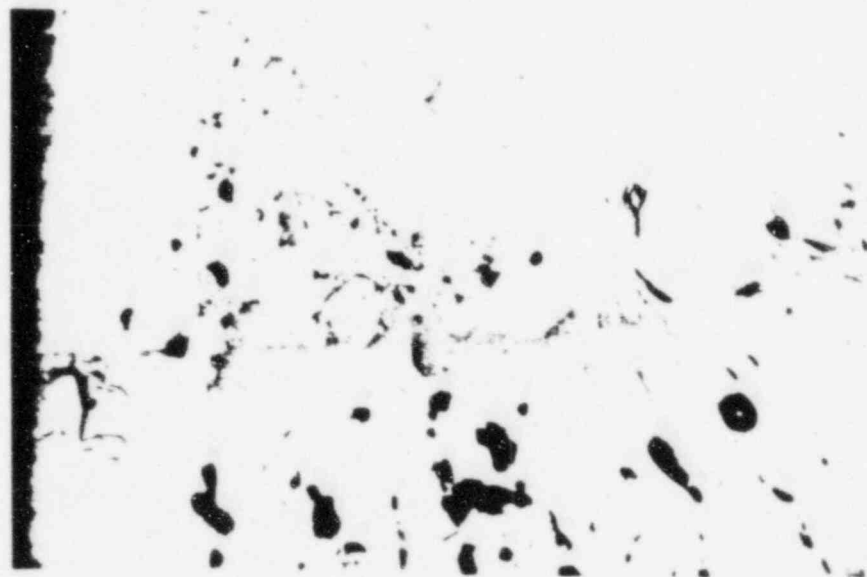
Photo 11(b);  
 Photomicrograph of Crack Segment  
 1 between B-Face and 319  
 Slab 1, 128x

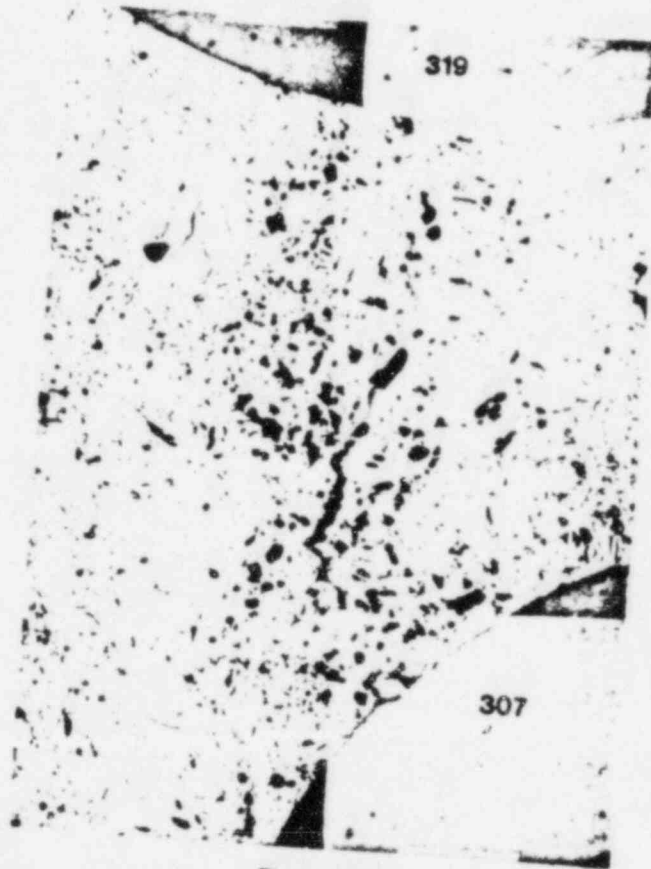
Photo 12(a)

Photomicrograph of Web between  
319 and 307, Slab 1

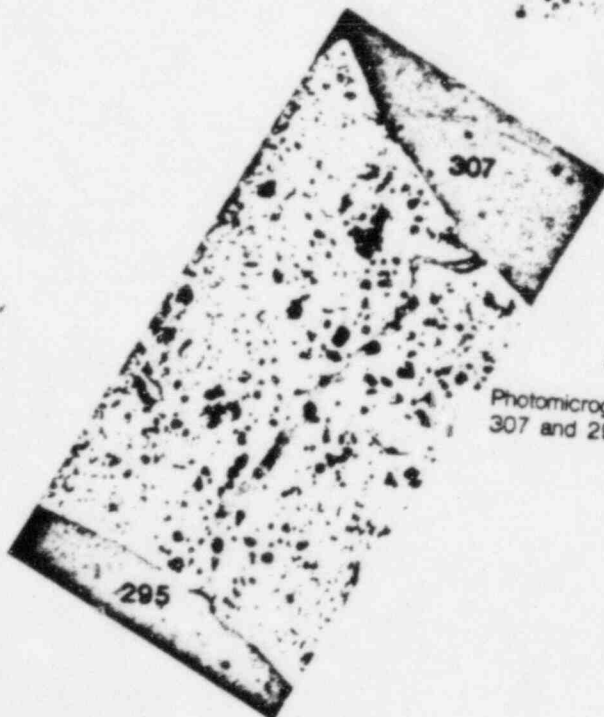
Photo 12(b)

Photomicrograph of Web between  
307 and 295, Slab 1
