LICENSEE EVENT REPORT (LER)

FACILITY NAME (1) Duane Arnold Energy Center										DOCKET NUMBER (2) 0 5 0 0 0 3 3 1										PAGE (3) 1 OF 0 9																																							
TITLE (4) Emergency Diesel Generators Sequencing Design Anomaly																																																											
EVENT DATE (5)										LER NUMBER (6)										REPORT DATE (7)										OTHER FACILITIES INVOLVED (8)																													
MONTH			DAY			YEAR			YEAR			SEQUENTIAL NUMBER			REVISION NUMBER			MO			DAY			YEAR			FACILITY NAMES										DOCKET NUMBER(S)																						
0 8			2 8			8 5			8 5			0 3 6			0 0 0			9 2 0			8 5			None										0 5 0 0 0																									
0 8			2 8			8 5			8 5			0 3 6			0 0 0			9 2 0			8 5													0 5 0 0 0																									
OPERATING MODE (9) N										THIS REPORT IS SUBMITTED PURSUANT TO THE REQUIREMENTS OF 10 CFR 5. (Check one or more of the following) (11)

Subject: Duane Arnold Energy Center
Docket No. 50-331
Op. License DPR-49
Licensee Event Report No. 85-036

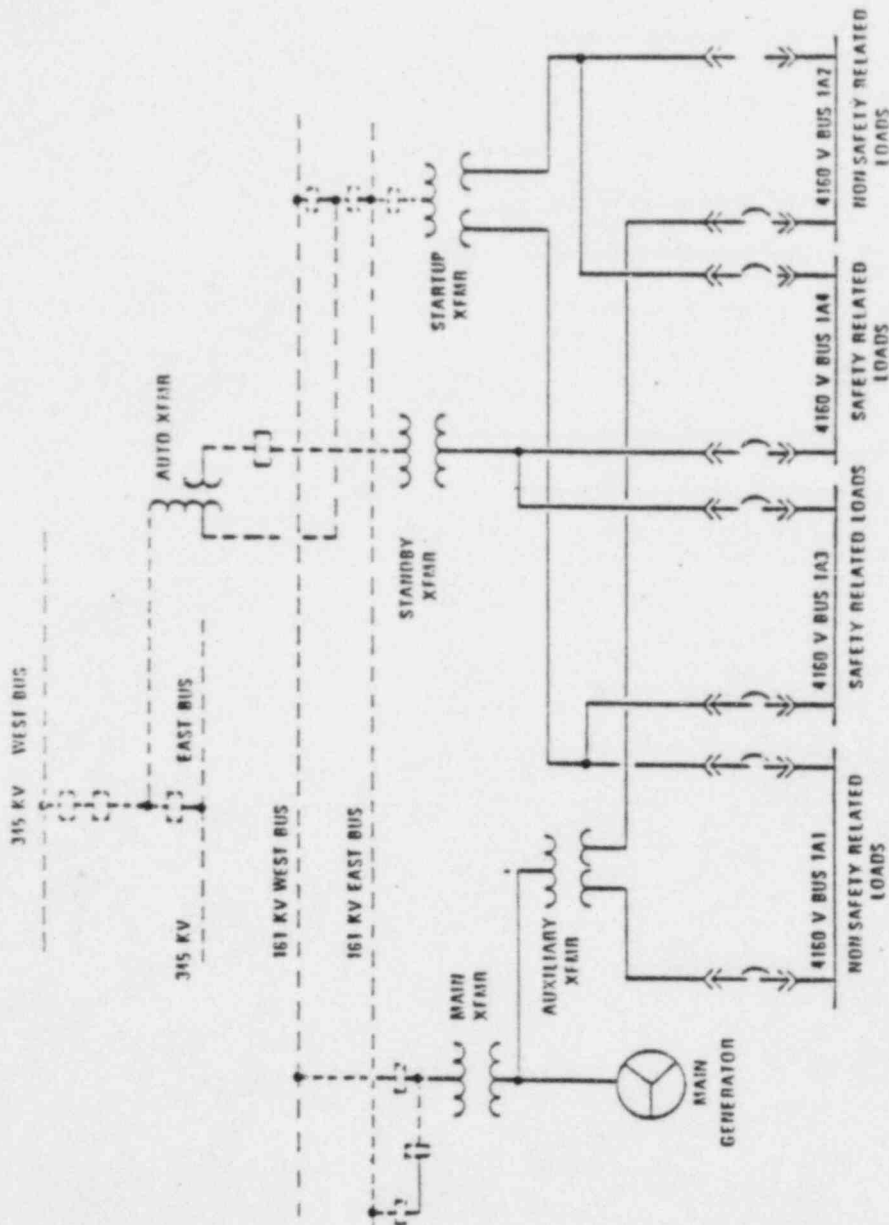
DAEC Electrical System
 Figure 8.2-6

The Duane Arnold Energy Center has four 4160 V buses, two vital and two non-vital. (See attached drawing identified as Figure 8.2-6.) The normal plant lineup when in power operation has the two vital buses powered off the Startup Transformer (which is connected to offsite power) and the two non-vital buses powered from the Auxiliary Transformer (which is fed from the plant's main generator). A third transformer, the Standby, which can only supply the two vital buses remains idle. Should the Startup Transformer fail, the vital buses are automatically transferred to the Standby Transformer and the EDGs start. Should the Standby Transformer also fail to provide power to the vital buses, the EDGs will load.

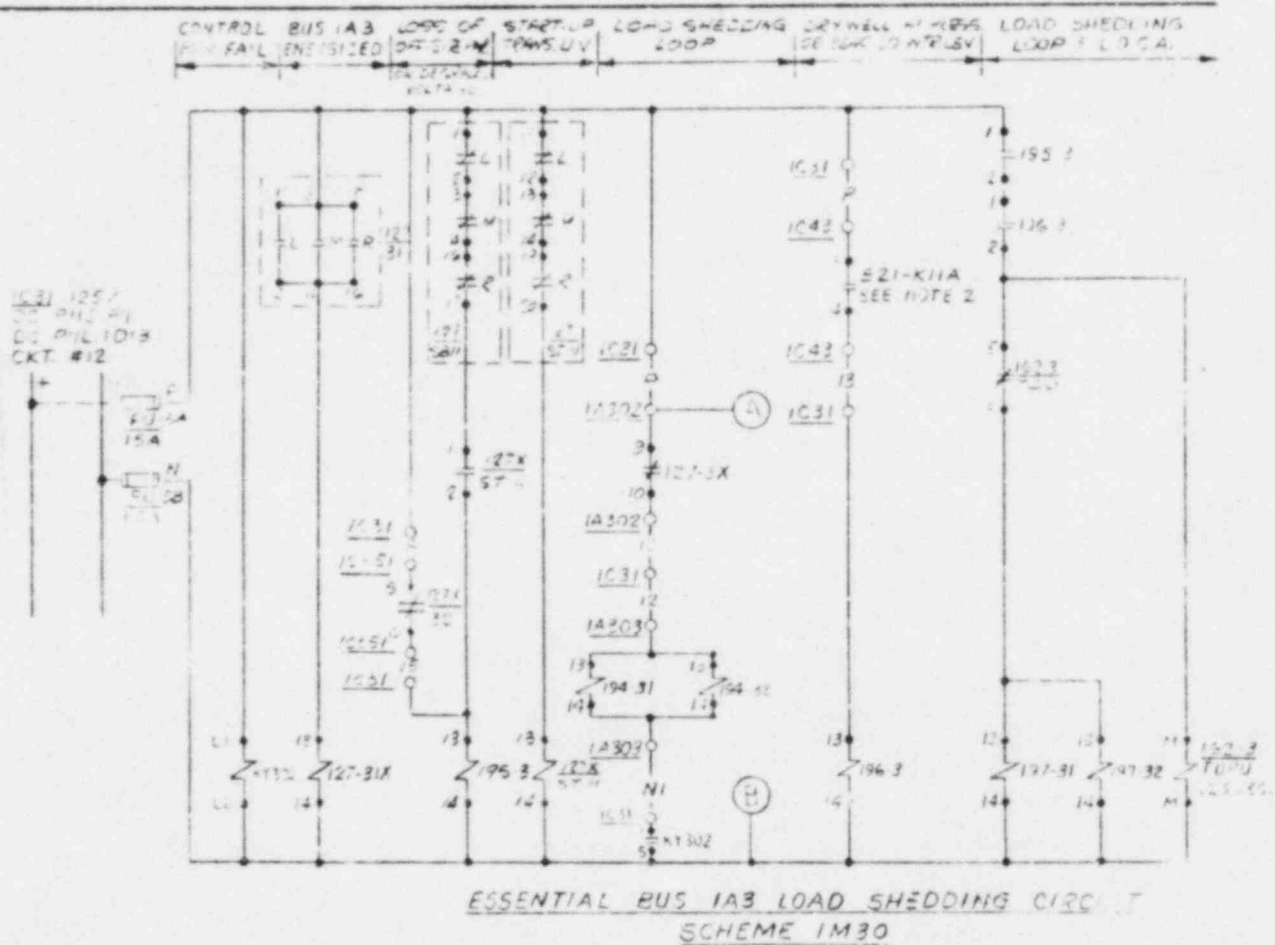
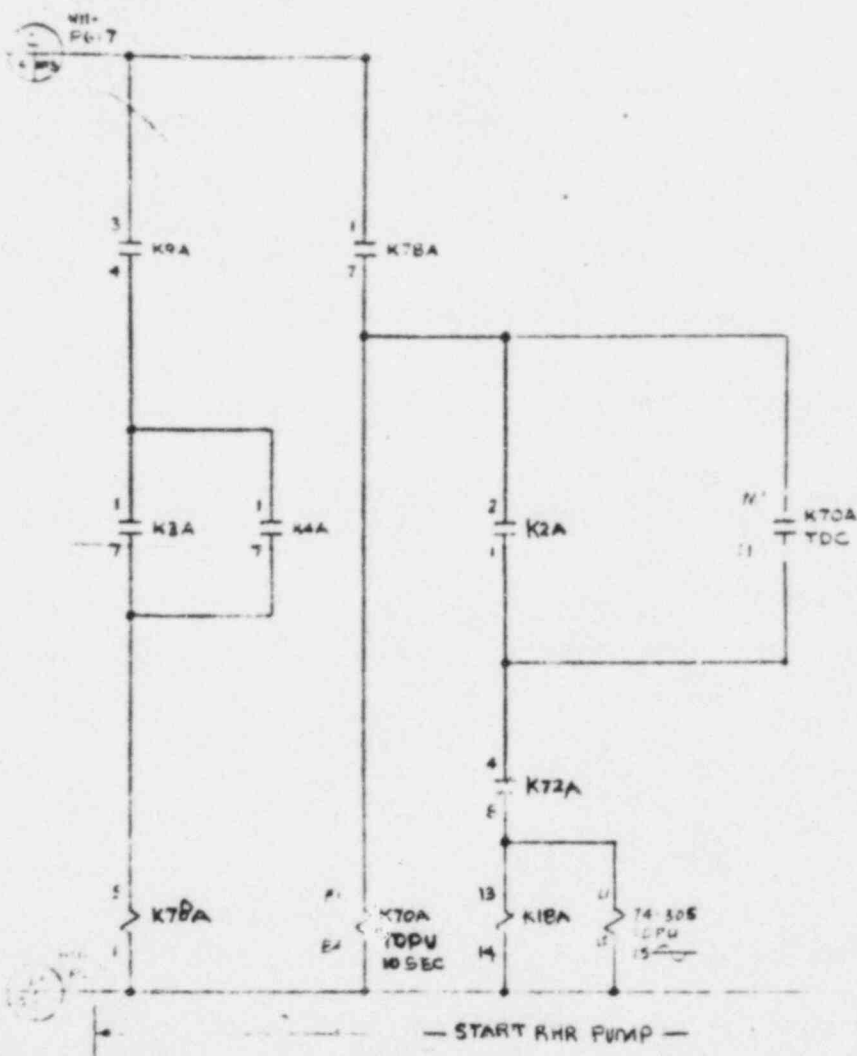
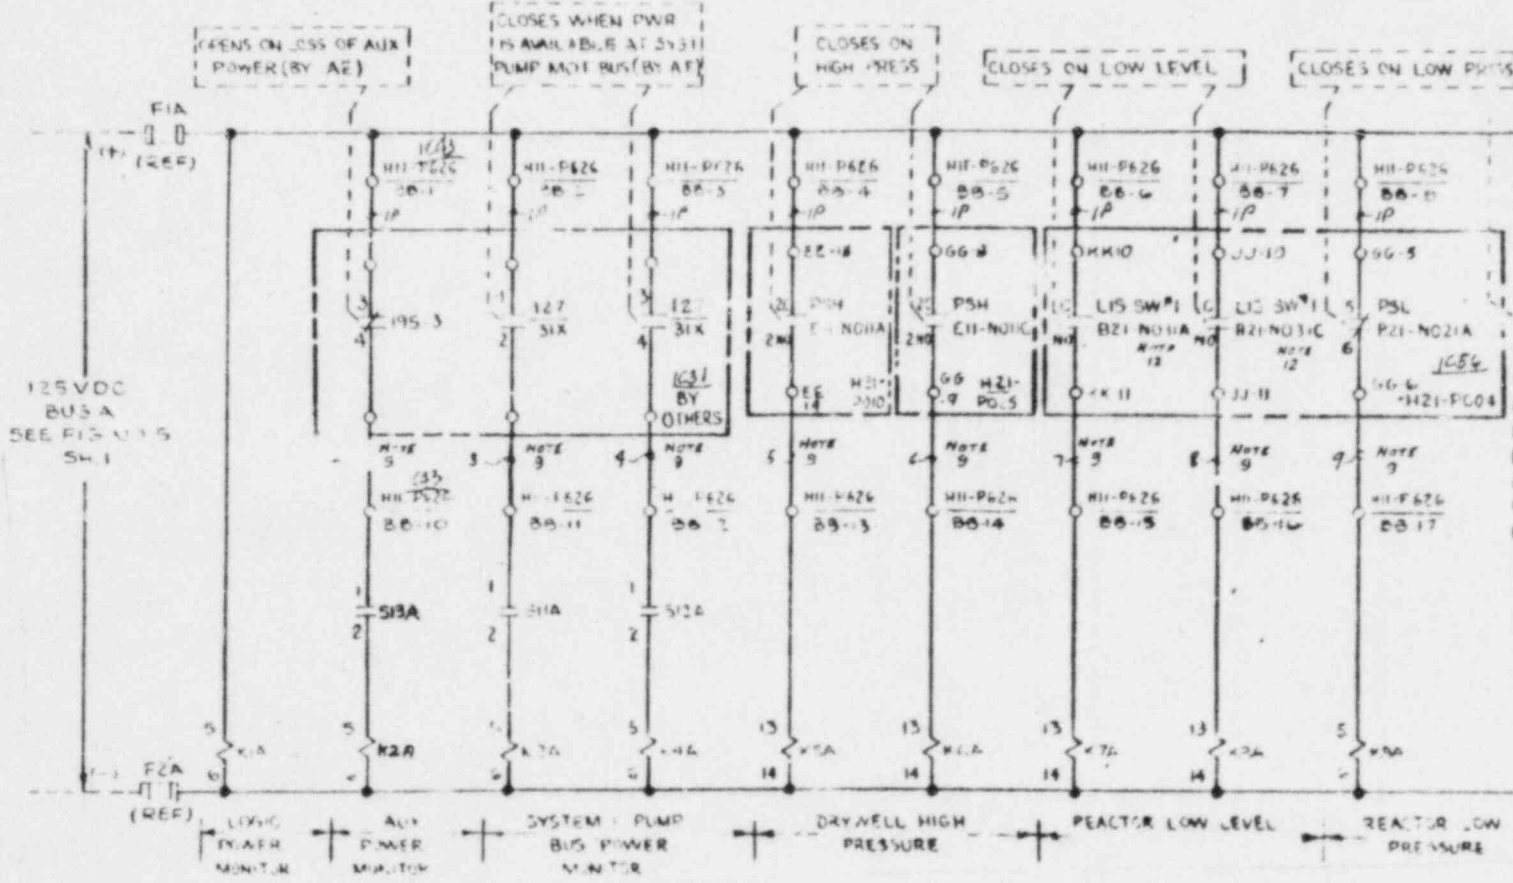
The specifics of the logic are as follows: (see attached partial schematics). On APED drawings (GE) the core spray and RHR pumps receive autostart signals through two parallel paths, K2A contacts or K70A TDC (time delay contacts - Note relay numbers differ for core spray and the other RHR pumps). The K2A relay coil is in series with relay 195-3 contacts and is energized (195-3 contacts closed, 195-3 deenergized) by 125 V DC unless both the Startup and Standby Transformers are less than 65% voltage on their secondaries. A degraded voltage relay (vital bus voltage, 92.5%) can also deenergize relay K2A (by energizing 195-3) when the logic is satisfied (8.5 seconds below 92.5% and either transformer output breaker are closed onto the vital bus). Were the vital buses on the Standby Transformer and were only this transformer to fail, the following sequence would occur. Since the Startup Transformer still would have normal output voltage on its secondaries, the series logic would not energize relay 195-3. Similarly, 195-3 would not energize on degraded voltage (92.5% with 8.5 second delay) since the vital bus breakers would be open. Therefore, K2A contacts would remain closed and the pumps would be immediately loaded onto the diesel when it achieved nominal output.

The resolution of this problem was to place two keylock test switches (per electrical division) in the RHR and Core Spray pump start logics in the test position. This always load sequences the pumps onto the vital buses in the event of a LOCA, with or without a concurrent loss of the Startup or Standby Transformers. The DAEC LOCA analysis considers, as a design basis event, a complete loss of offsite power with a concurrent LOCA, and therefore takes into account the time delays associated with the sequencing of these pumps. At 2240 hours on August 22, 1985, the test switches were placed in the test position, rendering both EDGs operable and cancelling the twenty-four hour Limiting Condition for Operation.
