**Florida  
Power**  
CORPORATION  
Crystal River Unit 3  
Docket No. 50-302

Subject: Licensee Event Report (LER) 97-008-00

FACILITY NAME (1) CRYSTAL RIVER UNIT 3 (CR-3)										DOCKET NUMBER (2) 0 5 0 0 0 3 0 2					PAGE (3) 1 OF 0 7														
TITLE (4) Discovery of Original Design Configuration Resulting in Unanalyzed Condition Regarding High Pressure Injection Pump Recirculation Leading to Possible Pump Failure and Dose Consequences																													
EVENT DATE (5)			LER NUMBER (6)				REPORT DATE (7)			OTHER FACILITIES INVOLVED (8)																			
MONTH	DAY	YEAR	YEAR	SEQUENTIAL NUMBER	REVISION NUMBER	MONTH	DAY	YEAR	FACILITY NAMES N/A				DOCKET NUMBER(S) 0 5 0 0 0																
0	3	0	7	9	7	9	7	---	0	0	8	---	0	0	0	4	0	7	9	7	N/A				0	5	0	0	0
OPERATING MODE (9)		5		THIS REPORT IS SUBMITTED PURSUANT TO THE REQUIREMENTS OF 10 CFR 5: (CHECK ONE OR MORE OF THE FOLLOWING) (11)																									
POWER LEVEL (10)		0 0 0		20.402(b)				20.405(c)				50.73(a)(2)(iv)				73.71(b)

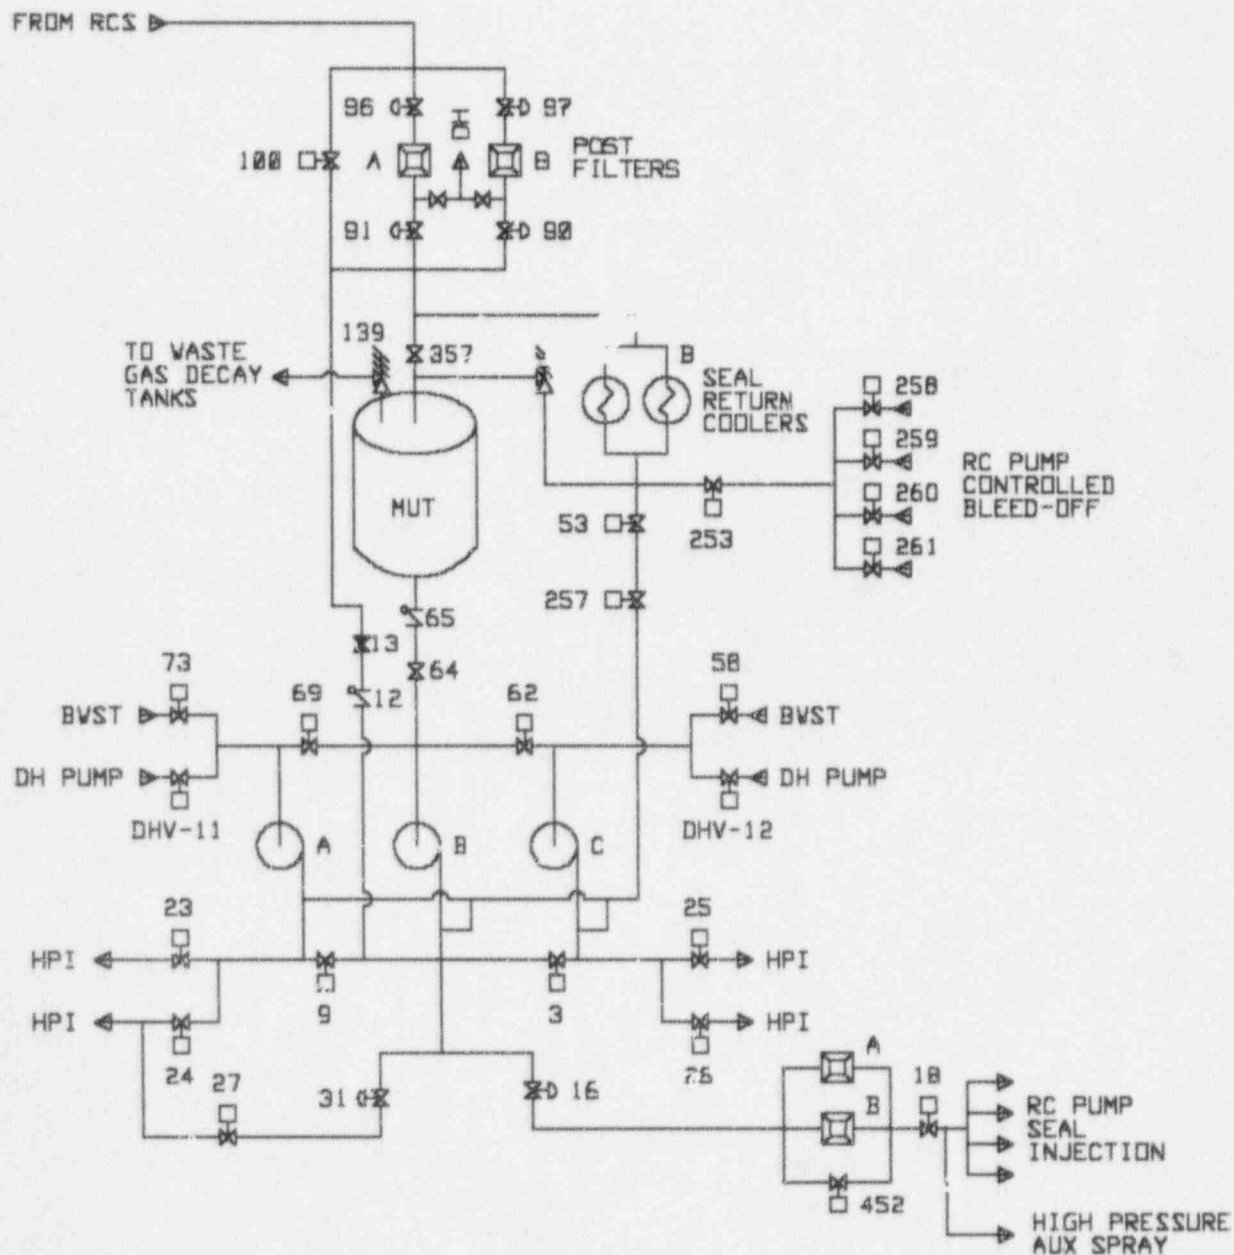
Figure 2 HPI and HPI Pump Recirculation Flow Path

Another postulated event has been determined be a failure of either of the two makeup pump recirculation valves (MUV-53 and MUV-257) whose power supplies are not single failure proof and which are installed in series with both required to be open to establish a recirculation path. A failure of the recirculation valve and inability to establish recirculation flow may result in HPI pump damage if HPI is throttled to very low flow rates after SCM is restored. Single failure criteria requires redundancy within systems to ensure the capability of meeting their design function.

Eventually, while minimizing subcooling margin, by throttling HPI flow, operators could reduce the flow rate below the pump's minimum flow requirement. To provide minimum pump flow, a flow path is established by opening MUV-53 and MUV-257. If one of these valves fails to open, a recirculation path can not be established and the Makeup/HPI pumps may fail due to extended operation under low-flow conditions. However, recent information obtained from the pump manufacturer, Sulzer Bingham Pumps, Inc., states that a minimum flow of 40 gpm for a period of approximately 90 days during/after an accident condition, should not adversely affect the pump performance with adequate NPSH available.

1. A "stand down" was implemented in Nuclear Operations Engineering (NOE) to emphasize the importance of improving safety culture. (MCAP Action B-RC1-1)
2. Engineering staffing levels have been increased to attract talent from outside FPC that can increase design competency. (MCAP Action B-RC1-7)
3. Training has been provided to managers and supervisors on the elements of achieving and maintaining regulatory compliance and its priority in plant activities. (MCAP Action D-RC1-2)
4. Additional recirculation capability for the HPI pumps will be provided by a plant modification to assure adequate pump protection and prevent the MUT relief valve from lifting. (FPC Restart Issue D-1)
