## LICENSEE EVENT REPORT (LER)

FACILITY NAME (1) Fort St. Vrain, Unit No. 1										DOCKET NUMBER (2) 0 5 0 0 0 2 6 7 1 OF 0 5										PAGE (3) 5			
TITLE (4) "D" Circulator Trip Following Isolation Of PDT-2178-1																							
EVENT DATE (5)			LER NUMBER (6)				REPORT DATE (7)			OTHER FACILITIES INVOLVED (8)													
MONTH	DAY	YEAR	YEAR	SEQUENTIAL NUMBER	REVISION NUMBER	MONTH	DAY	YEAR	FACILITY NAMES N/A					DOCKET NUMBER(S) 0 5 0 0 0									
1	0	2	3	8	5	8	5	0	2	3	0	0	1	0	2	2	8	5	0	5	0	0	0
OPERATING MODE (9) N		THIS REPORT IS SUBMITTED PURSUANT TO THE REQUIREMENTS OF 10 CFR 5: (Check one or more of the following) (11)																					
POWER LEVEL (10) 0 1 0 8		20.402(b)				20.405(c)				50.73(a)(2)(iv)				73.71(b)

SUBJECT: Licensee Event Report  
85-023, Final Report

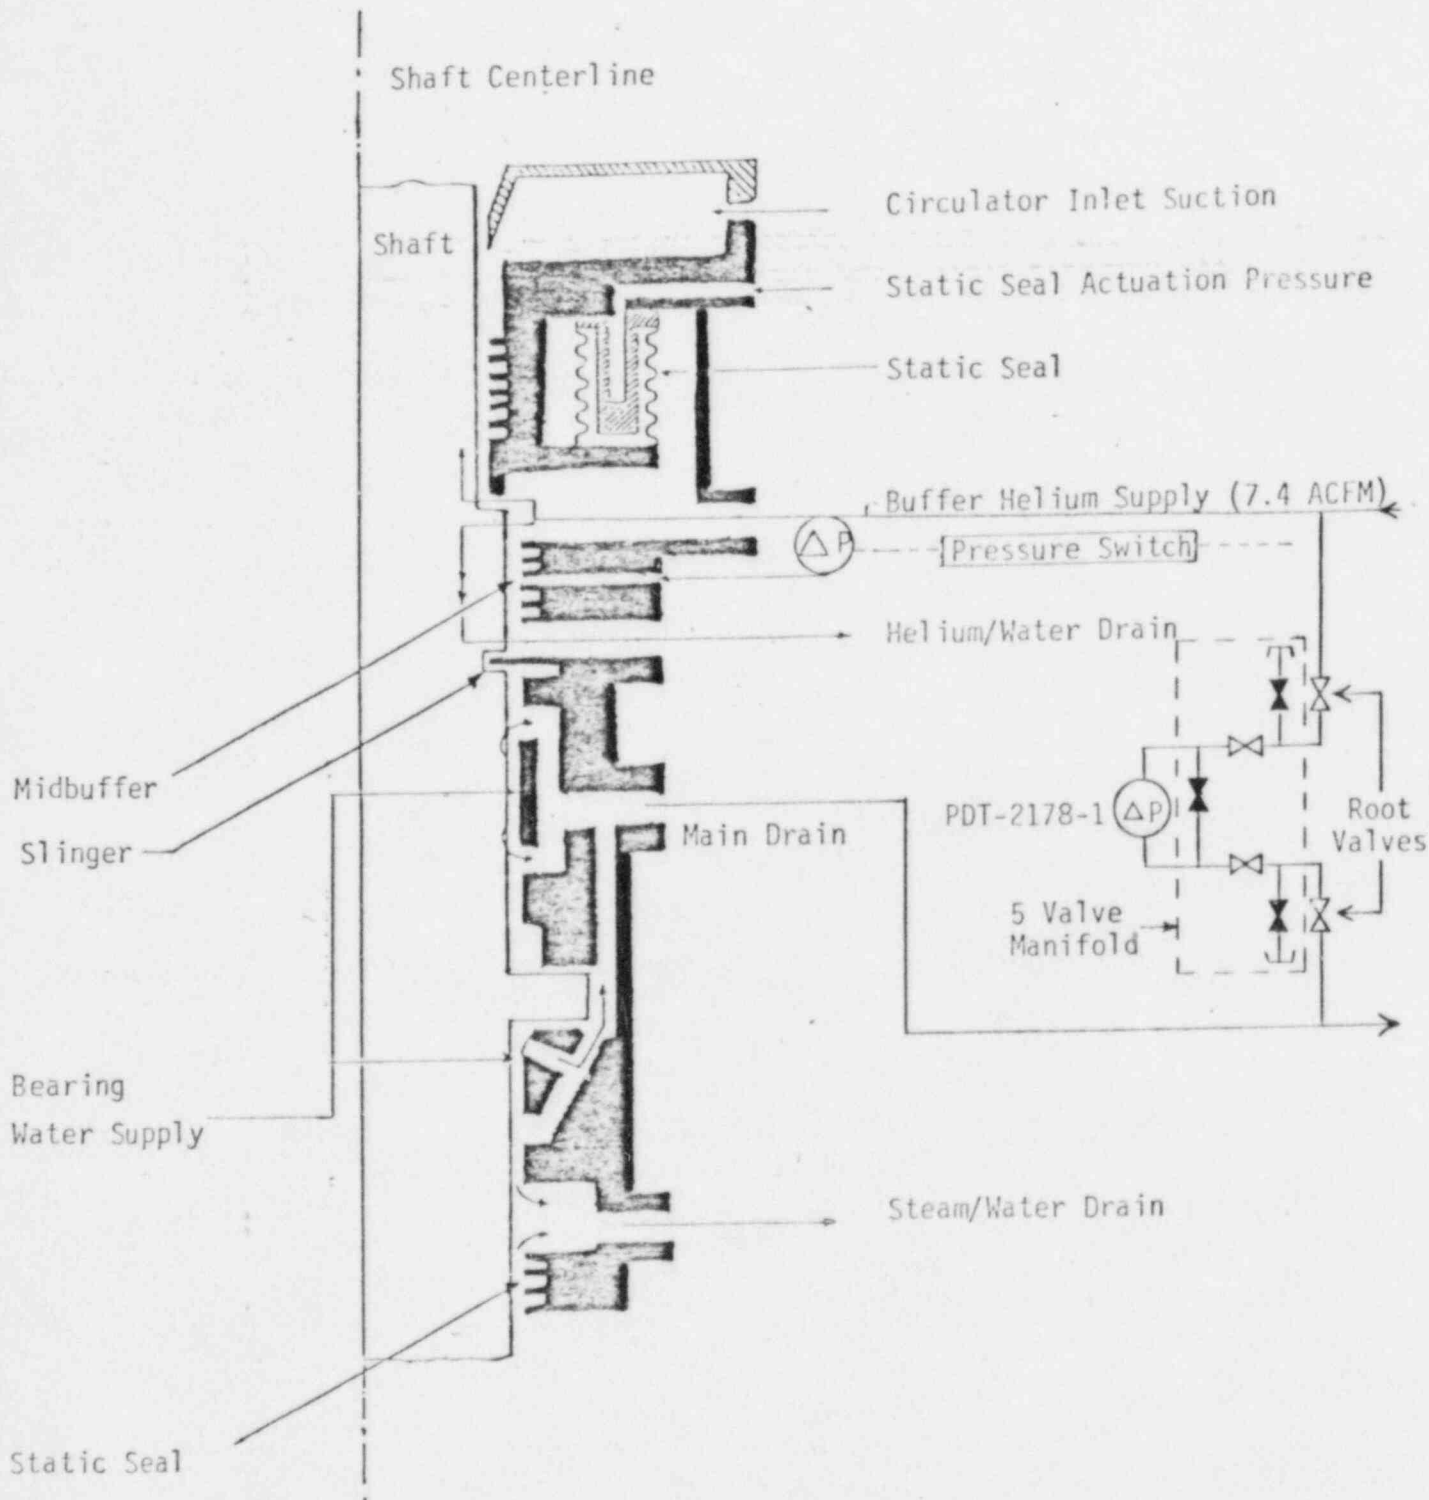
FIGURE 1.

The five valve manifold (see Figure 1) was leaking through on the gas side and would not isolate PDT-2178-1. Therefore, the root valves were closed in order to isolate the pressure differential transmitter for repair. This effectively stopped the buffer helium leak. Since "D" circulator buffer helium supply flow was above normal level, the circulator tripped on high buffer-mid-buffer  $\Delta P$  when the root valves were closed.

Buffer helium was leaking through PDT-2178-1. To compensate for this leak, Control Room Operators had increased "D" circulator buffer helium supply flow to maximize buffer-mid-buffer  $\Delta P$ . In order to isolate PDT-2178-1 for repair, the root valves were closed, effectively stopping the buffer helium leak. Since buffer helium supply flow was higher than normal, this resulted in a "D" circulator trip on high buffer-mid-buffer  $\Delta P$ .

PDT-2178-1 has been repaired and returned to service. A Station Service Request has also been initiated to repair the five valve manifold of PDT-2178-1. These corrective actions are not considered to be safety significant nor impact public health and safety.
