LICENSEE EVENT REPORT (LER)

FACILITY NAME (1) Fort St. Vrain, Unit No. 1										DOCKET NUMBER (2) 0 5 0 0 0 2 6 7										PAGE (3) 1 OF 0 7															
TITLE (4) "C" Circulator Trip On Buffer-Mid-Buffer																																			
EVENT DATE (5)						LER NUMBER (6)						REPORT DATE (7)						OTHER FACILITIES INVOLVED (8)																	
MONTH		DAY		YEAR		YEAR		SEQUENTIAL NUMBER		REVISION NUMBER		MONTH		DAY		YEAR		FACILITY NAMES		DOCKET NUMBER(S)															
0 1		1 3		8 6		8 6		0 0 3		0 0		0 2		1 2		8 6		N/A		0 5 0 0 0															
0 1		1 3		8 6		8 6		0 0 3		0 0		0 2		1 2		8 6		0 5 0 0 0		0 5 0 0 0															
OPERATING MODE (9)		THIS REPORT IS SUBMITTED PURSUANT TO THE REQUIREMENTS OF 10 CFR 5. (Check one or more of the following) (11)																																	
N		20.402(b)										20.405(c)										XX 50.73(a)(2)(iv)		73.71(b)											
POWER LEVEL (10)		0 0 0										20.405(a)(1)(i)										50.36(c)(1)										50.73(a)(2)(v)		73.71(c)

SUBJECT: Licensee Event Report
86-003, Final Report

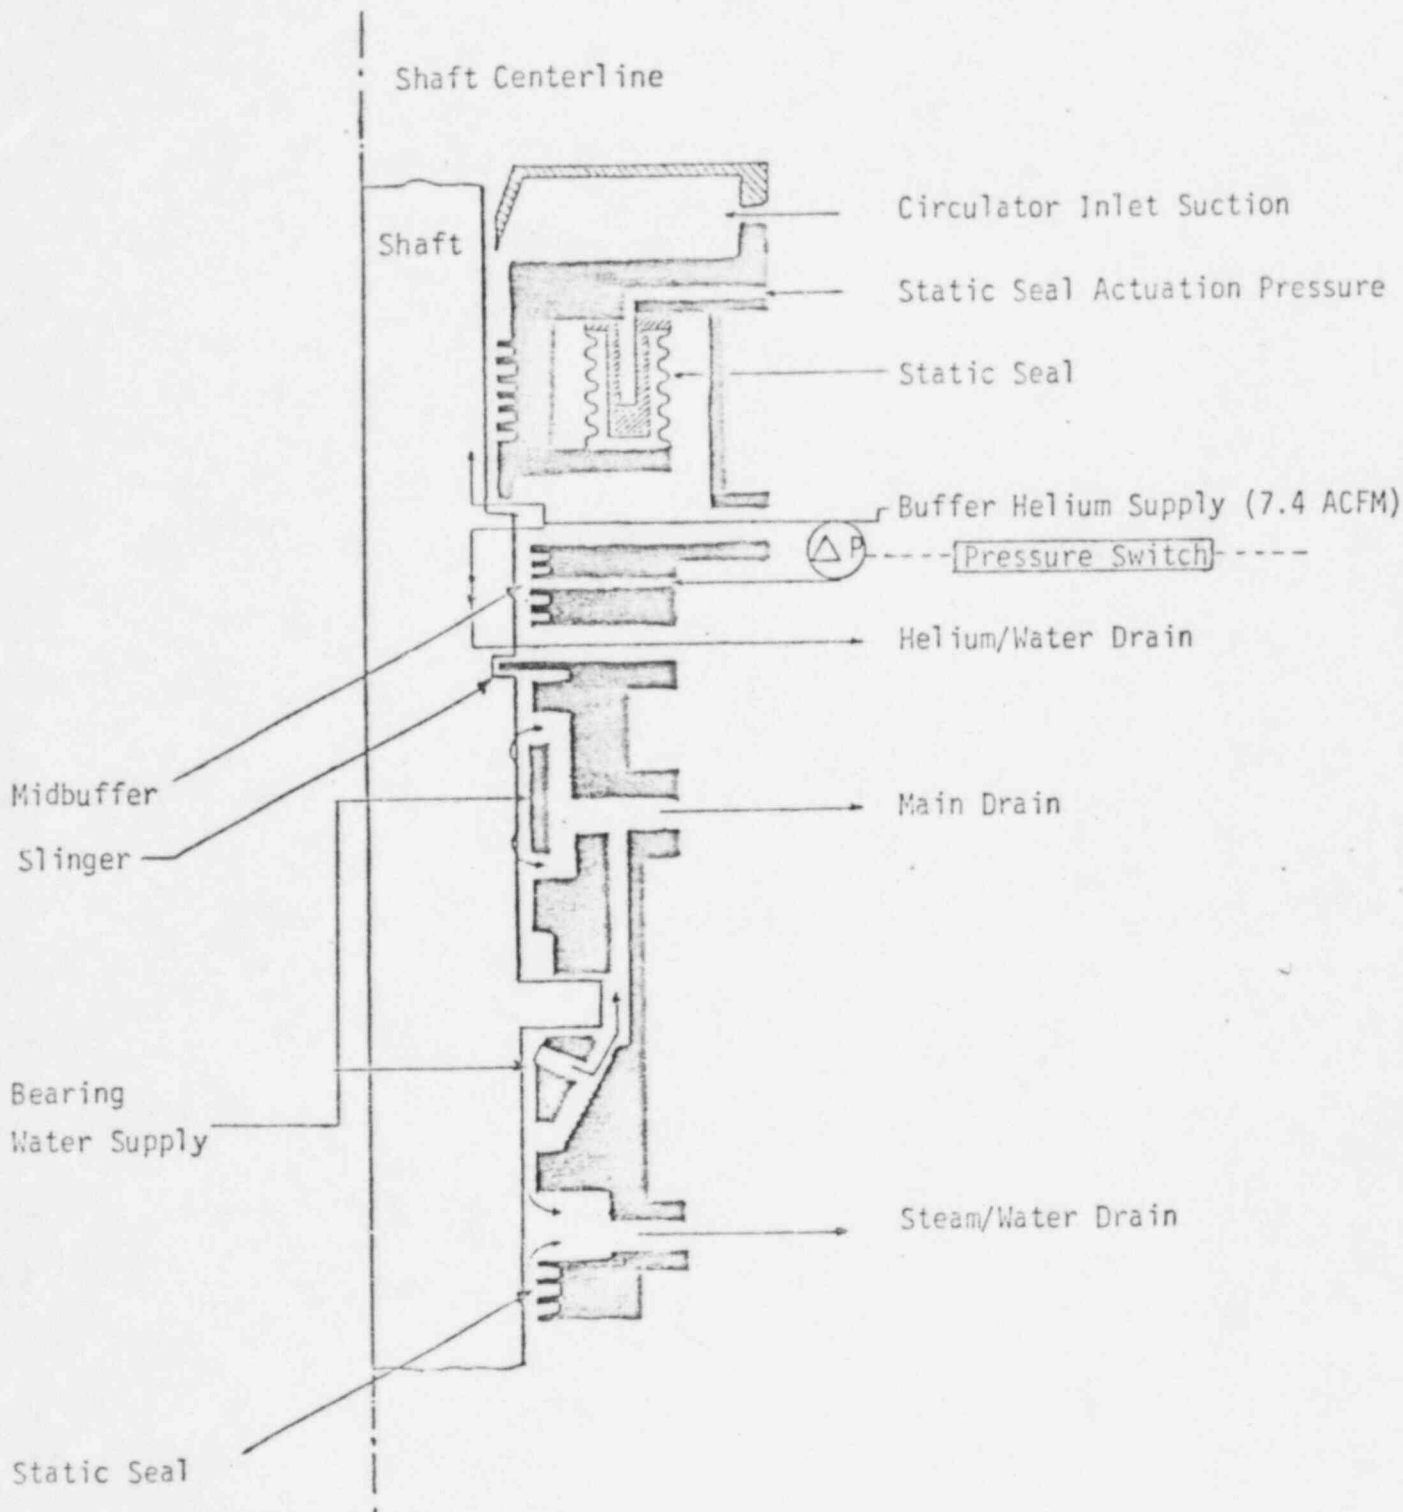
FIGURE 1.

It has been determined that water entered the "C" circulator buffer sense lines, thereby causing erratic buffer mid-buffer indication and the single circulator trip action.

The differential pressure between the buffer supply line and the mid-buffer is monitored to detect an imbalance in buffer mid-buffer pressures that would indicate either bearing water leakage up the circulator shaft or primary coolant leakage down the circulator shaft (see Figure 1).

"C" circulator's buffer mid-buffer sense lines were "blown down" with clean helium. Approximately one quart of water was removed from the lines.

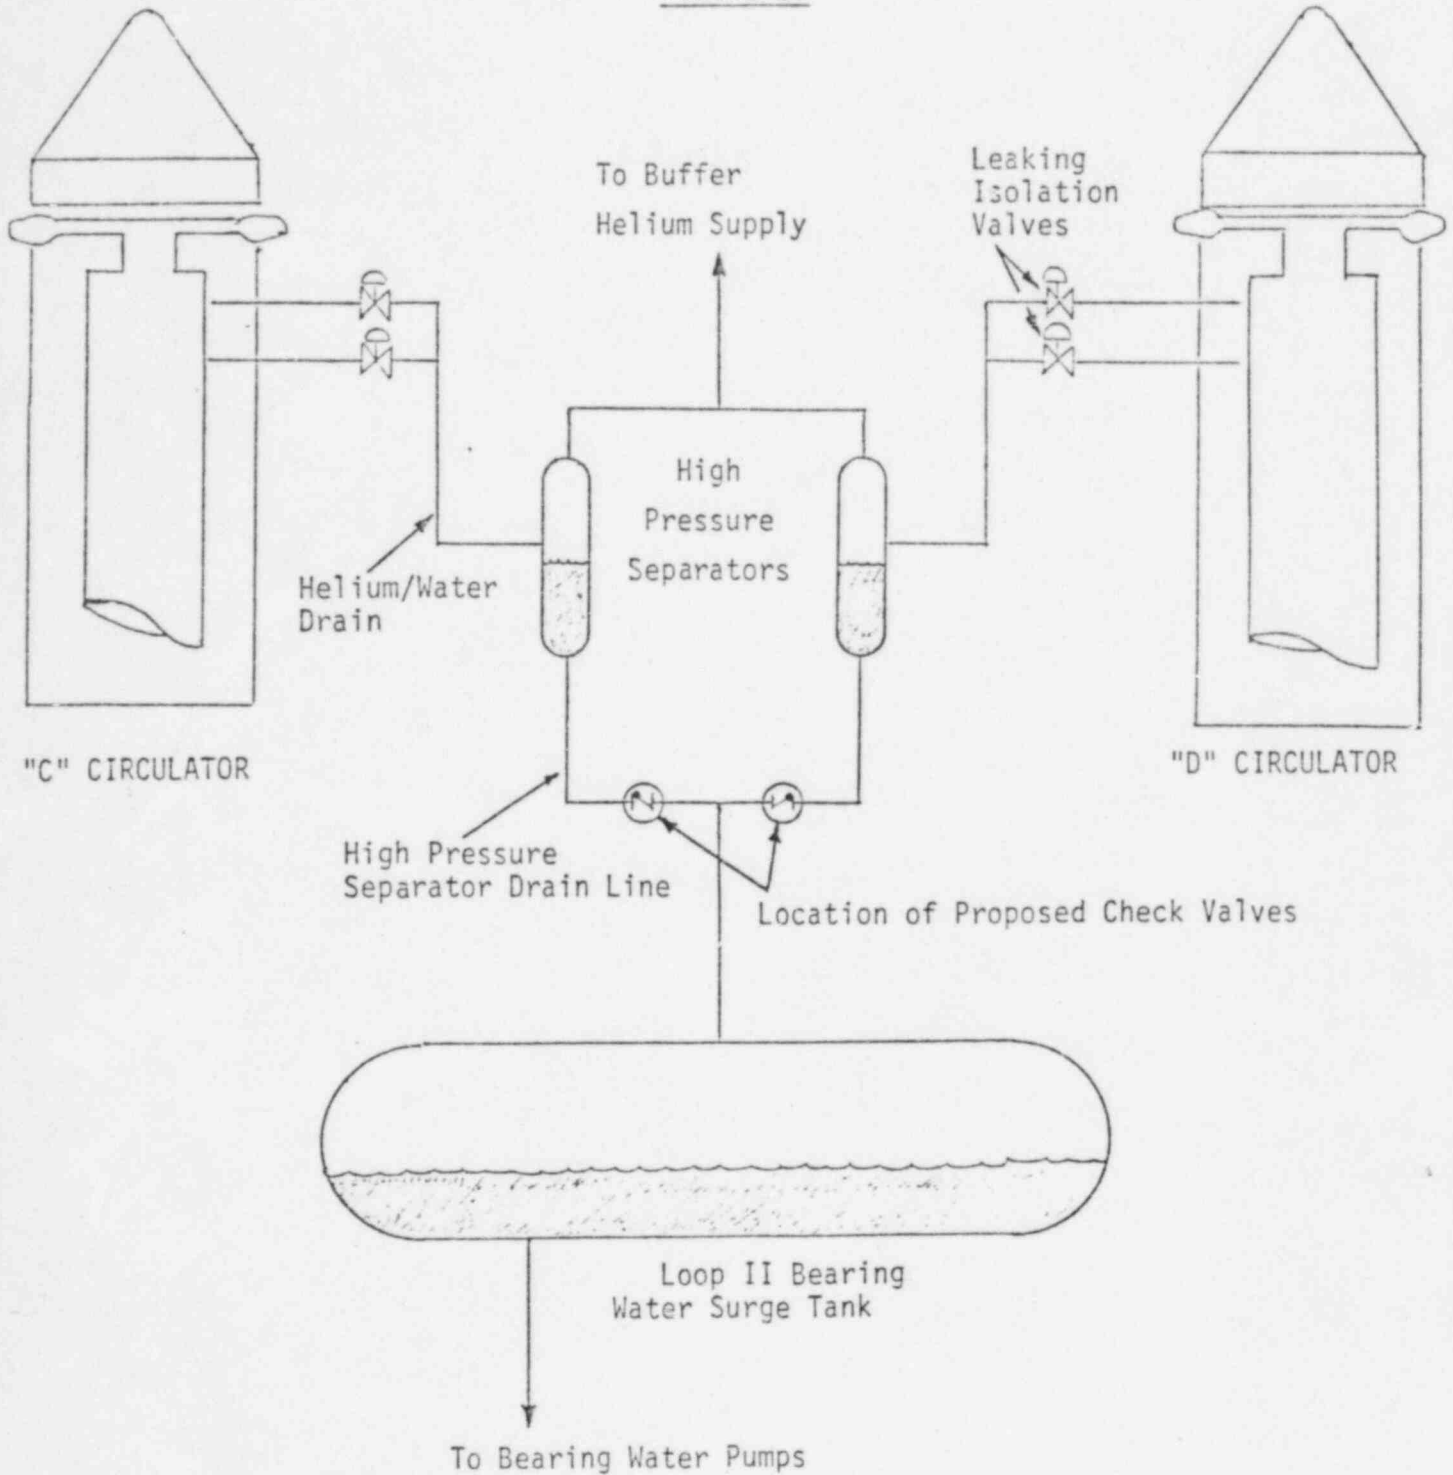
FIGURE 2.

Recently, it was discovered that "D" circulator's helium/water drain isolation valves leak by the seat, as reported in LER 85-026. With "D" circulator shutdown and its auxiliaries isolated, these leaking valves allowed a reverse flow from the Loop II high pressure separator drain lines, through the "D" circulator high pressure separator, and into the "D" circulator helium/water drain cavity (see Figure 2). This reverse flow resulted from the differential pressure between the Loop II high pressure separator drain lines and the "D" circulator bearing water cavity. With "D" circulator shutdown and its auxiliaries isolated, the circulator bearing water cavity pressure fell to approximately atmospheric while "C" circulator's helium/water drain line functioned at approximately reactor pressure.

Since the "C" and "D" circulator high pressure separator drain lines join before entering the Loop II surge tank (see Figure 2), reverse flow through "D" circulator's high pressure separator drain line affected drain flow from the "C" circulator high pressure separator. This in turn affected "C" circulator helium/water drain flow and hence its buffer mid-buffer balance as evidenced by the erratic buffer mid-buffer indication. This buffer mid-buffer imbalance resulted in water entering the buffer mid-buffer sense lines. At 0450 hours, while attempting to return "C" circulator to service, it is believed that the small buffer seal pressure transient caused by releasing the seal, combined with the existing water in the buffer mid-buffer sense lines caused the high buffer mid-buffer condition and subsequently the circulator trip.

The leaking helium/water drain isolation valves on "D" circulator will be repaired.

Check valves will be installed on each of the four helium circulator high pressure separator drain lines (see Figure 2).
