U.S. NUCLEAR REGULATORY COMMISSION
REGION IV

Docket No.: 40-8084
License No.: SUA-1119
Report No.: 40-8084/97-01
Licensee: Rio Algom Mining Company
Facility: Former Lisbon Mill Facility
Location: La Sal, San Juan County, Utah
Dates: March 26-27, 1996
Inspector: Robert J. Evans, P.E., Health Physicist
Nuclear Materials Inspection and
Fuel Cycle/Decommissioning Branch
Division of Nuclear Materials Safety
Approved By: Charles L. Cain, Technical Assistant
Division of Nuclear Materials Safety

Former Lisbon Mill Facility NRC Inspection Report 40-8084/97-01

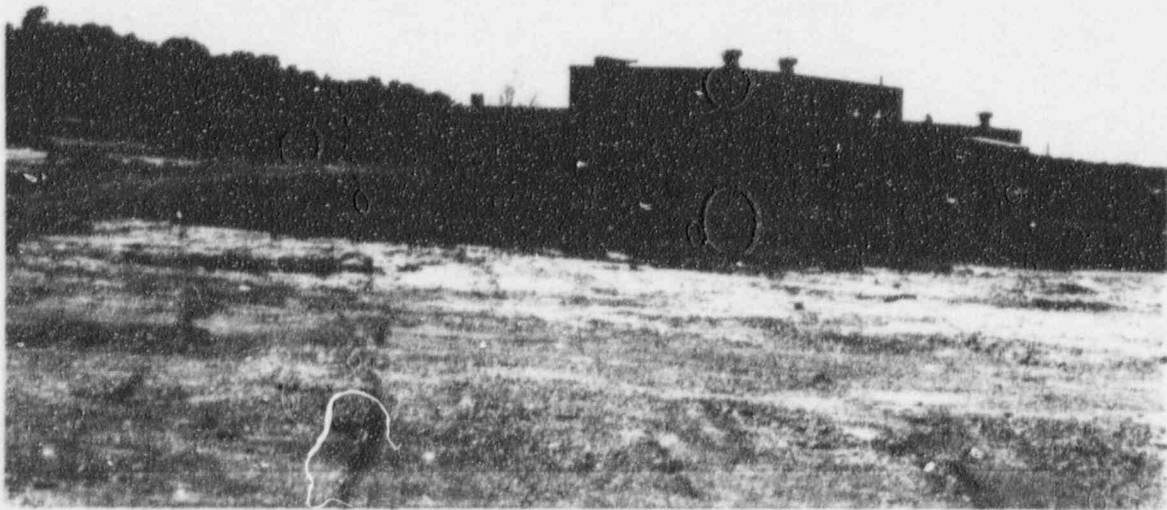
Photograph 1 - Rio Algom-Lisbon site structures; the mill was previously located in the foreground.

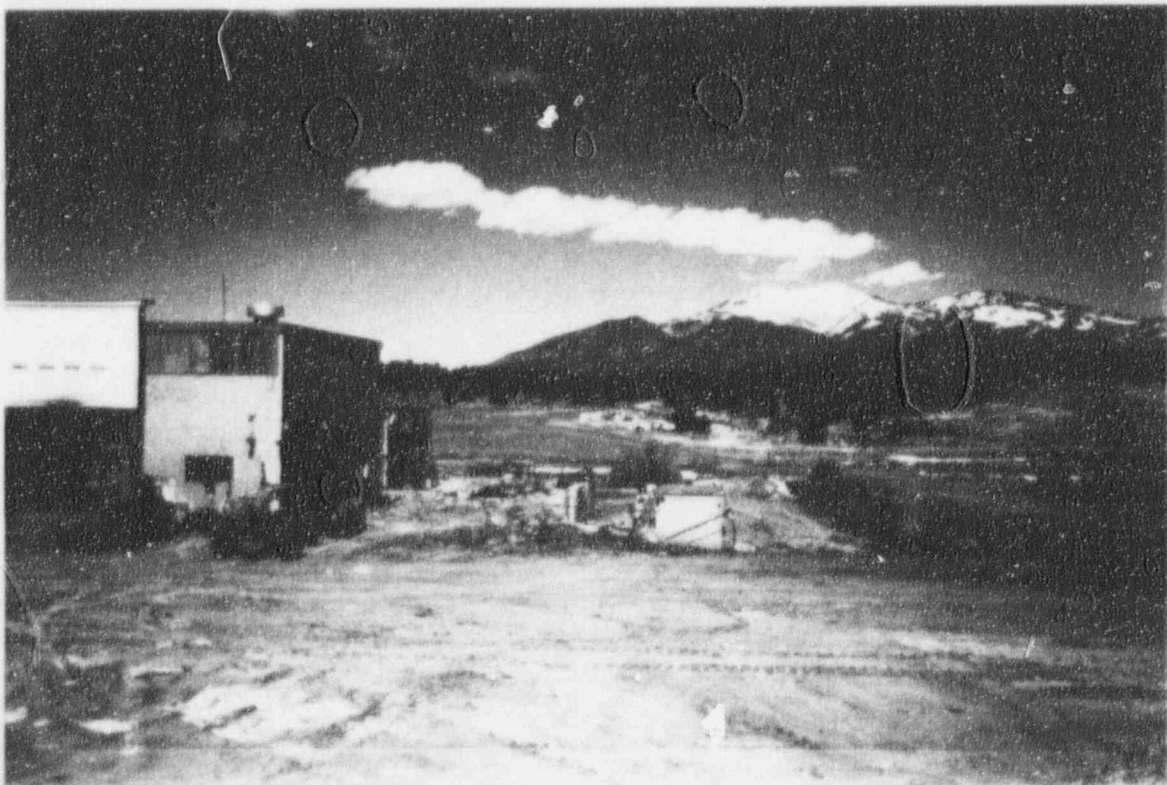
The mine headframe was disassembled by contract workers during September-November 1996. The salvageable material was radiologically scanned and released for unrestricted use. Eight truckloads of scrap material was released from the site. The scrap material was subsequently sold to dealers in Utah and Texas. The headframe material that was unsalvageable was buried onsite in a location southwest of Bisco Lake.

Photograph 2 - Area where Headframe was previously situated; the Headframe was disassembled in September-November 1996.

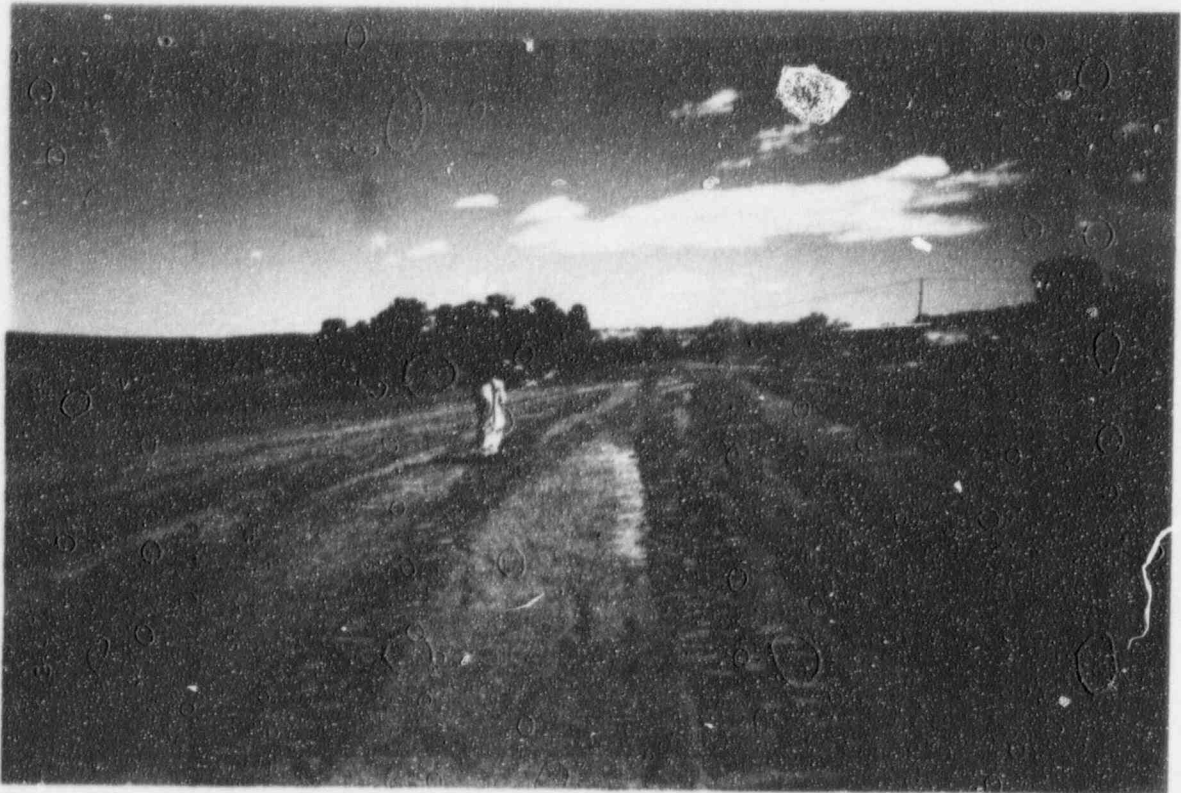
Photograph 3 - Area near Bisco Lake where unsalvageable Headframe material was buried; NRC inspector is performing a gamma survey of the area.

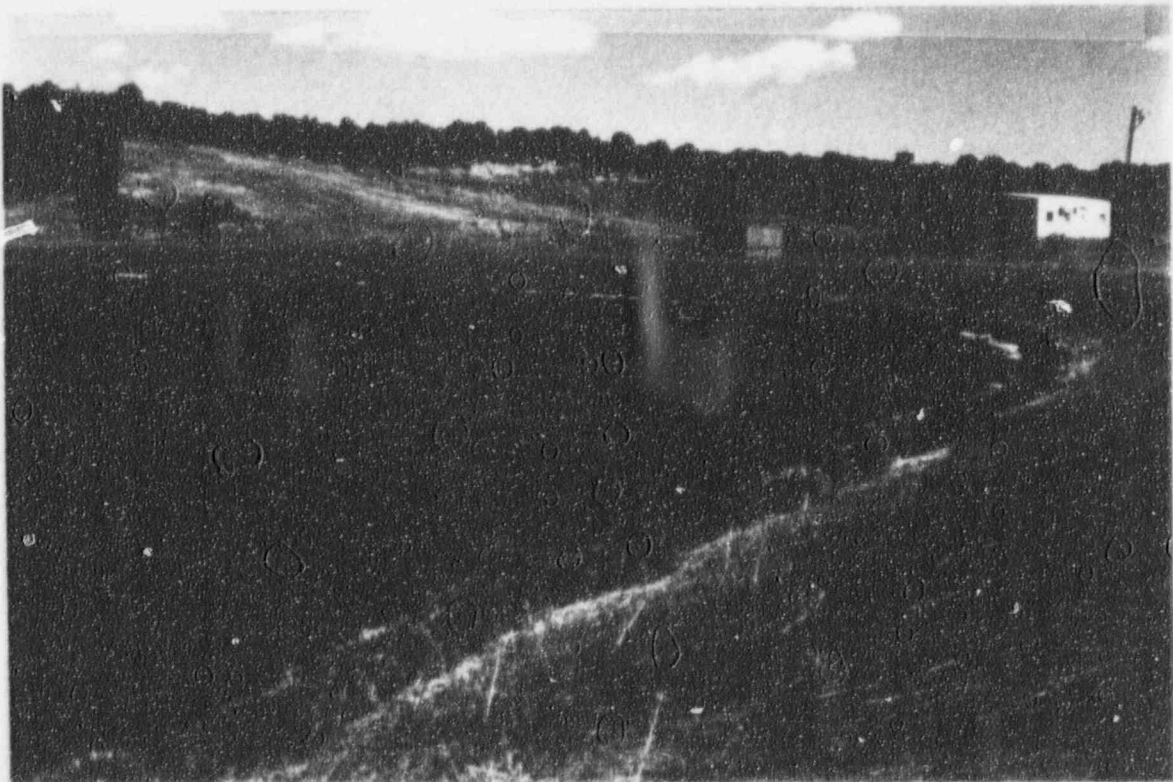
The two evaporation ponds were in service during the inspection. The minimum freeboard requirements established in License Condition 45 were not being exceeded in either pond. (During the inspection, the licensee presented documentation that indicated that the pond levels had remained below the maximum allowed elevations during 1996 and the first quarter of 1997.) Also, a pond-to-pond transfer system was available on an as-needed basis to control pond level in either pond. At the time of the inspection, the transfer system was not

Photograph 4 - Upper Evaporation Pond; bales of hay was added to the shoreline to provide erosion protection from wave action.
