LICENSEE EVENT REPORT (LER)

PILGRIM NUCLEAR POWER STATION

05000-293

Loss of Preferred Off-Site Power and Oil Spill Due to Main Transformer Fault While Shut Down

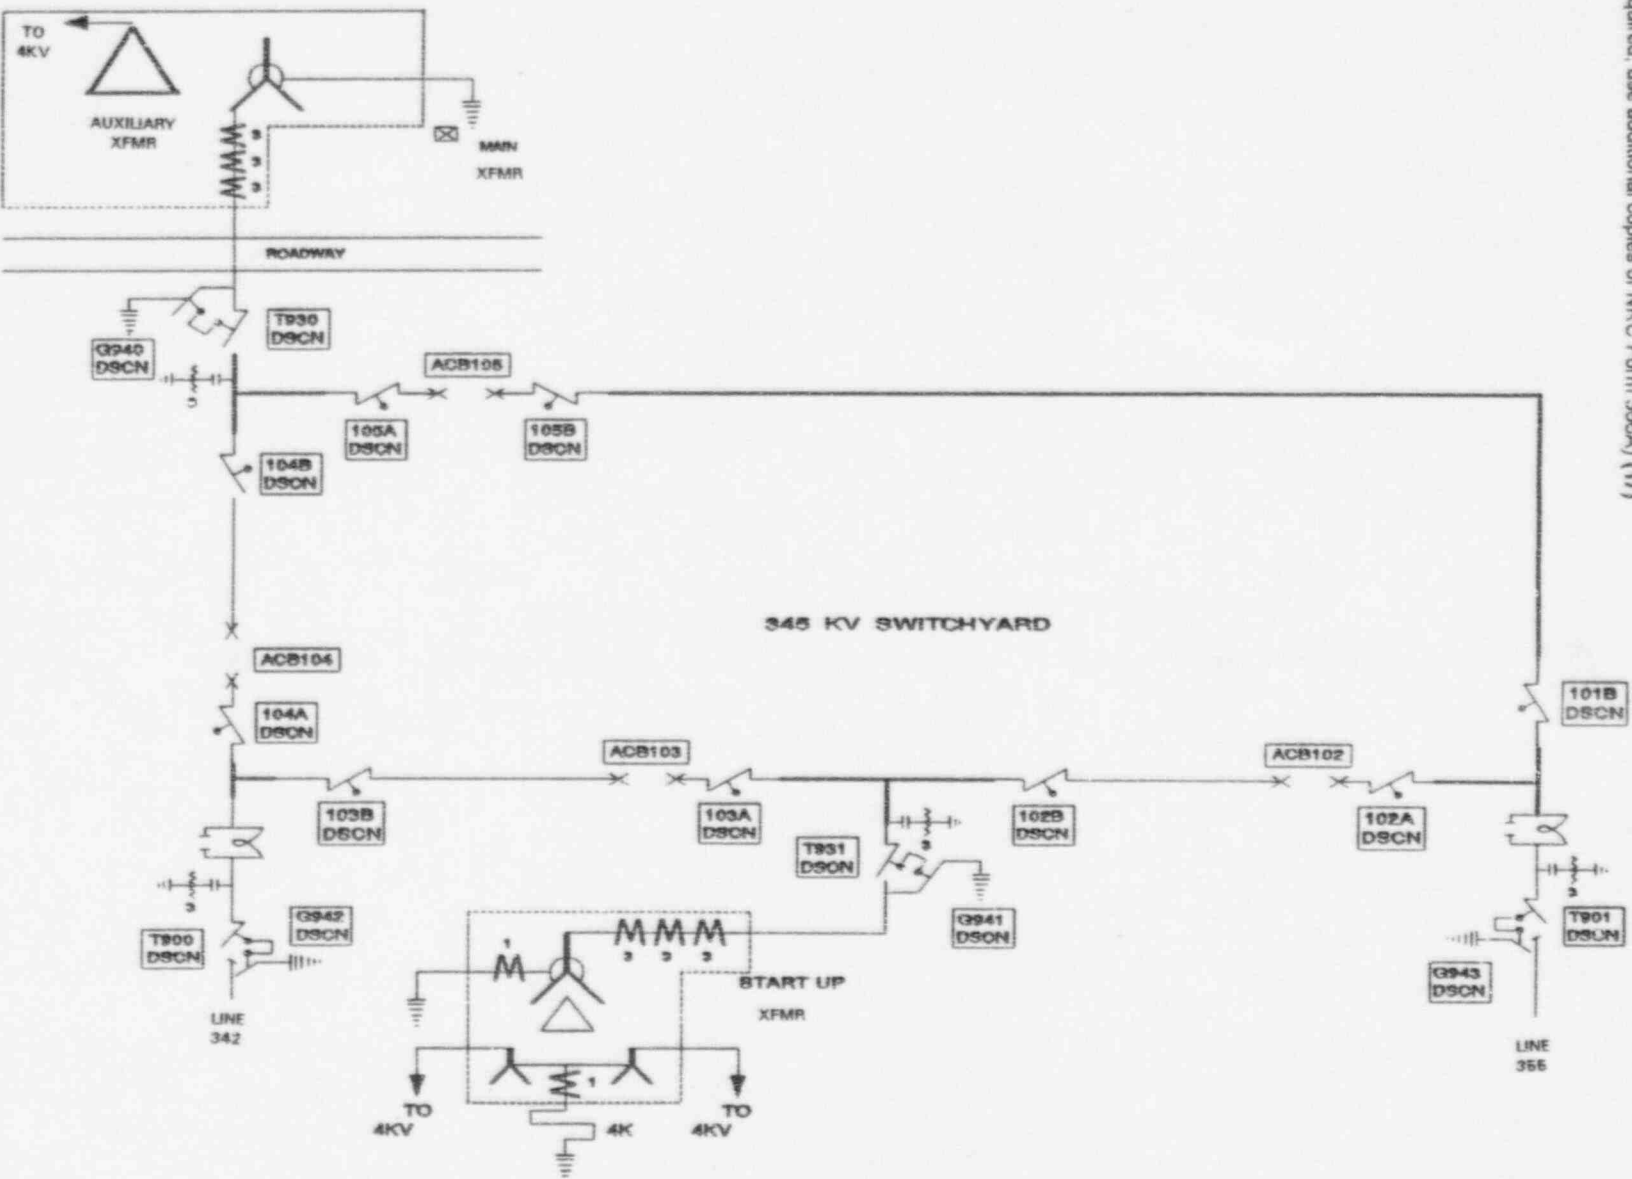
ONE LINE DIAGRAM - 345 KV SWITCHYARD

- The preferred off-site 345 Kv power sources, transmission lines 342 and 355, were energized. The 345 Kv switchyard ring bus circuit breakers ACBs 102, 103, 104, and 105 were closed. The startup transformer (SUT) was tagged out of service for maintenance and the mechanical disconnects from ACB-102 and ACB-103 to the SUT were open. Portions of the station's 4.16 Kv auxiliary power distribution system were being powered from the unit auxiliary transformer (UAT) that was energized by the 345 Kv switchyard via ACBs 104 and 105 and the main transformer. Located at the end of this report is a simplified single line diagram of the 345 Kv switchyard, SUT, and UAT.
