# **1996 Annual Prelicensing Inspection of the Mexican Hat, Utah, UMTRA Project Disposal Site**

## **1.0 Introduction**

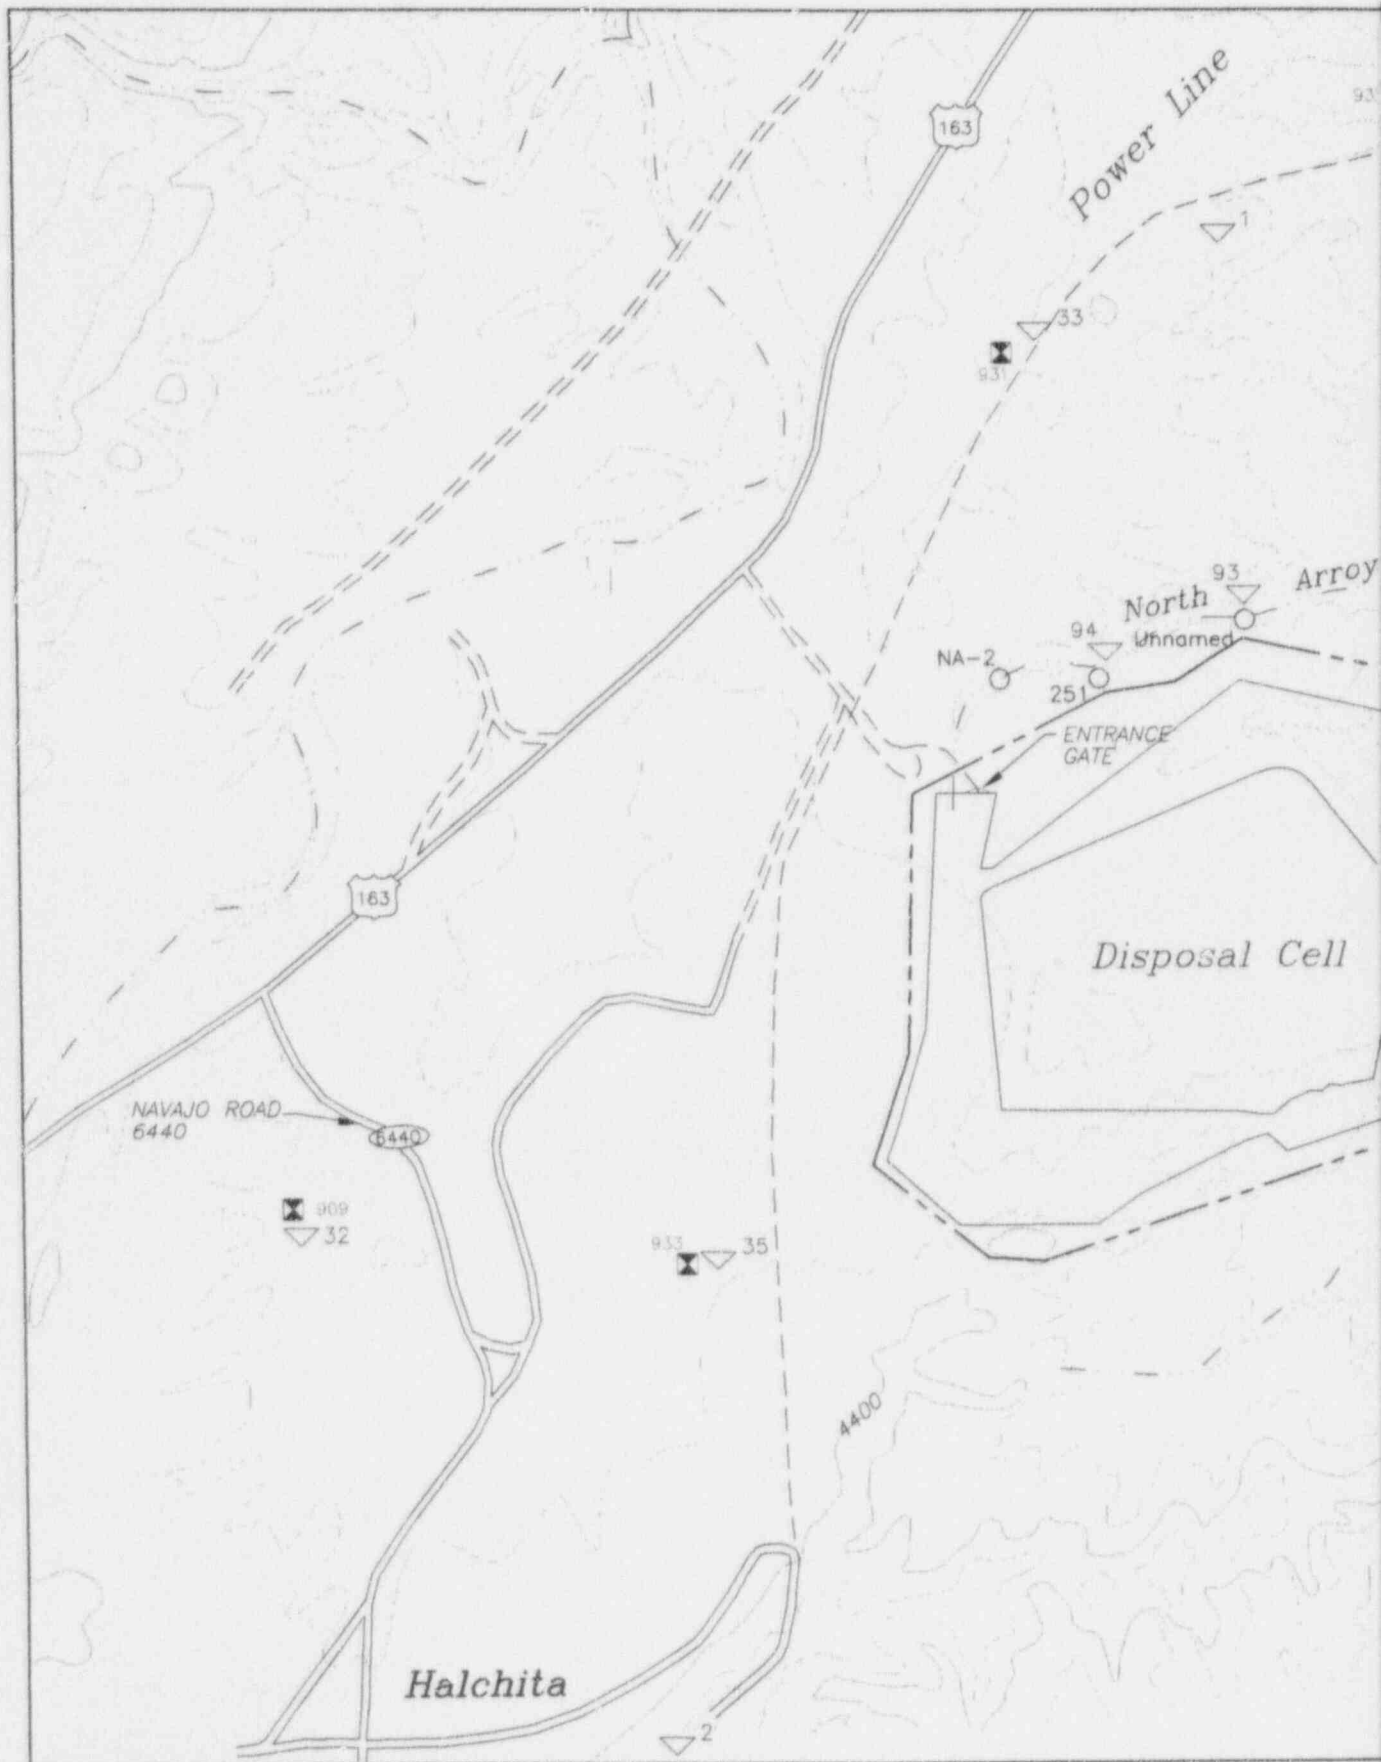
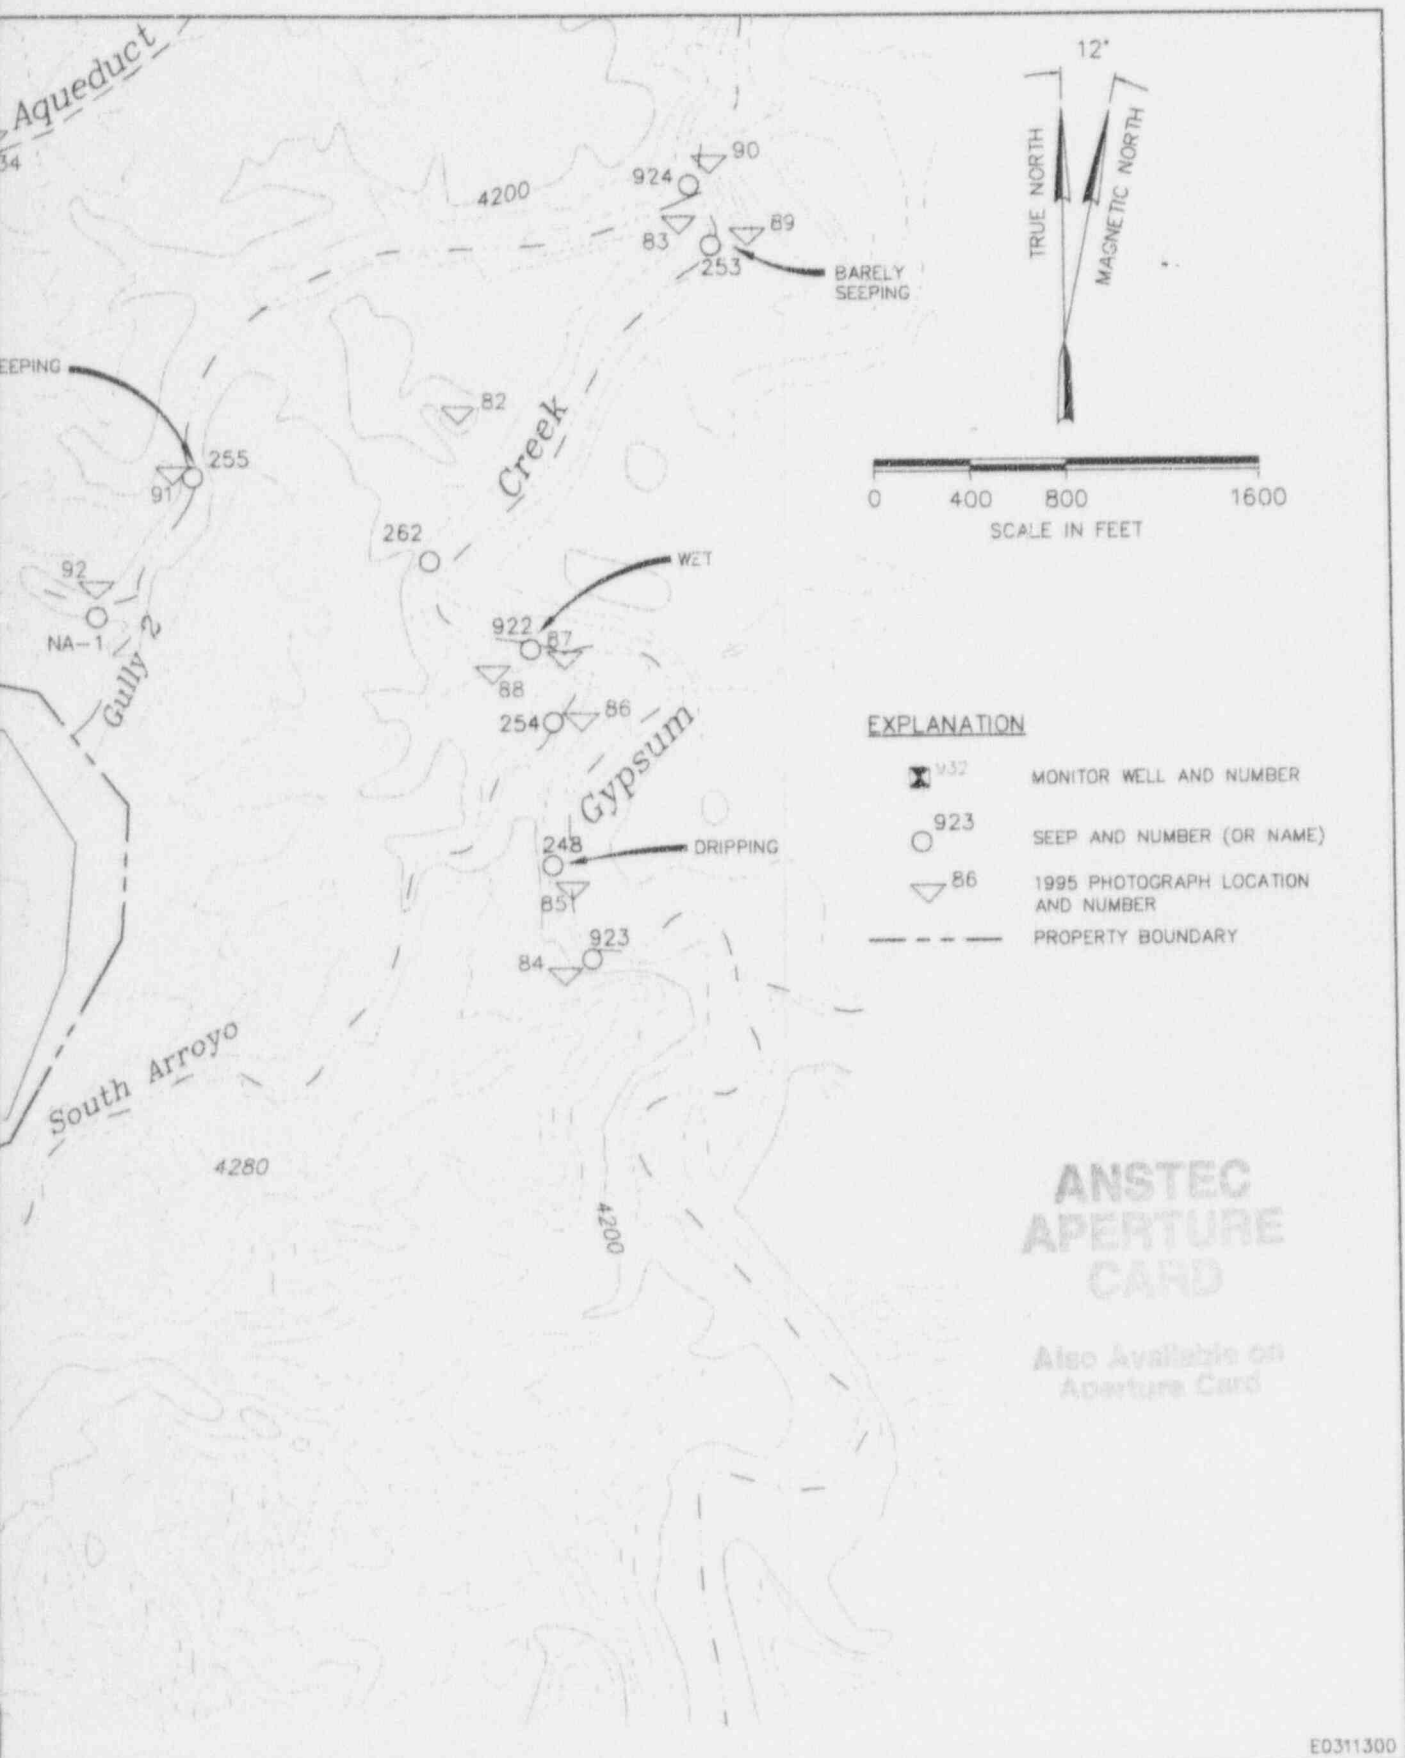
Attachment 2. Location of Monitor Wells, and See

There are six wells in the area surrounding the site. All but two were noted during the 1995 inspection to be in disrepair and unusable as monitor wells. Because these wells are not identified in the Long Term Surveillance Plan (LTSP) as specific site surveillance features, they were not included in this inspection and will not be included in future inspections. Unless the Navajo Nation has a use for these wells, it is recommended that these wells be formally abandoned. If the UMTRA Project has an understanding or agreement with the Navajo Nation with respect to these wells, this information should be included in the final LTSP before the site is transferred to the GJPO for long-term custody.

The LTSP states that certain seeps in North Arroyo and along Gypsum Creek will be sampled periodically as a best management practice. The LTSP also states that flow at the seeps may be intermittent. The seeps were inspected to record their current state. Of the several seeps noted in the 1995 inspection report, all but four seeps were dry.

Seep 255 in North Arroyo was damp enough that a sample could probably be obtained if a shallow depression were dug to collect the water. Seep 248, upstream along the west bank of Gypsum Creek, was dripping and could easily be sampled. Seep 922, downstream along Gypsum Creek was wet and could be sampled. Flow from Seep 253, just above the confluence of Gypsum Creek and North Arroyo, was meager but perceptible. The flow was from bedding planes in the rock at about the same elevation as standing water in the creek. A sample here would be difficult because it would be hard to exclude creek water from the sample. Clearly, sampling these seeps will at times be impractical.

2. The status of six wells, all outside the site boundary, is unknown. Four of the six wells are in disrepair and can not be used for monitoring. These wells are not listed in the LTSP as specific site surveillance features. (See page 2.)

**Recommendation:** If the Navajo Nation has no use for these wells, the wells should be abandoned. If the UMTRA Project has an agreement or understanding with the Navajo Nations with respect to these wells, this information should be included in the final LTSP before the site is transferred to the GJPO.

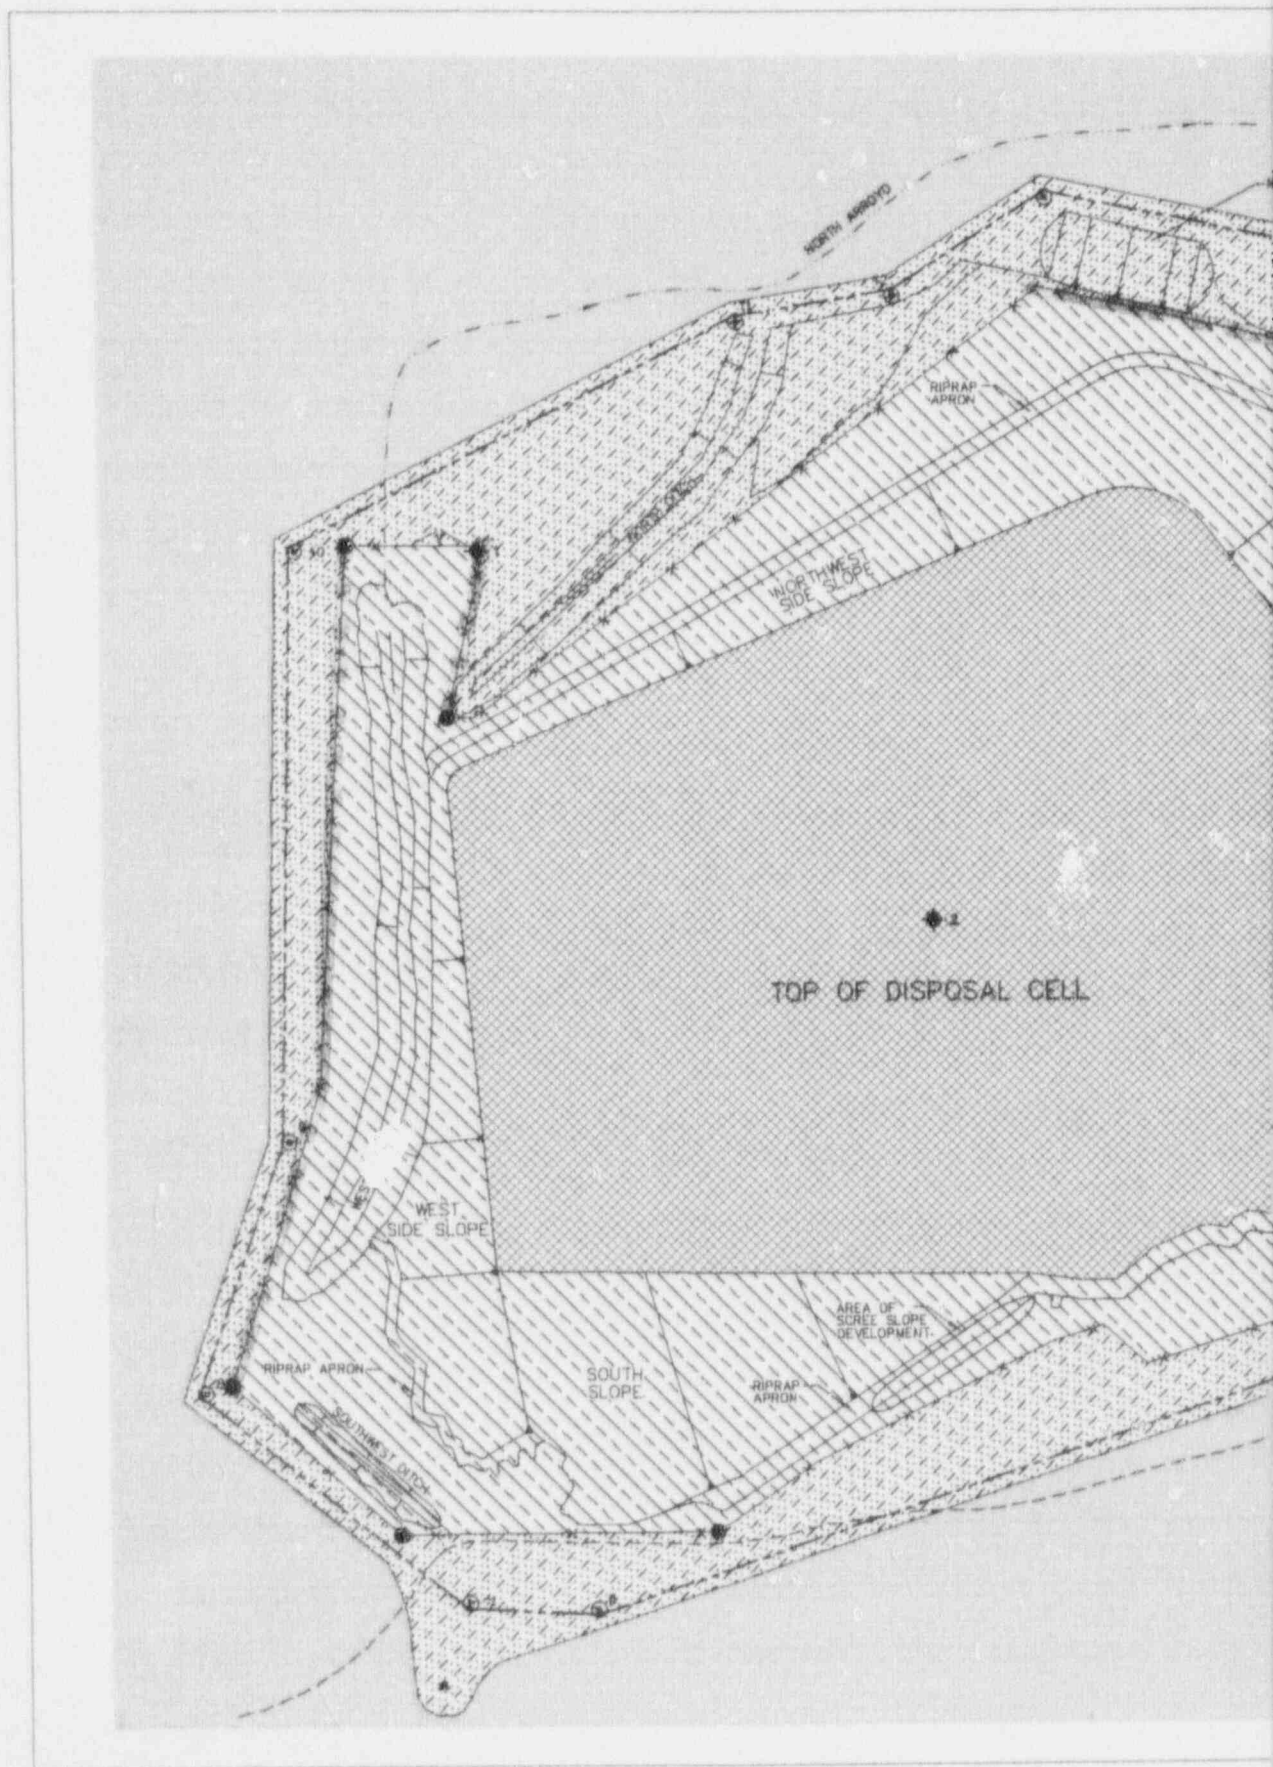
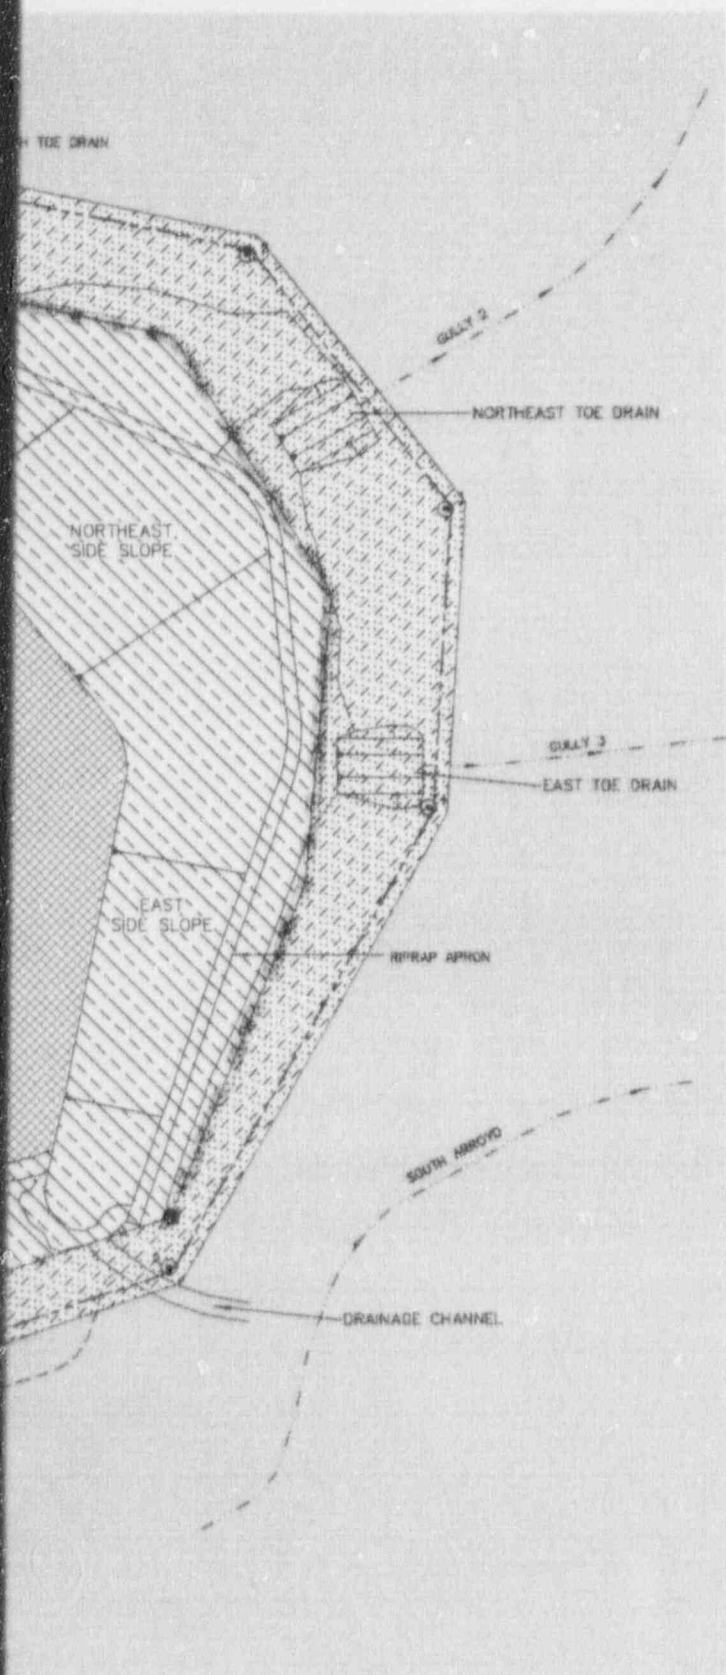
Attachment 1. Map of Inspection Trans

Two problems were noted. First, the bottom strand of barbed wire in the fence, and sometimes the second strand from the bottom as well, are slack at some fence corners. Mr. Charley expressed concern that young livestock could get under and through the fence at these locations. It is recommended the strands be tightened.

Second, here as at other sites in this region, tumbleweeds are beginning to accumulate along fence lines perpendicular to prevailing winds. At this time, the problem can be solved by a few hours of work with a pitch-fork. This work will be easier if completed before this year's crop of tumbleweeds adds to the accumulation.

3. The bottom and sometimes the second strand of barbed wire are slack at several corner posts. (See page 2.)

4. Tumbleweeds are beginning to accumulate along fence lines perpendicular to prevailing winds. (See page 2.)

**Recommendation:** Take up the slack to keep young livestock out.

**Recommendation:** Clear the weeds from the fence line before this year's crop adds to the accumulation.
