NUREG/CR-6456
INEL-96/0089
AEOD/E97-01

Review of Industry Efforts To Manage Pressurized Water Reactor Feedwater Nozzle, Piping, and Feeding Cracking and Wall Thinning

Prepared by
V. N. Shah, A. G. Wire, A. M. Porter

Idaho National Engineering Laboratory
Lockheed Idaho Technologies Company

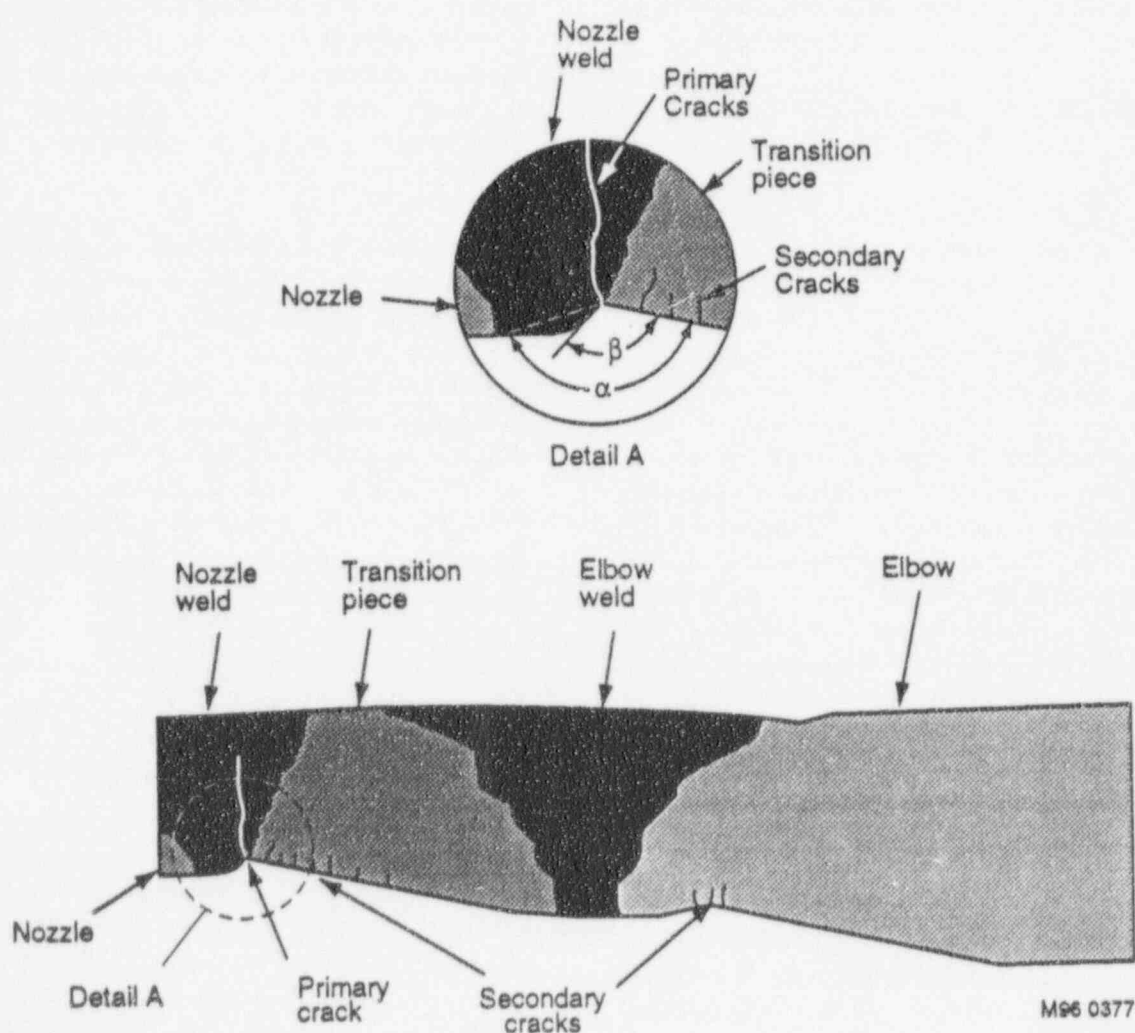
between the nozzle and the transition piece which is smaller than the design angle α ; this causes a stress concentration greater than the design value. This higher stress concentration factor contributed to the initiation of a primary crack at this location (discussed in Section 6.3.1).

Figure 18. Geometric discontinuity introduced by the field welding between the feedwater nozzle and the transition piece (TVA 1992) (modified).

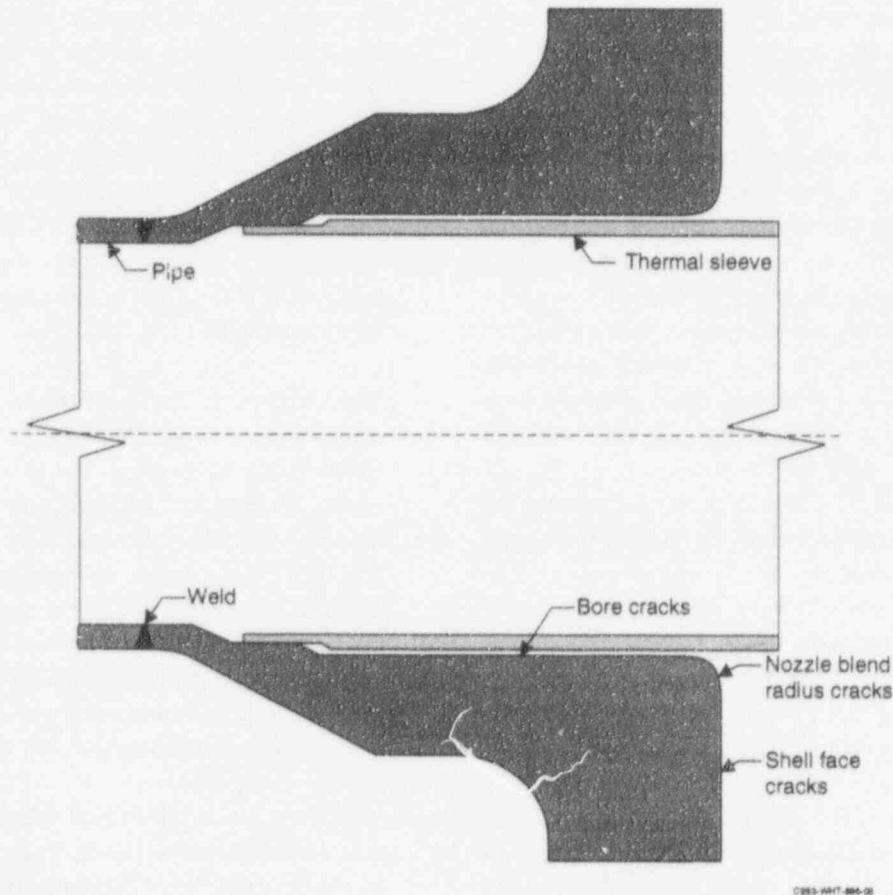
Visual examination detected linear indications on the inner radius section of one of the four feedwater nozzles. These indications were located on the lower 120-degree segment of the nozzle. Liquid penetrant examination confirmed these indications and also found additional indications on the two support brackets welded to the nozzle just below the knuckle. Visual and penetrant examination on the other three nozzles revealed linear indications on the inner radius section of one

Figure 23. Locations of thermal fatigue cracks in an Indian Point Unit 2 feedwater nozzle and steam generator shell caused by bypass leakage of cold feedwater (Westinghouse 1989).

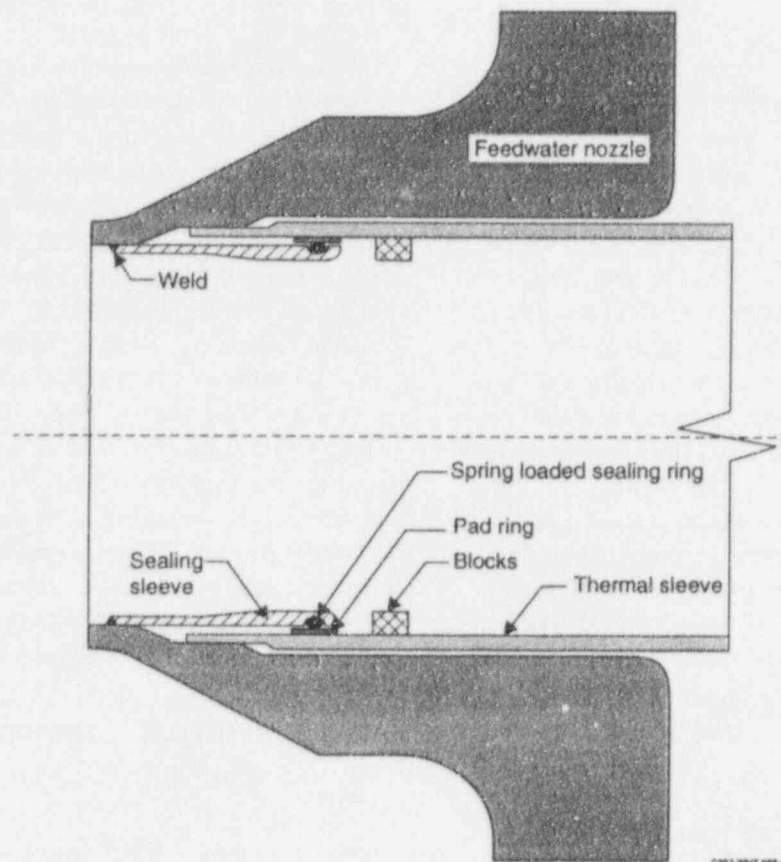
Figure 24. Indian Point Unit 2 feedwater nozzle sealing sleeve installed to prevent bypass leakage of cold feedwater (Consolidated Edison 1991).

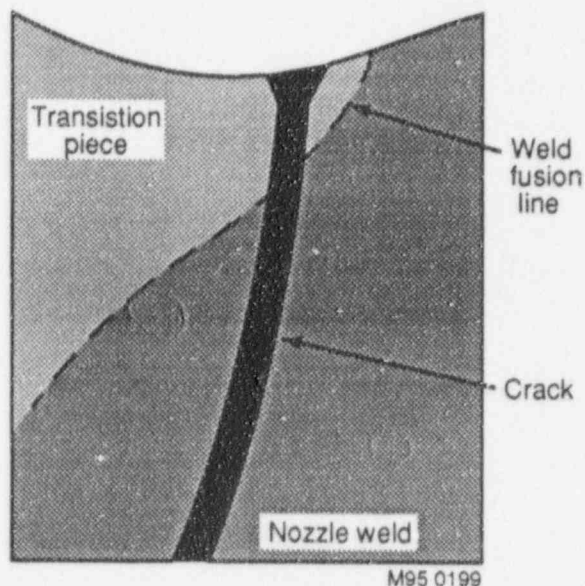
through-wall circumferential crack in the feedwater nozzle-to-transition piece weld region. The crack was on the transition piece side of the weld, as shown in Figure 26. Although the crack was estimated to be 25 mm (1 in.) in length on the outside diameter by visual inspection, radiography revealed that the crack was 51-mm (2-in.) long on the outside diameter and 178-mm (7-in.) long on the inside diameter.

Figure 26. Through-wall crack in the feedwater nozzle weld at Sequoyah Unit 1 (TVA 1992b).

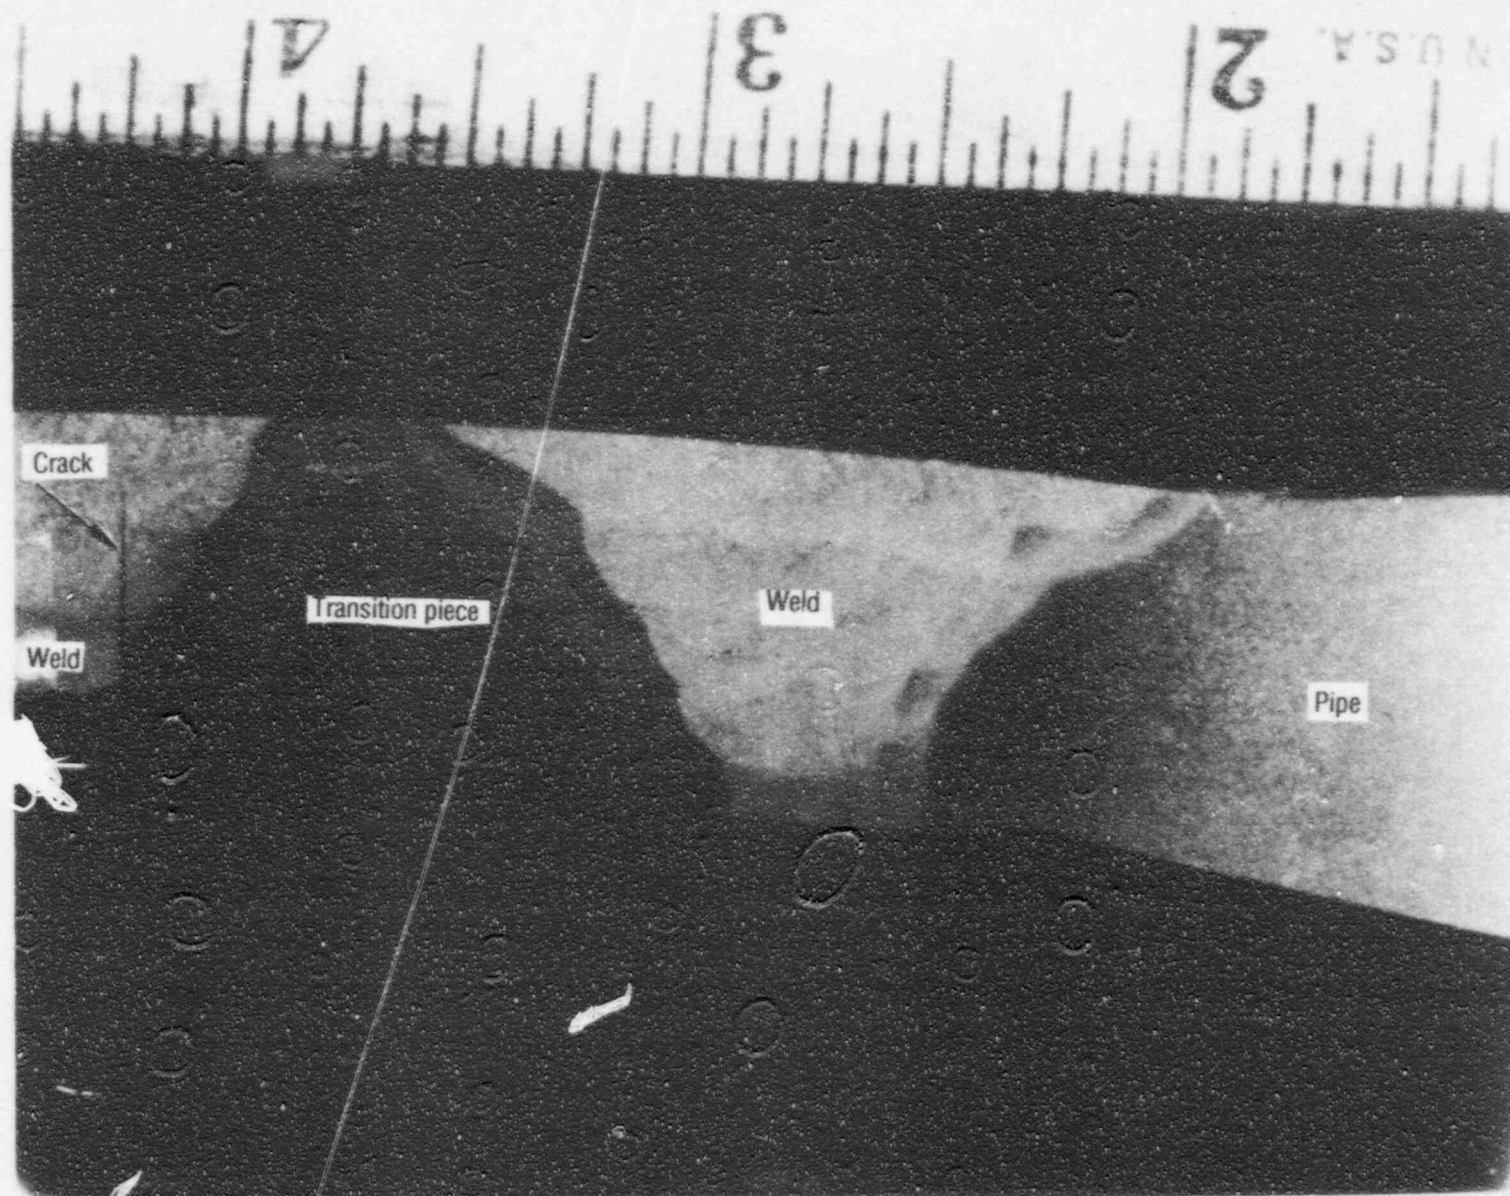
Figure 28. Direction of propagation of a primary crack in Sequoyah Unit 1 (TVA 1992b).

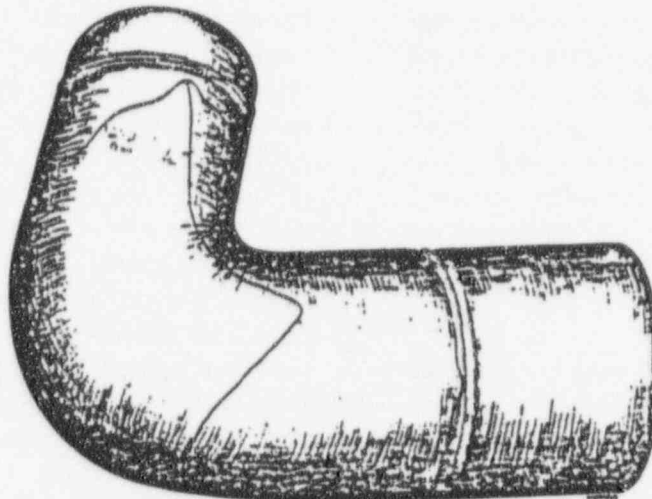
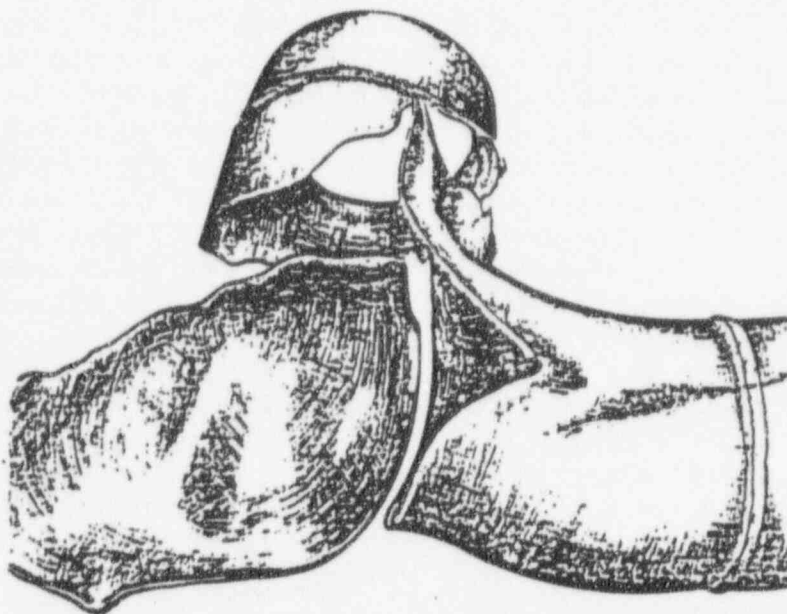
(a) Rupture lines in intact pipe.

(b) Pipe after rupture.
