CATAWBA NUCLEAR STATION
DIESEL ENGINE 2A COMPONENT REVALIDATION INSPECTION

PREPARED BY
DUKE POWER COMPANY

September 25, 1985

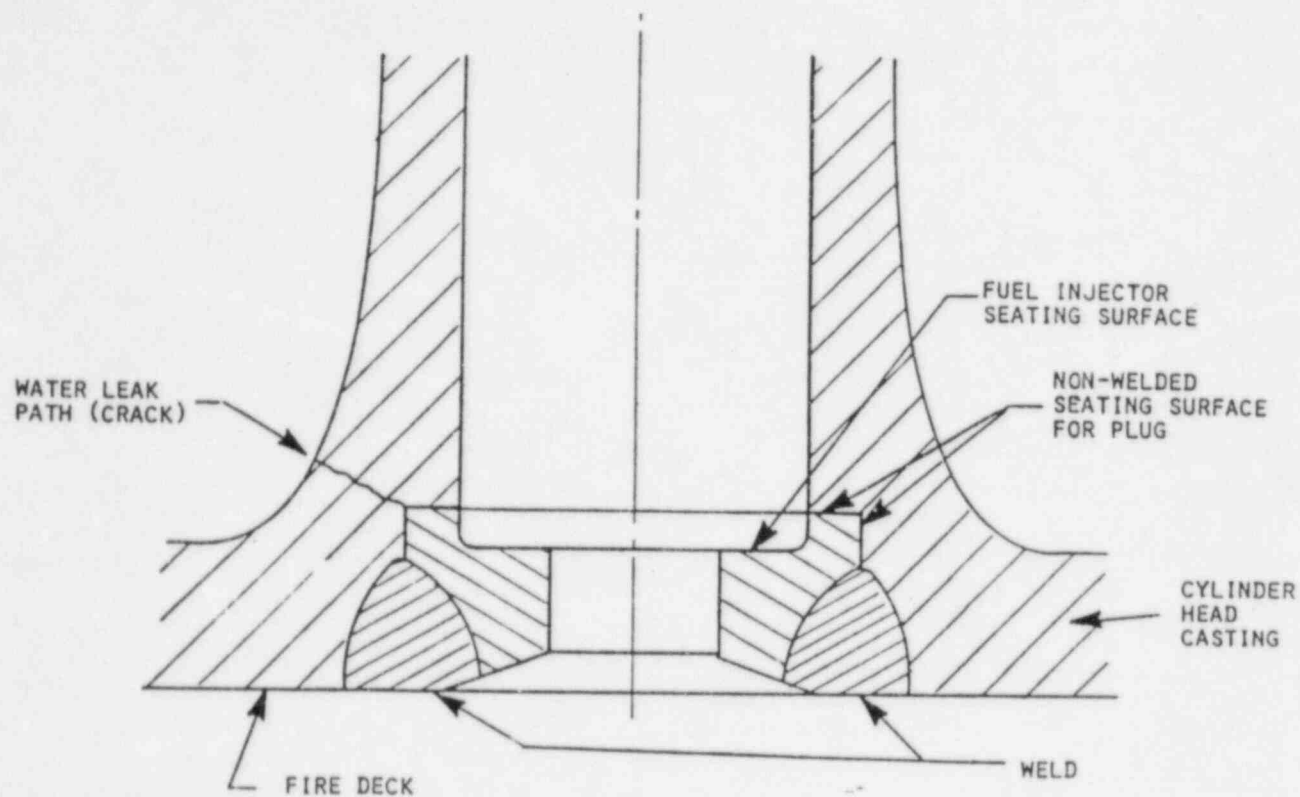
A. OLD HEAD REPAIR

Four cylinder heads at Catawba, one on engine 1A and three on engine 1B, developed small jacket water leaks into the fuel injection cavity. The 1A cylinder head has been examined by FaAA. This investigation (reference 4) revealed that the leak was caused by a crack initiating from the corner of a welded-in plug where it was seated in the cylinder head as shown in Figure 2-1A. This welded-in plug is reported by TDI to have been used to repair the casting around the fuel injector hole.

Duke Power Company has developed both visual and ECT inspection techniques to detect the partial penetration plug weld in a cylinder head. On diesel 2A five heads had been repaired with the partial penetration plug welds. These heads have been replaced. Of the heads replaced three heads (cylinders 6L, 7L and 8L) are heads with no weld repair. The other two replacement heads (cylinders 2R and 3R) have been repaired per Figure 2-1B.

Three small jacket water leaks have been experienced on Catawba diesel 1B (reference 2) resulting in water leaking into the fuel injector nozzle cavity. One leak of similar origin was seen on diesel 1A (reference 3). Failure analysis of one of the leaking heads has been completed (reference 4). The leak was due to cracks propagating from a corner where a welded plug was installed in the fuel injector nozzle seating area. This welded plug was used to repair the injector bore during manufacture. (Figure 2-3, reference 3 and Figure 2-1A, this report).
