UNITED STATES NUCLEAR REGULATORY COMMISSION

ADVISORY COMMITTEE ON REACTOR SAFEGUARDS

SUBCOMMITTEE ON REACTOR OPERATIONS

DATE: WEDNESDAY, FEBRUARY 12, 1986

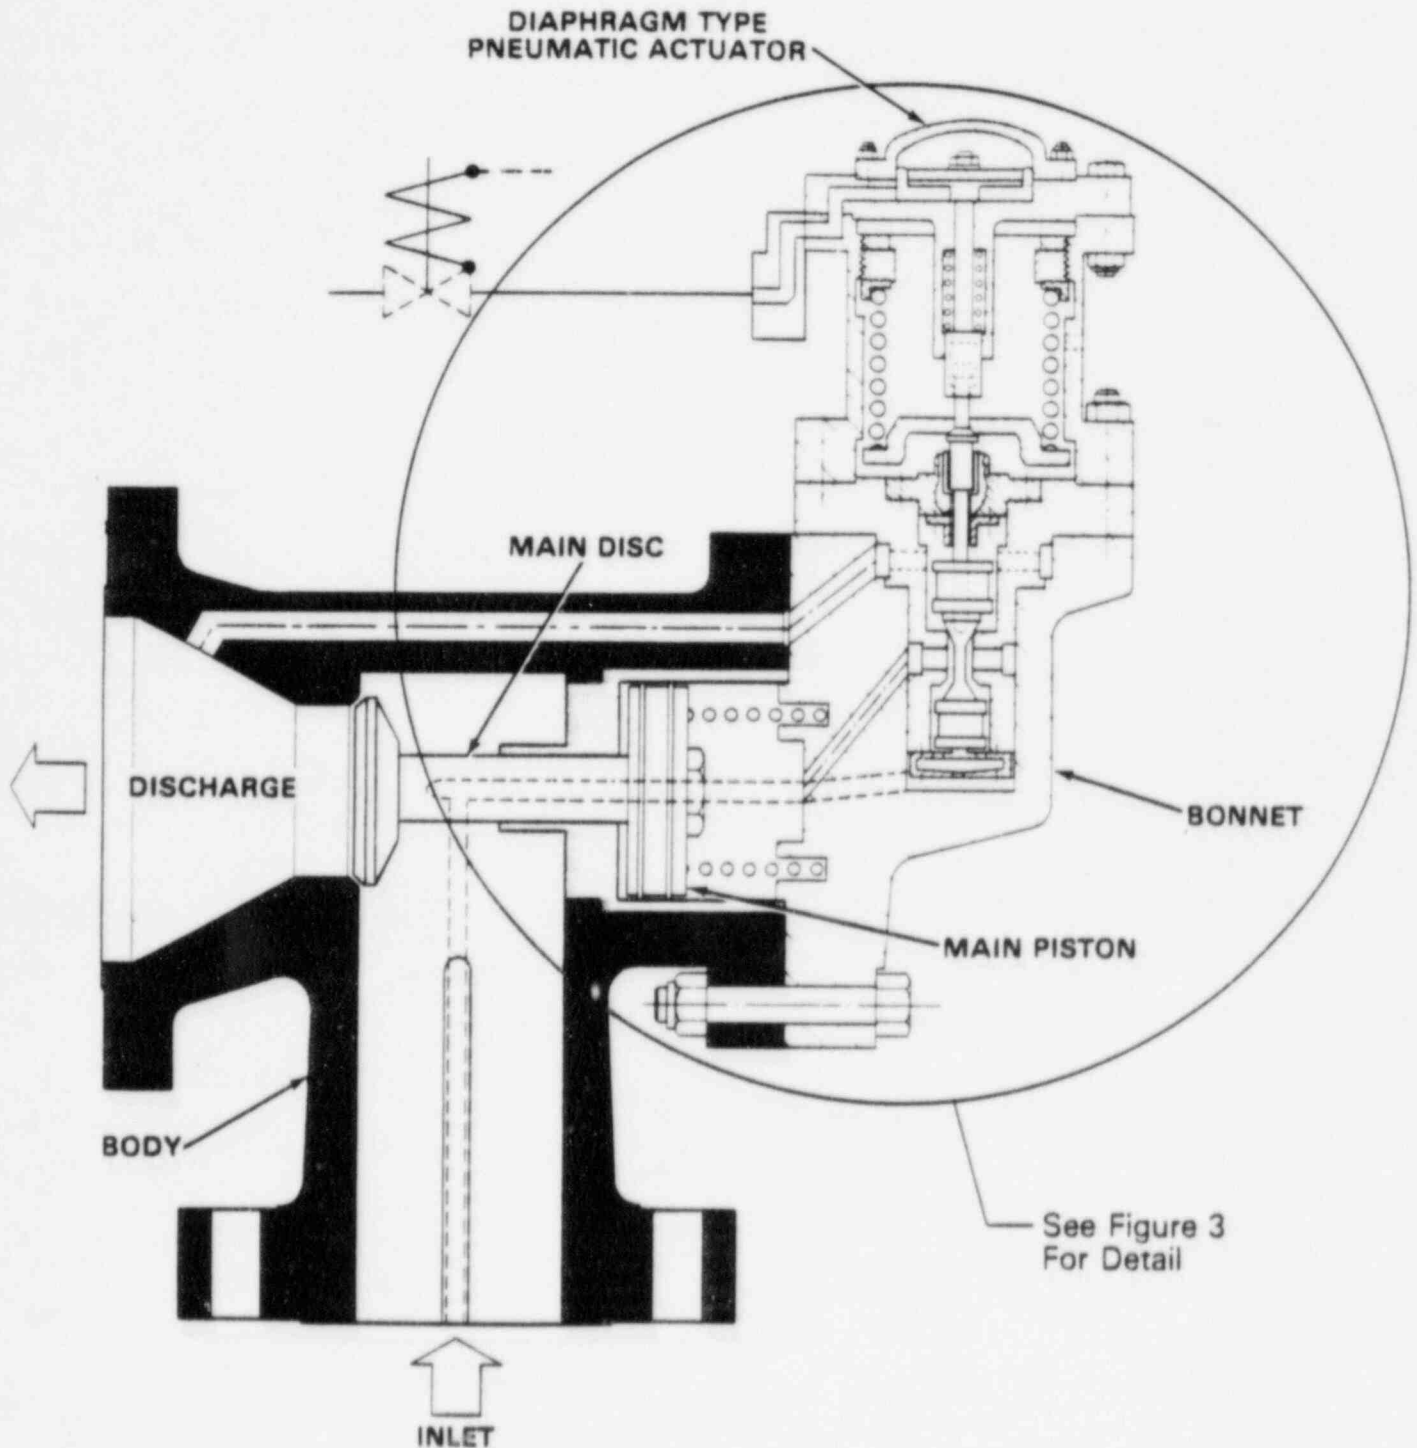
Figure 2 Target Rock Two-Stage Pilot Actuated, Safety/Relief Valve

18 As a bit of background, the two-stage Target
19 Rock safety relief valves were the solution to the problems
20 that had been experienced with the three-stage valves.
21 Two-stage valves exhibited some setpoint drift during
22 testing and became a major concern in July of 1982 when 11
23 of the Hatch 1 SRVs, of which there are 11, failed to open
24 at pressures well above their setpoints following a scram
25 in isolation. Subsequently, three of the valves opened at

11 The principal causes were determined to be
12 galling in the labyrinth seal area, and corrosion-induced
13 seat-to-disc bonding in this area.

20 The recommended solutions were an enhanced
21 maintenance program and a replacement disc of a material
22 whose oxide film would be less likely to bond to the oxide
23 film of the disc. The seat, sorry. Both the seat and the
24 disc were of a stellite 6 or 6B.

14 The next step taken by the owners group was the
15 selection of a replacement material for the pilot disc
16 which would have less tendency to develop this oxide bond
17 with the seat. The material which they eventually selected
18 was a precipitation-hardenable stainless steel disc. The
19 replacement disc had recently become available and had been
20 installed in 50 percent of the Hatch 1 and the Brunswick
21 valves which were tested at Wyle towards the end of 1985.
22 And the beginning of 1986.

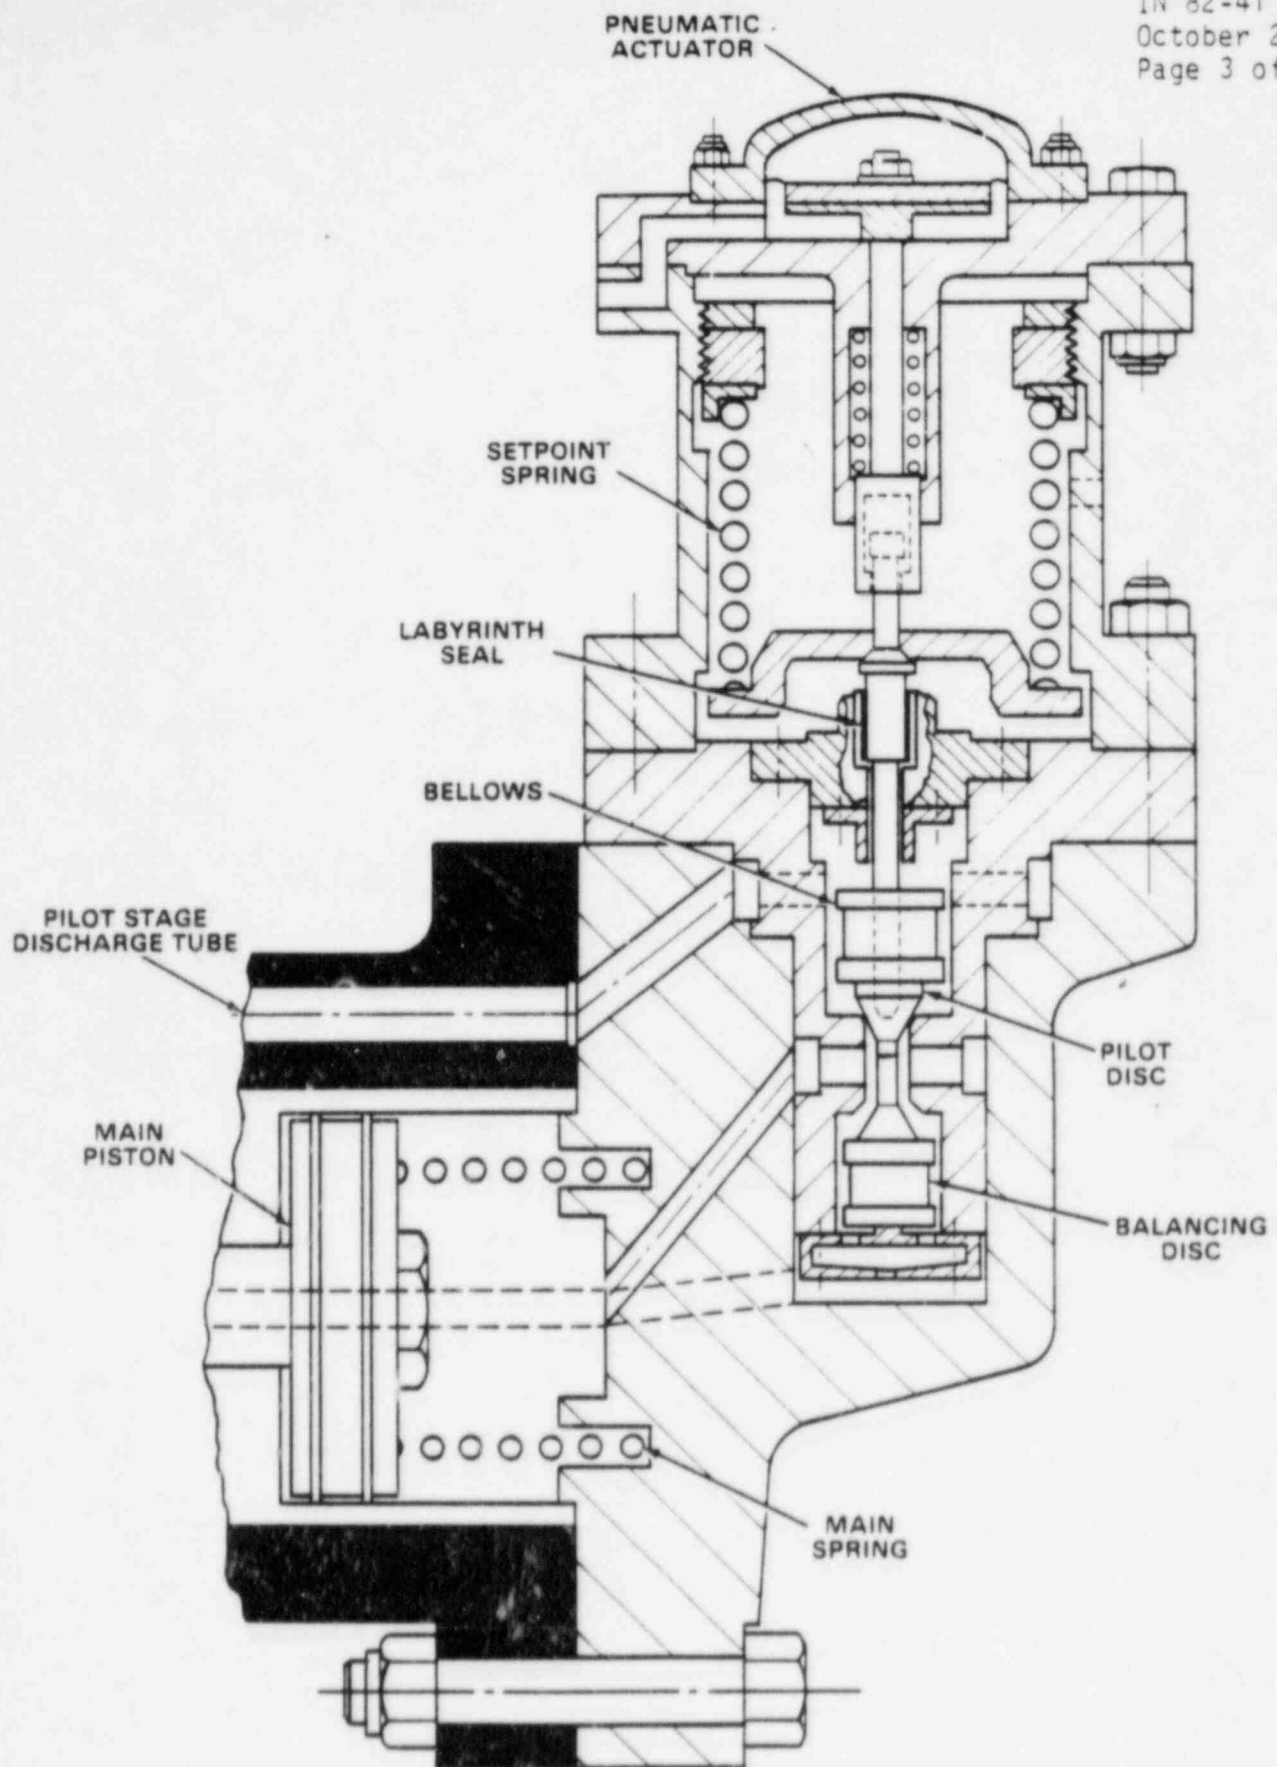
Figure 3 Topworks of Target Rock Two-Stage Safety/Relief Valve

3 The owners group that was formed after this
4 event, the General Electric Company and the Target Rock
5 Company, investigated the causes of the setpoint drift and
6 developed recommendations for solutions to the problem.
7 This is a closeup of the two-stage topworks.

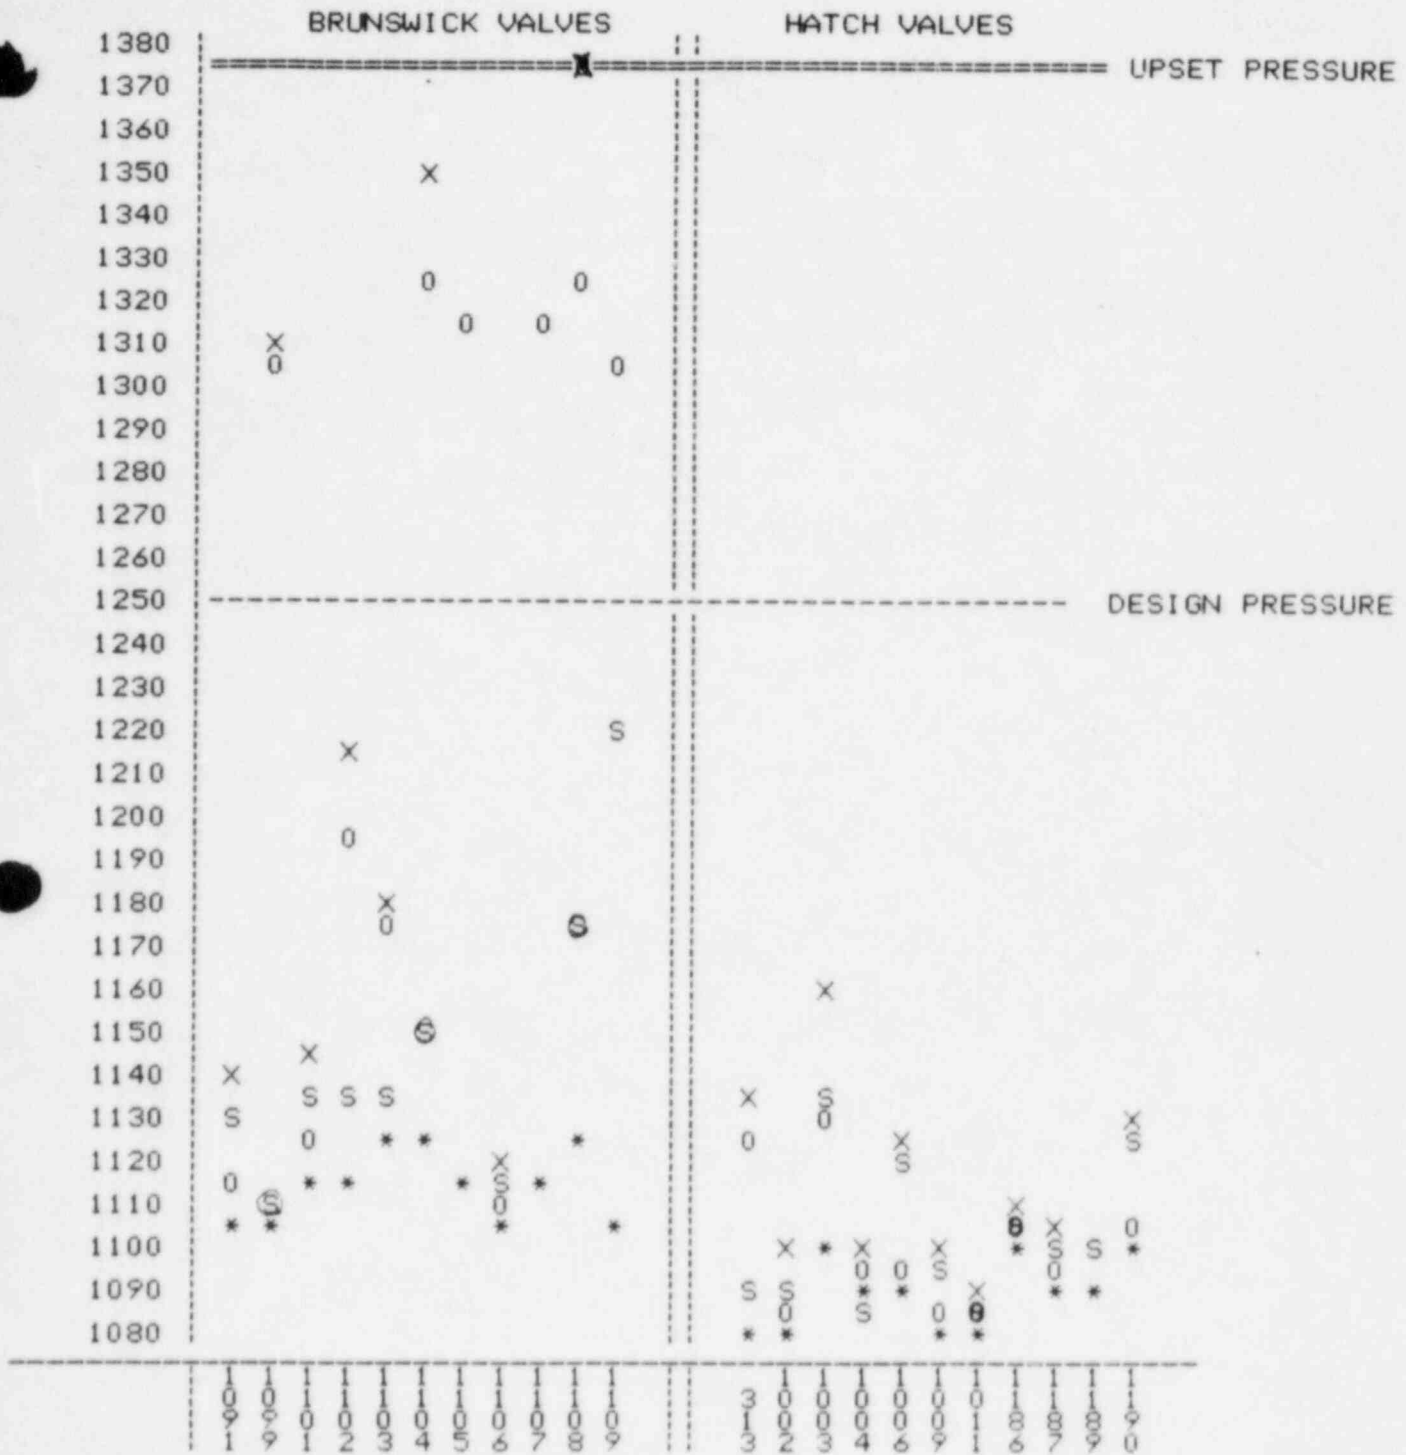
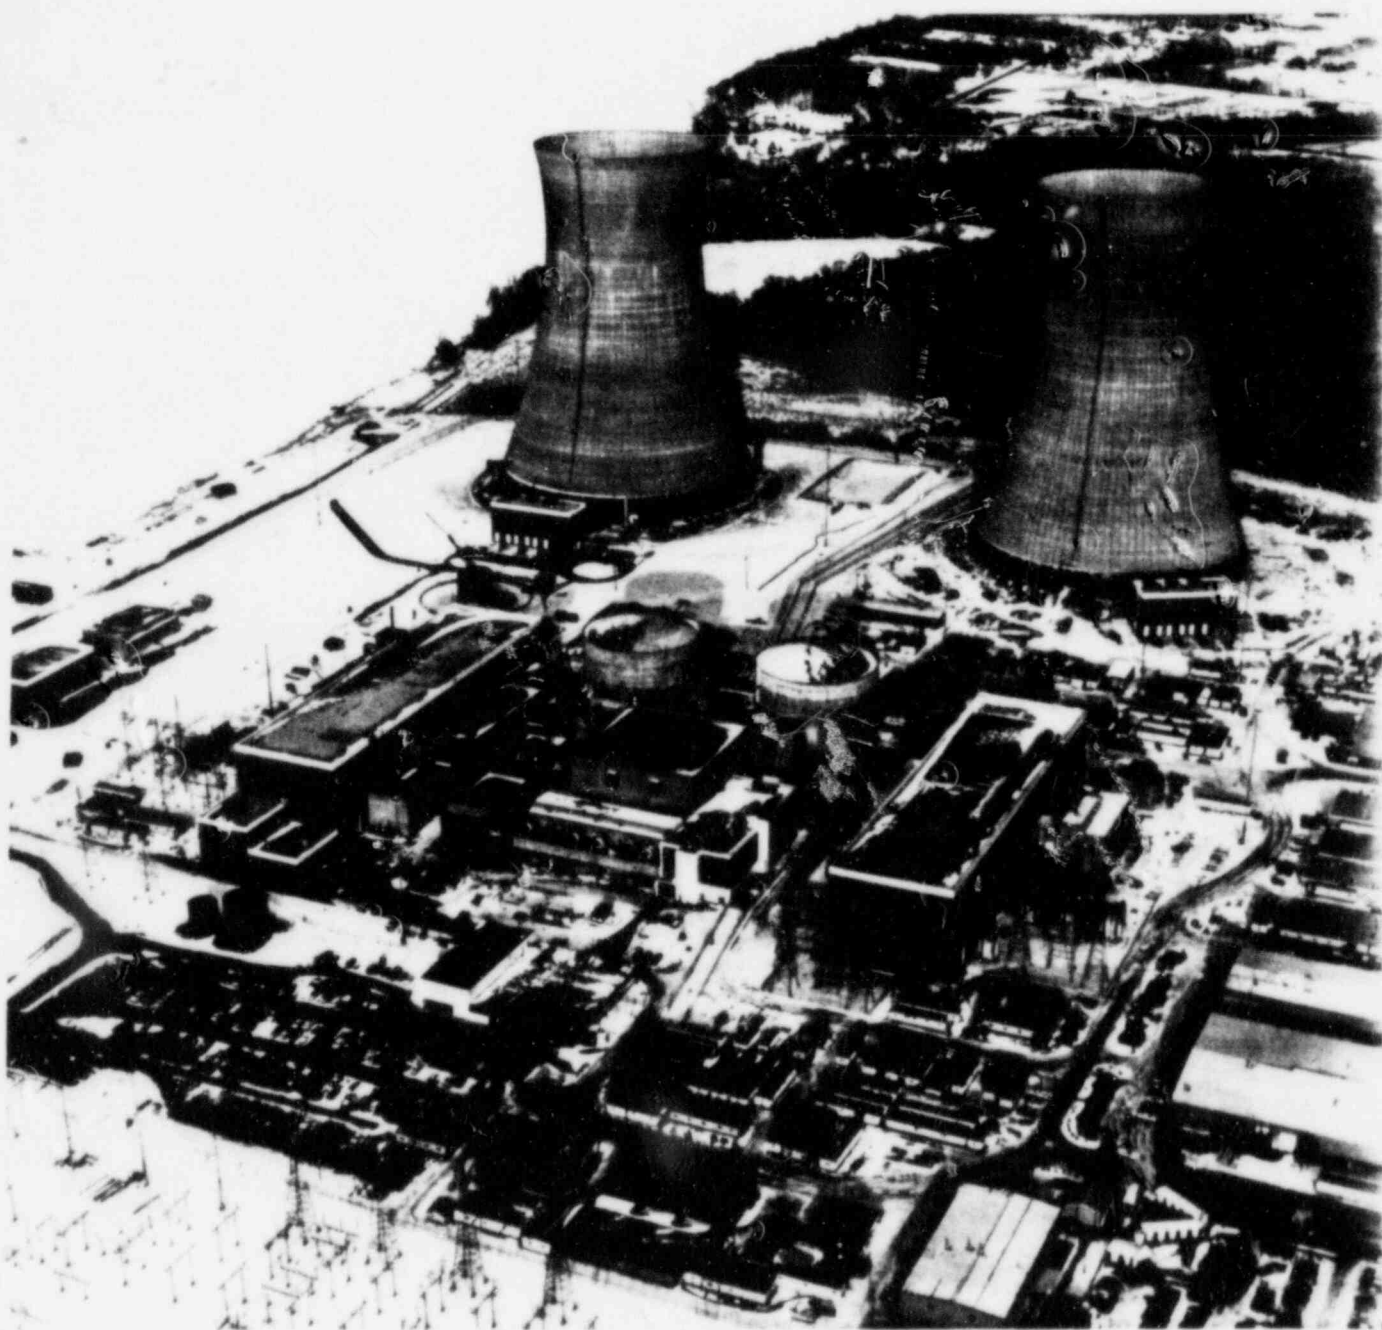
SRV TEST RESULTS

7 MS. WEGNER: On January 7, 1986, Carolina Power
8 & Light Brunswick phoned in the following 5072 report.
9 Test results from Wyle Laboratory on 11 SRV, six SRV failed
10 to lift at pressures as high as 200 psi above setpoints.
11 Two SRV were satisfactory and three SRVs lifted outside the
12 tolerance band.

11 MS. WEGNER: All 11 valves failed to operate
12 until three valves lifted at 1180 psig. Since then we have
13 seen some valves, mostly on the test stand, actuate very
14 much higher than that. Or not actuate at all.
