U.S. NUCLEAR REGULATORY COMMISSION

Report No. 50-289/85-30

Facility At: Three Mile Island Nuclear Station, Unit No. 1

Inspection Conducted: December 13, 1985 - January 10, 1986

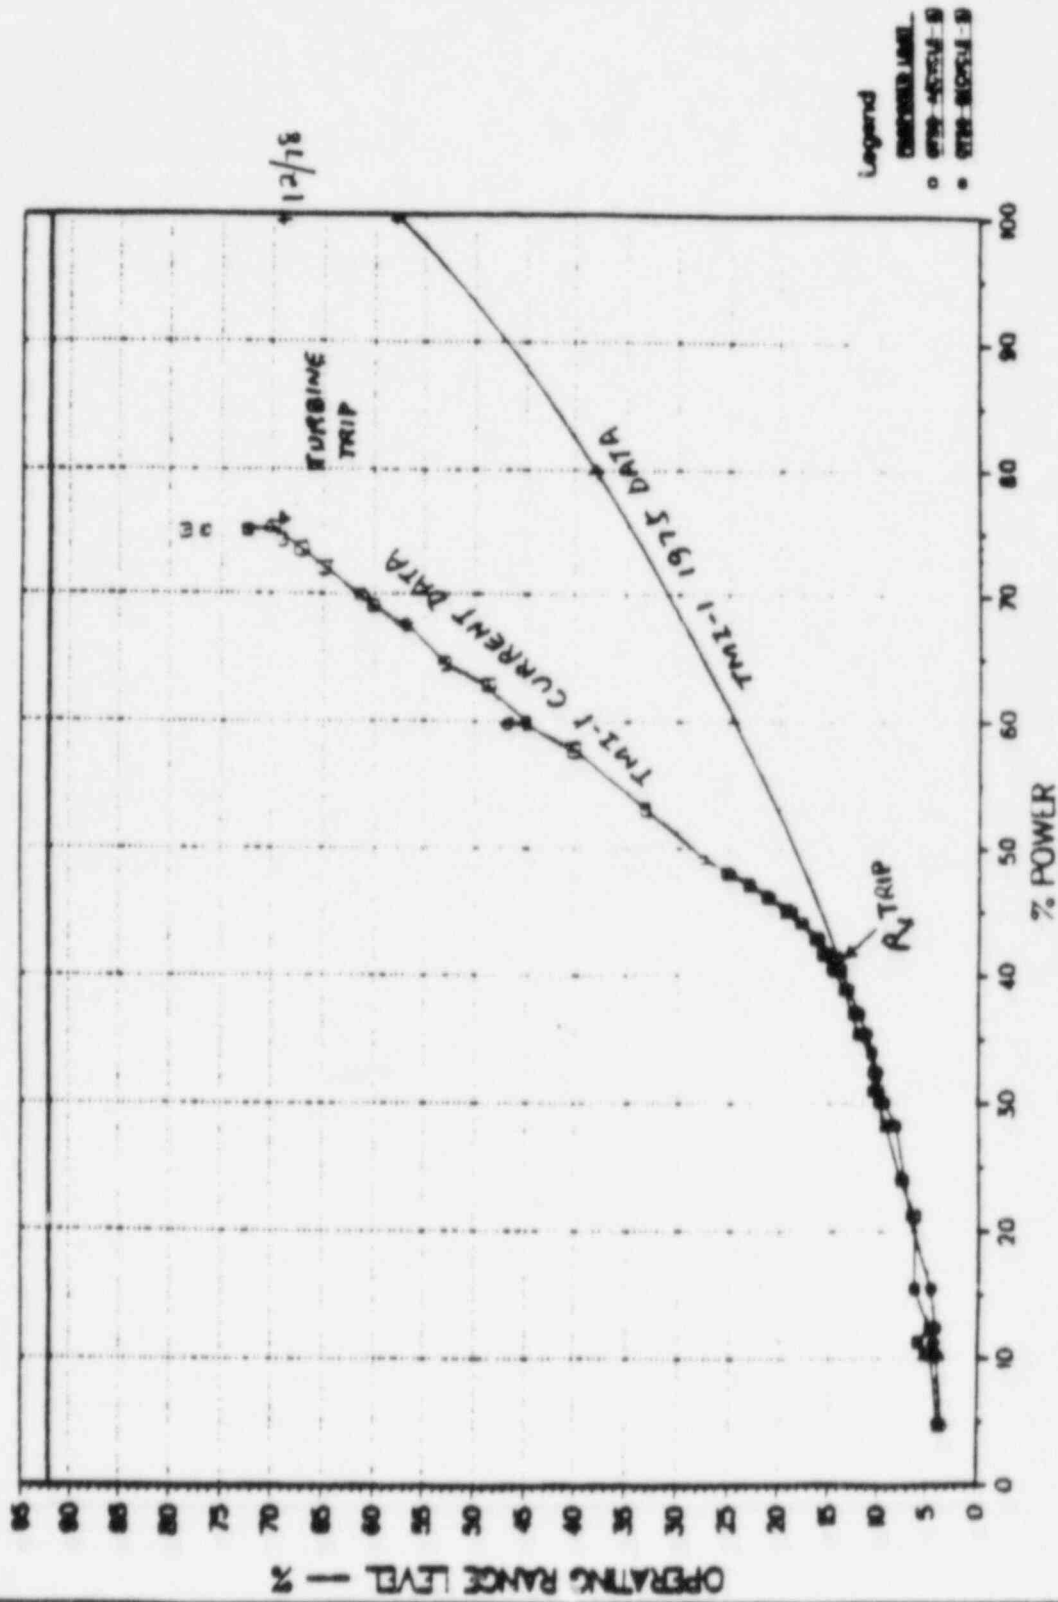
## TMI-1 STEAM GENERATOR Delta-P TRENDS

As previously noted in prior inspection reports, steam generator water levels had been higher than expected due to apparent deposits on the secondary side of the steam generator tubes. Following the most recent reactor startup on January 4, 1986, the steam generator levels were at a lower level than had been expected. Due to the importance of steam generator levels to plant operations, a review was conducted to develop some assurance that the level readings were accurate. To accomplish this, five steam generator level instrument differential pressures on each steam generator were compared and found to agree with the instrument tolerances.

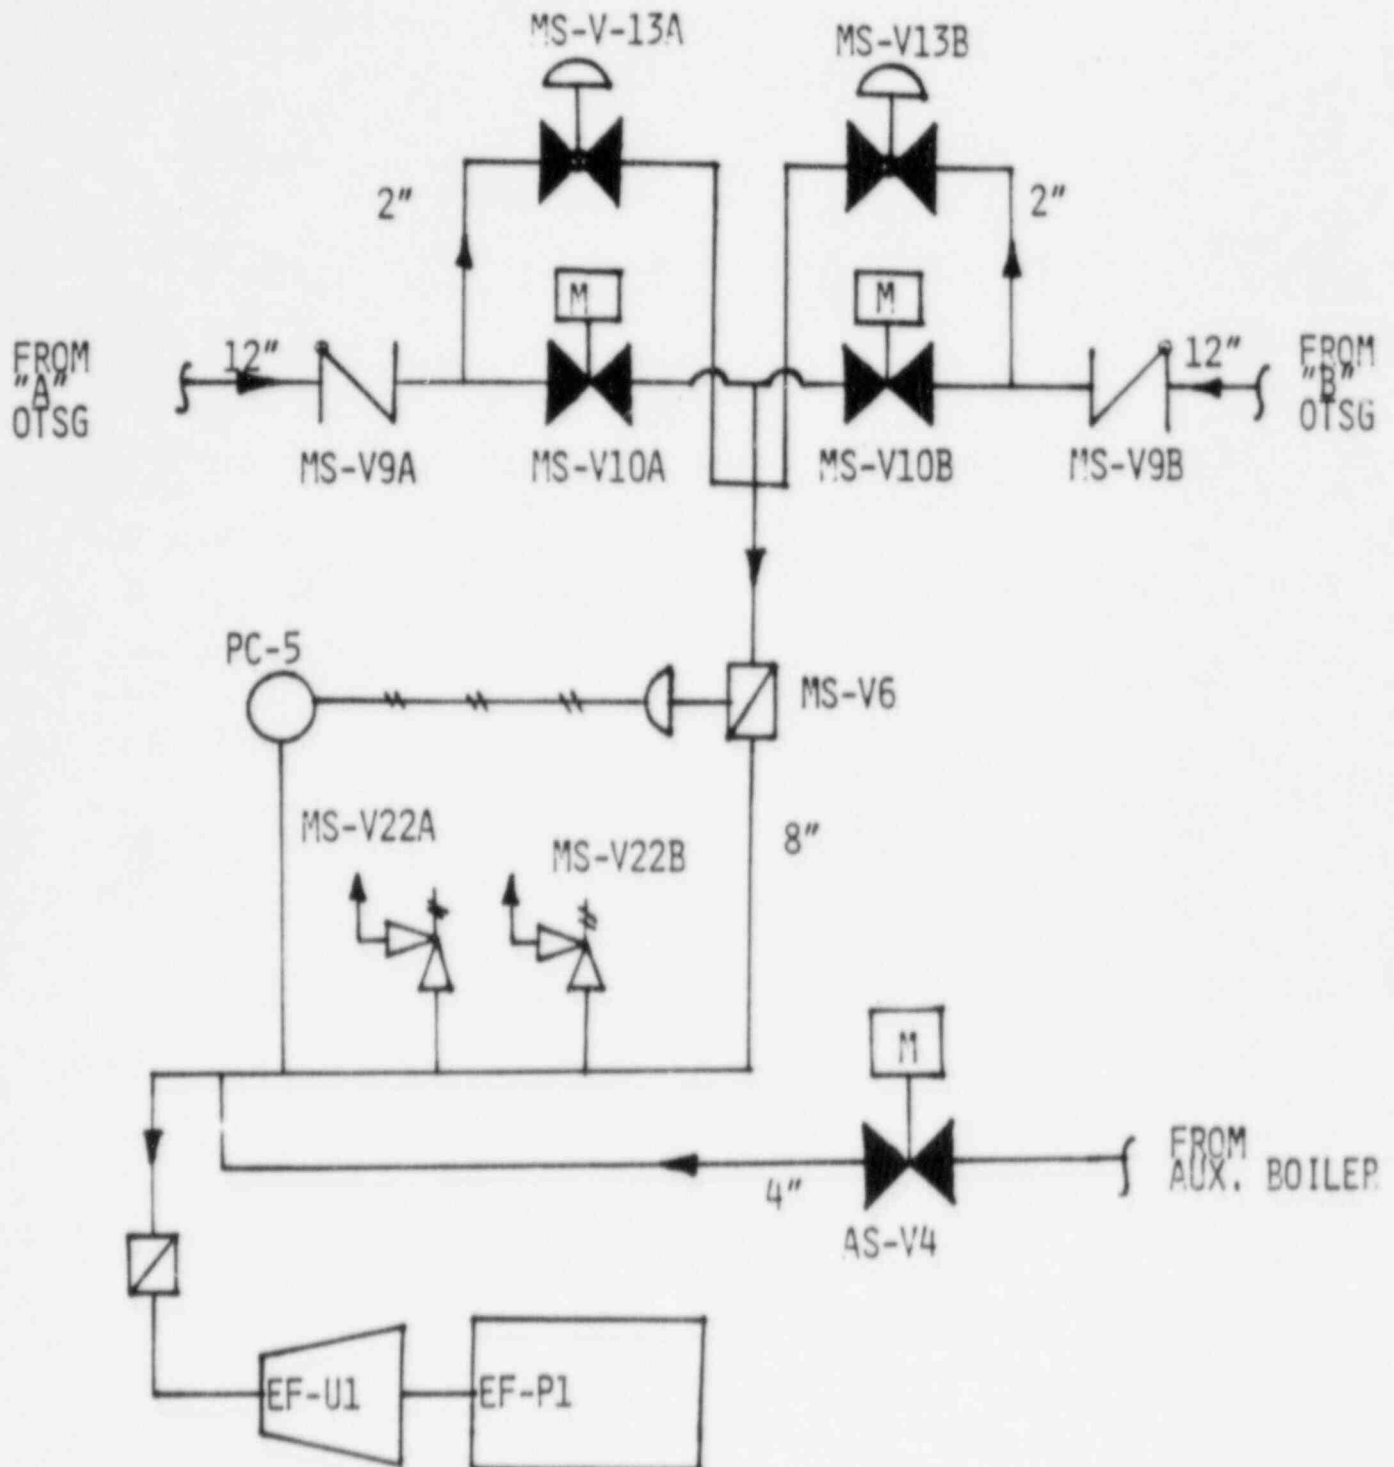
TMI-1  
STEAM SUPPLY TO  
EFW PUMP TURBINE

1. MSV22B LIFT OCCURS ONLY WITH SIMULTANEOUS MSV13A/B OPENING.
2. o INTERIM ACTION TO BE REVISED TO ONLY OPEN ONE MSV13  
o IMPROVED CONTROLLER TO BE TESTED AS CORRECTIVE ACTION
3. ABOVE ASSURES EF-P-1 OPERABILITY. NO NUCLEAR SAFETY CONCERN
