Subject: Docket No. 50-361
Voluntary Report
Licensee Event Report No. 97-005
San Onofre Nuclear Generating Station, Unit 2

LICENSEE EVENT REPORT (LER)															
Facility Name (1) SAN ONOFRE NUCLEAR GENERATING STATION, UNIT 2										Docket Number (2) 0 5 0 0 0 3 6 1			Page (3) 1 of 0 4		
Title (4) Reactor Coolant System Leakage - Shutdown Cooling System Valve Packing Leakoff Plug															
EVENT DATE (5)			LER NUMBER (6)				REPORT DATE (7)			OTHER FACILITIES INVOLVED (8)					
Month	Day	Year	Year	///	Sequential Number	///	Revision Number	Month	Day	Year	Facility Names		Docket Number(s)		
0	3	1	9	9	7	9	7	---	0	0	5	---	0	0	0
OPERATING MODE (9) 3			THIS REPORT IS SUBMITTED PURSUANT TO THE REQUIREMENTS OF 10CFR (Check one or more of the following) (11)												
POWER LEVEL (10) 0 0 0			20.402(b)			20.405(c)			50.73(a)(2)(iv)			73.71(b)

Plant: San Onofre Nuclear Generating Station Unit 2
Reactor Vendor: Combustion Engineering
Event Date: March 19, 1997
Event Time: 0500
Mode: 3
Power: 000%
Temperature: 545 Deg F
Pressure: 2250 PSIA

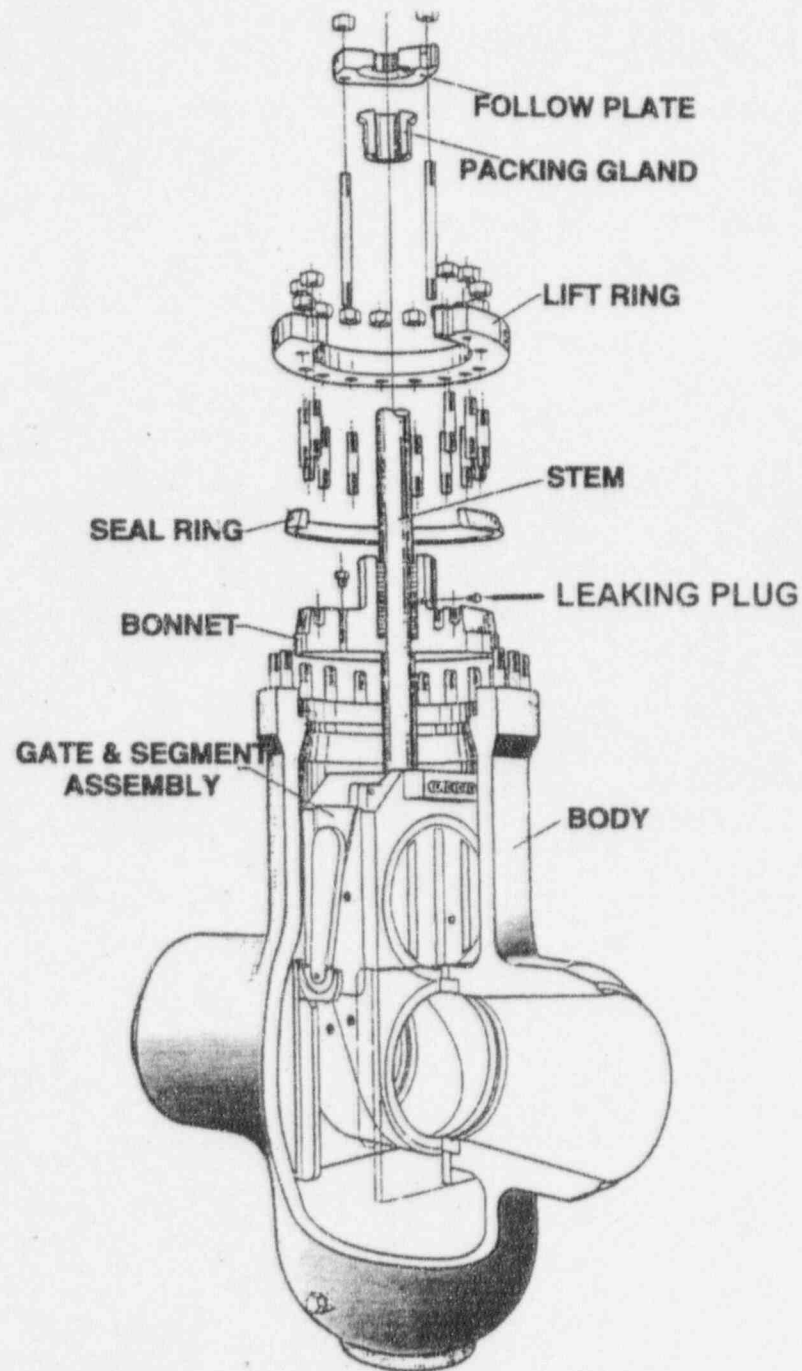
Figure 1 - SDC Isolation Valve 2HV9339

On March 18, 1997, Operators were moving Unit 2 from Mode 4 to Mode 3 at the end of the Cycle 9 refueling outage. At about 2045, an Engineer (utility, non-licensed) performing a routine Mode 3 inspection inside containment noted steam emanating from the Shutdown Cooling System [BP] isolation valve 2HV9339 (a WKM valve). At 0500 the next day, the leak was determined to be through the metal body of the valve's packing leakoff plug. See Figure 1.

Edison determined the leak was caused by a metallurgical defect in the plug itself. This defect, micro-shrinkage porosity and micro-shrinkage cracking, was introduced during manufacturing of the ingot from which the plug's bar stock was made. Under operating conditions, these flaws interconnected, providing a leak path through the plug's body.

This was a new plug, installed during this outage (U2C9). The threads were in good condition. Edison confirmed the plug had been installed properly and in accordance with plant procedures.

The defective plug did not adversely affect the valve's operation. Leakage through the defect was limited to the normal leakage past the inner valve disc and was measured at 0.4 gpm. The plug is a 1/2 inch nominal pipe size (approximately 5/8 inch diameter hole). The catastrophic failure of the plug, while not considered credible, is bounded by the small break loss of coolant accident analysis in the UFSAR. Therefore, this event had minimal safety significance and did not pose a substantial safety hazard.

Edison replaced the defective plug with a new plug which had been confirmed to be free of similar defects. After the plug was installed, its head was removed and ground smooth, and the plug seal welded in place.
