NO. PMA 84-06

TITLE: FAILURE ANALYSIS, F010 AND F011 VALVES, CLINTON PROJECT

Date: December 3, 1985

Failure Analysis Report of F010 and F011  
Valves From The Clinton Reactor

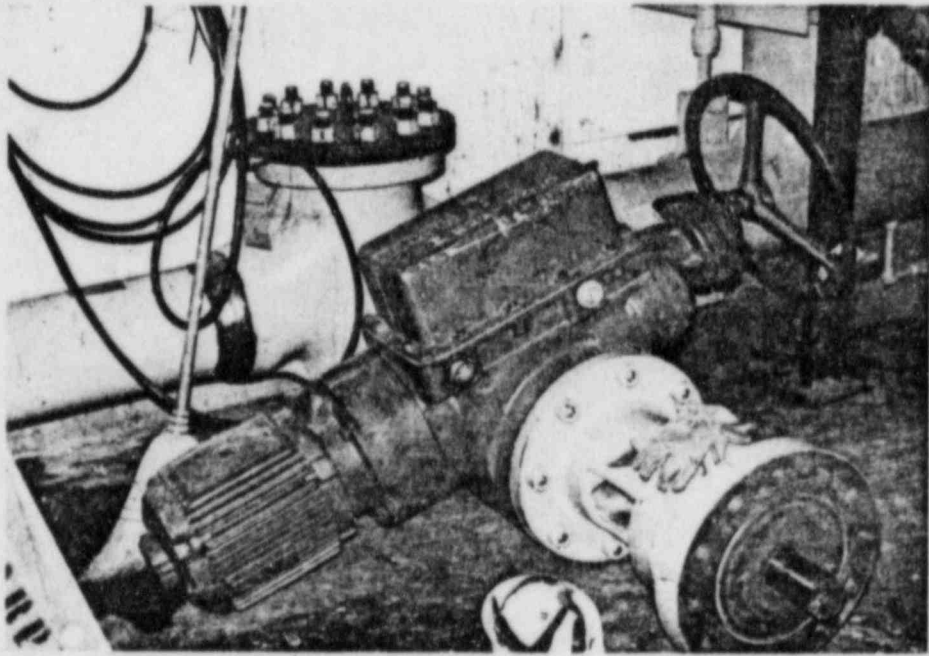
FIGURE 1. FO10 VALVE DISASSEMBLED. BODY IS BLANKED OFF WITH A COVER PLATE

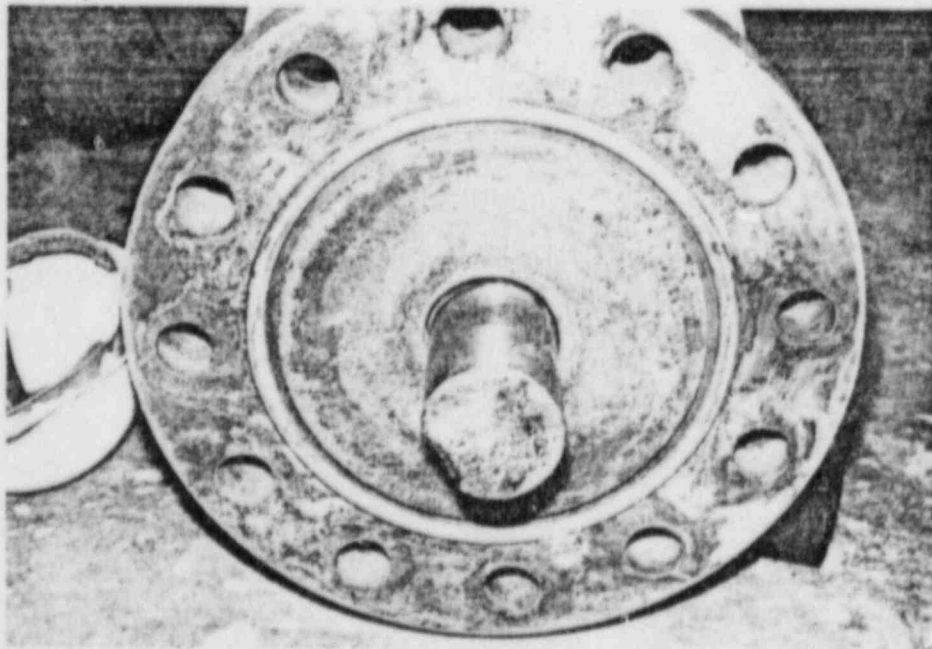
- a. Broken Valve Stem - As shown in Figures 1 and 2, the stem was broken above the back seat, 1 7/8 to 2 1/2 inches beyond the newly formed back seat area on the shaft.

FIGURE 2. FO10 VALVE DISASSEMBLED SHOWING  
BROKEN VALVE STEM

All damaged items should be replaced or repaired. The stems should be replaced with properly heat treated Type 410 stainless steel. General Electric's current standards require hardness of Type 410 not to exceed RC28 (See paragraph 2.4 for basis). 17-4 Ph stems may also be used providing the aging temperature is 1075°F or greater (material temperature).

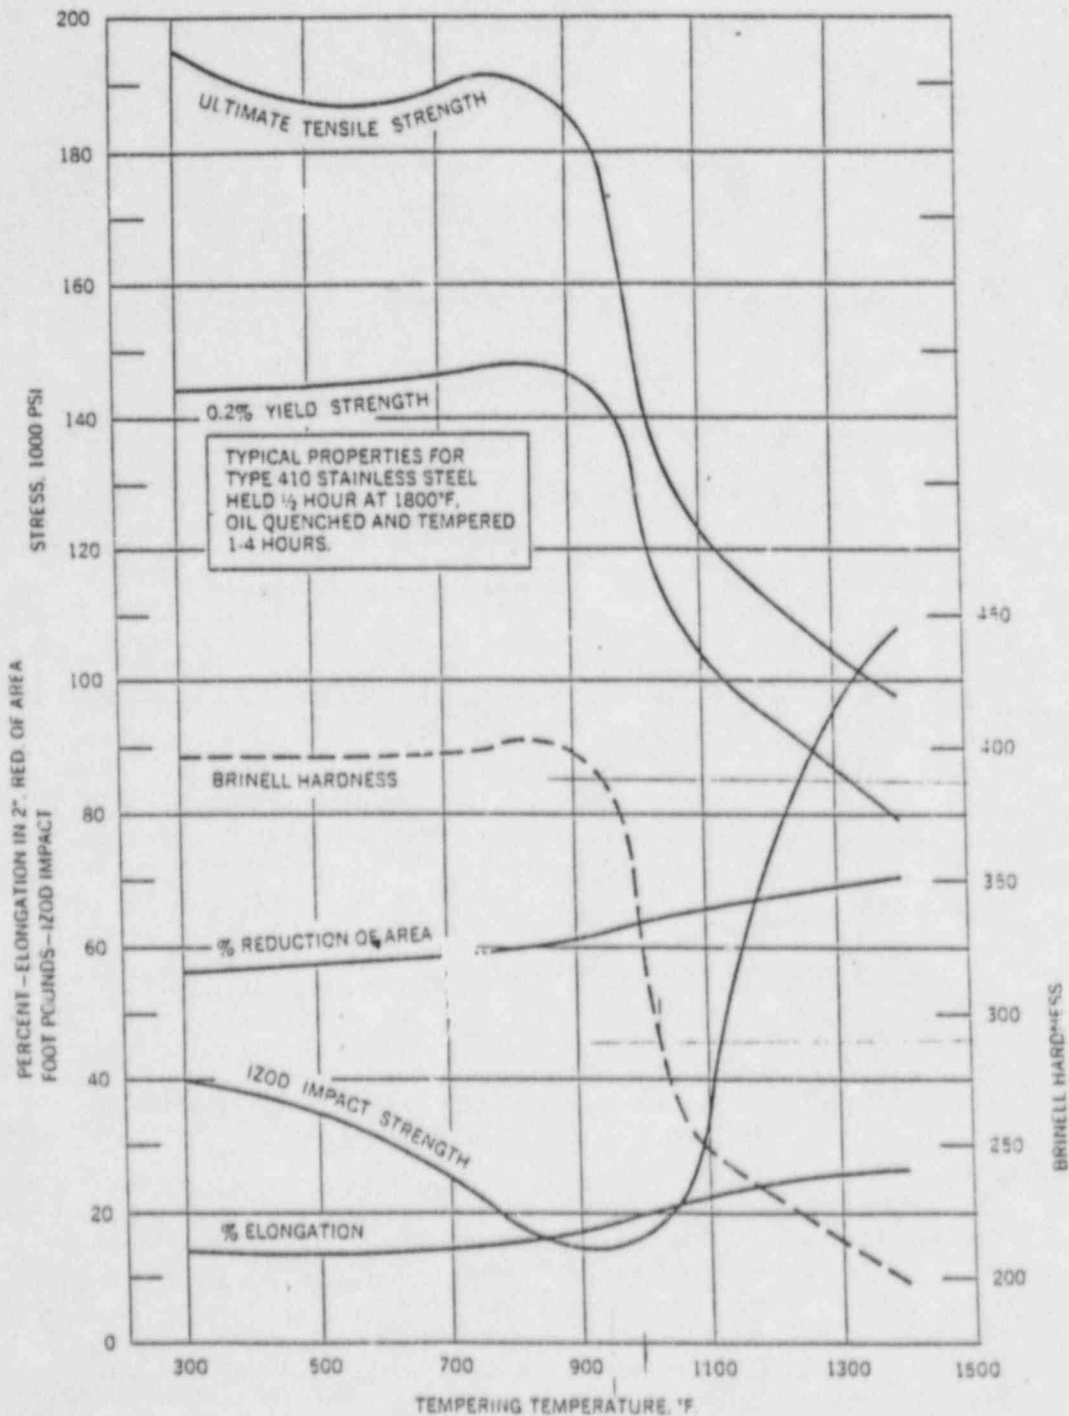
- a. It is unusual to see intergranular cracks this deep with so little apparent time exposed to water considering the low temperatures involved (ambient temperature)
- b. There is corrosion on the stem just above the back seat suggesting that the valve was backseated with water present for a long period of time. F011 valve does not show this corrosion.
- c. The valve stem shows a considerable gradient in hardness from one end to another. In the area of the fracture the hardness is RC40-41 while at the other end it is RC30-31. This suggests a tempering temperature of less than 950°F at the lower end and approximately 1050°F at the upper end.
- d. The fracture exclusive of the IGC area is almost entirely a brittle cleavage failure. This would correspond to a notched tensile fracture of material heat treated in the 800-1000°F range, Figure 2.1

FIGURE 2.1 TYPICAL MECHANICAL PROPERTIES FOR TYPE 410 STAINLESS STEEL TEMPERED AT VARYING TEMPERATURES

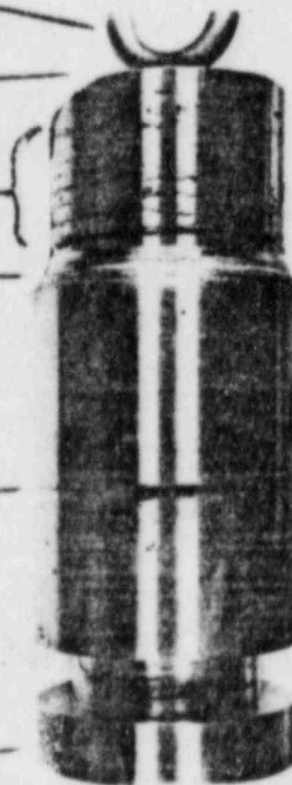
FIGURE 3. LOWER END OF BROKEN VALVE STEM (F010)

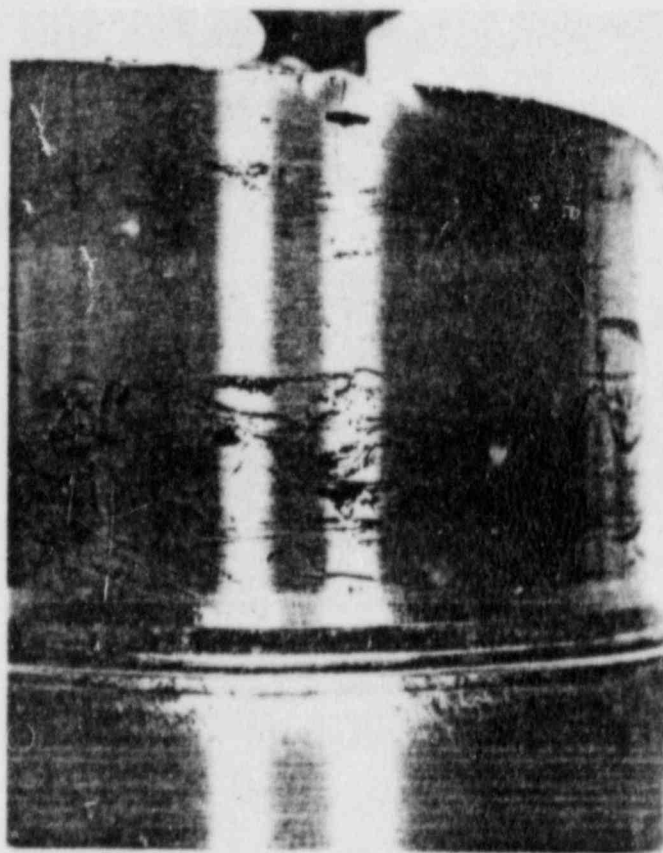
- b. Stem Upset in Area of Backseat. The upset was caused by the motor pulling the stem into the backseat, (Figure 3 and 4).
- c. Gouged Area on Stem - See Figure 5. The heavily abraded area on both the upper and lower part of the stem, were due to the bottom shaft (attached to disc) becoming cocked in the valve and the upper shaft scraping against the lower shaft when the valve was closed. See Figures 5, 6, and 8.

FIGURE 4. CLOSEUP VIEW OF UPSET AREA ON STEM  
(IN REGION OF THE BACK SEAT) (F010)

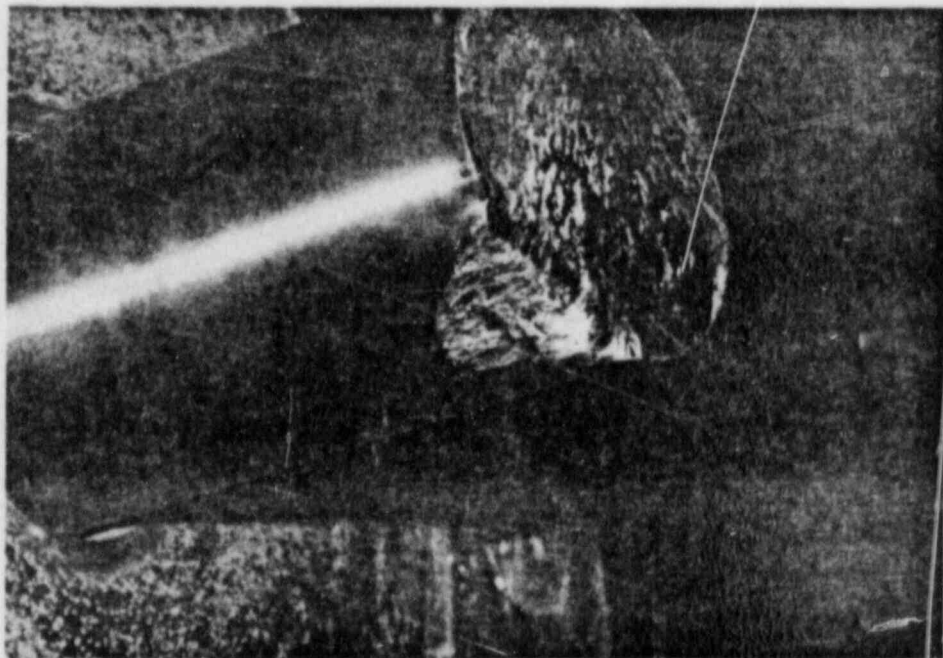
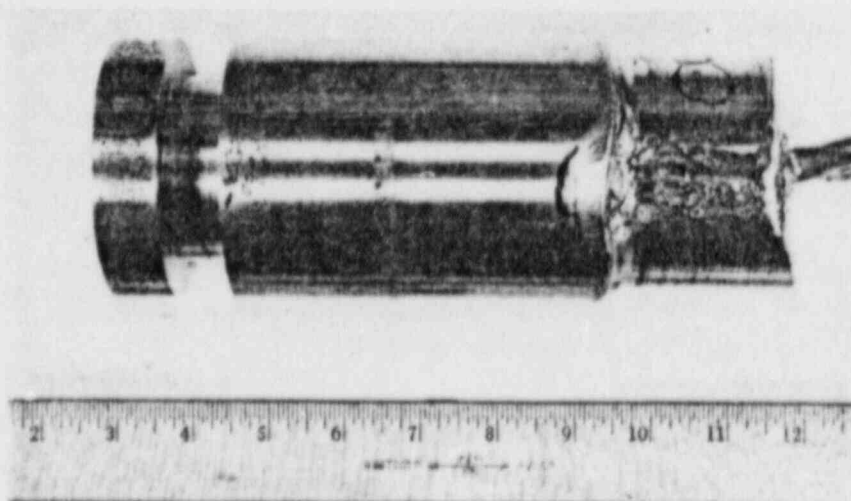
FIGURE 5. GOUGED AREAS IN UPPER PART OF STEM (ABOVE) AND LOWER PART OF STEM (BELOW). GOUGES CAUSED BY UPPER SHAFT MOVING AGAINST LOWER SHAFT WHEN LOWER SHAFT WAS COCKED IN VALVE. SEE ALSO FIGURE 8. (F010)

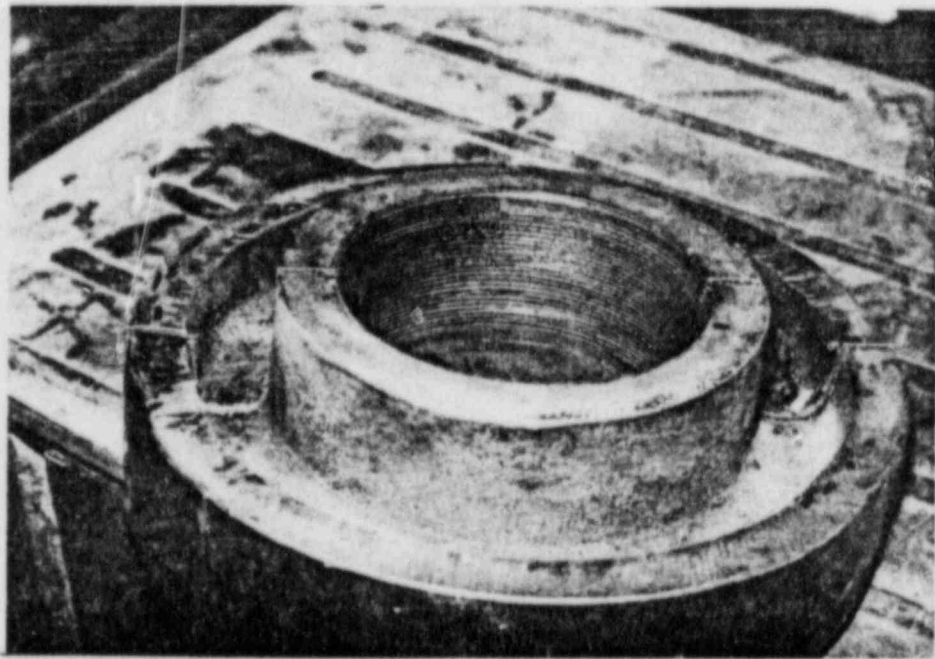
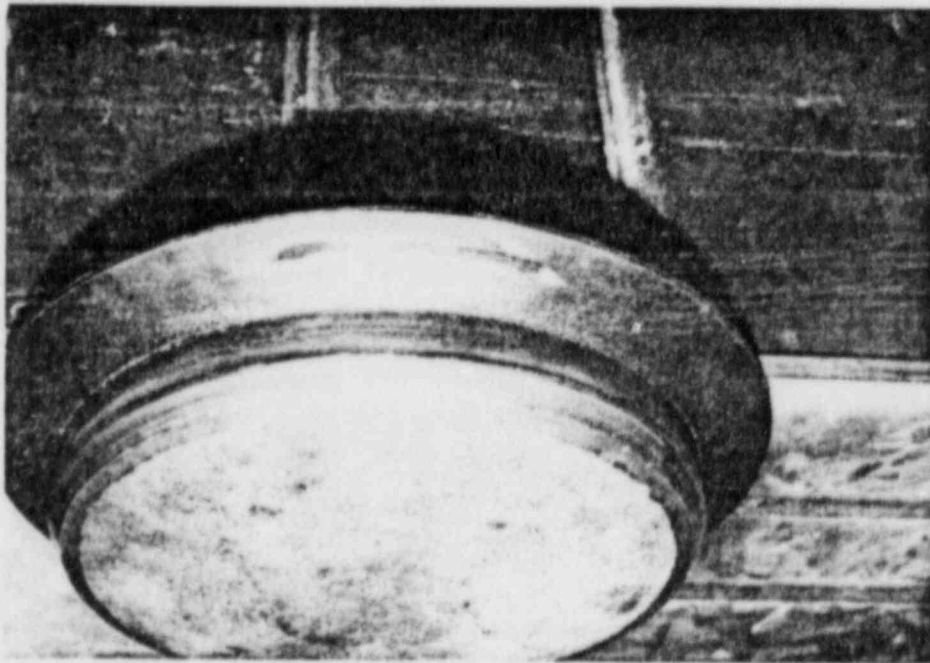
- f. Disc and Stub Shaft Wedged in Valve at an Angle, Figure 7 and 8. The lower part of the stem and the disc were found tightly wedged in the valve at an angle. The disc had a circular shaped indentation on the lower edge where the disc was pressed into the stellite seat and the upper flanged part of the disc had two

impressions matching the guide ribs in the valve body. The disc was not seriously damaged but maintenance was unable to separate the nut from the disc and subsequently cut the lower part of the disc from the upper part (to avoid cutting the stellite and then saw cut the upper part of the disc to allow disassembly of the disc from the stem.

FIGURE 7. UPPER AND LOWER PARTS OF THE DISC (SAW CUT TO ASSIST IN DISASSEMBLY) SHOWING DEFORMATION WHERE THE DISC WAS PRESSED AGAINST THE GUIDE RIBS (UPPER PHOTO) AND THE SEAT (LOWER PHOTO) (F010)

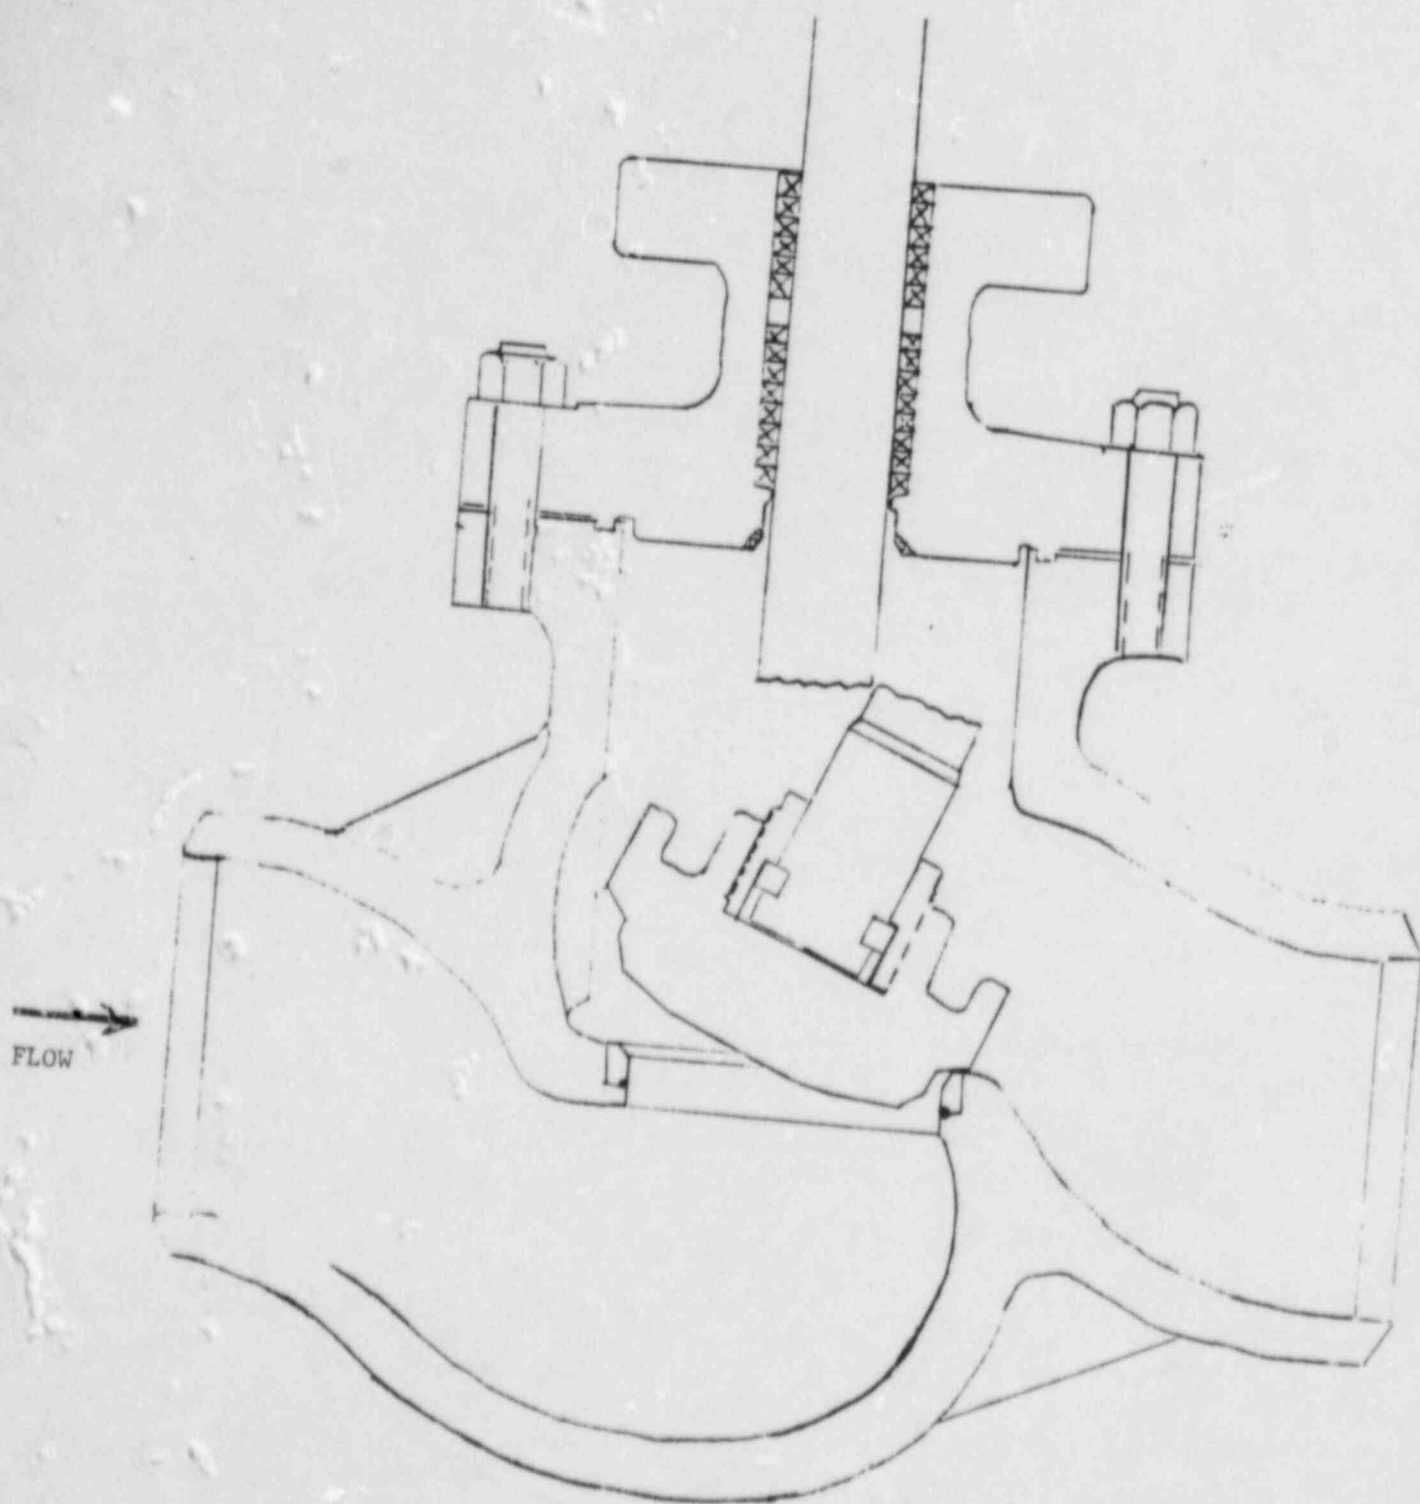
Sometime after fracture of the stem the disc became cocked in the valve such that one edge was striking the seat and the opposite side was wedged in the guides, Figure 8. This effectively jammed the valve open with no possibility of closing. The broken top part of the stem was striking the lower part of the stem such that it wedged the disc tighter in the open position with each stroke. The cocking of the disc was most likely due either to use of the valve for throttling or from closing the valve while the pump was operating. It is not likely that the stem could have cocked with no flow in the valve.

FIGURE 8. VIEW SHOWING FO10 VALVE WITH CRACKED  
SHAFT AND APPROXIMATE ANGLE OF WEDGING  
FOR DISC, FO10 VALVE

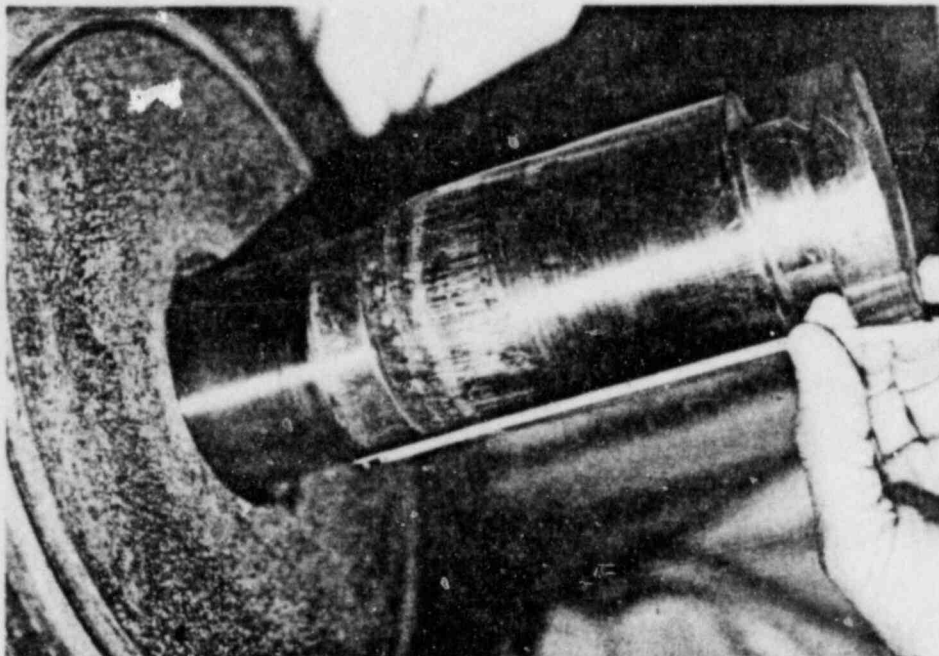
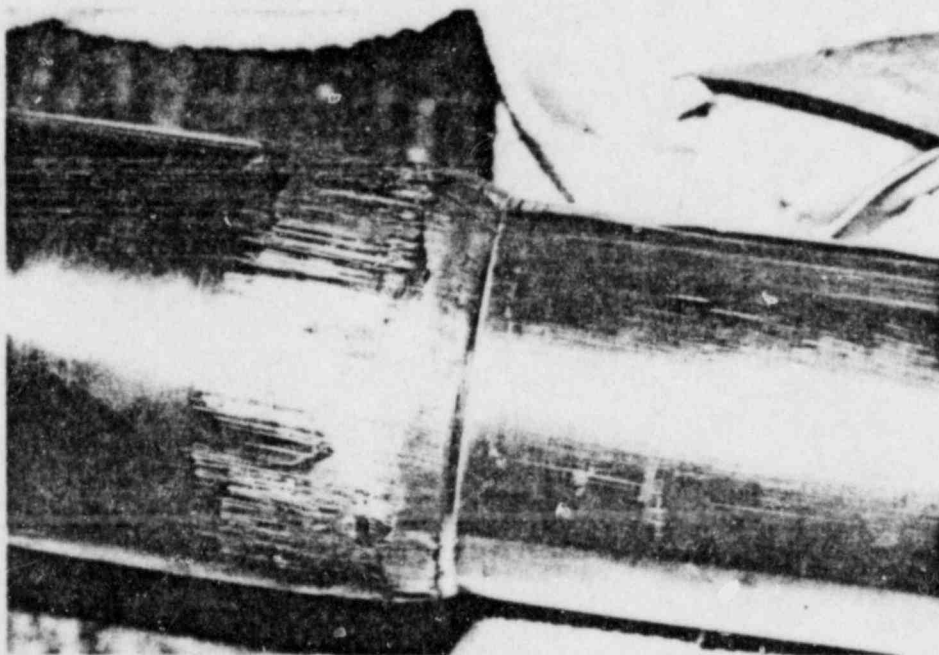
FIGURE 9. BADLY CALLED AREA ON STEM OF F011 VALVE.  
CALLING DUE TO PULLING STEM INTO BACKSEAT  
IN BONNET

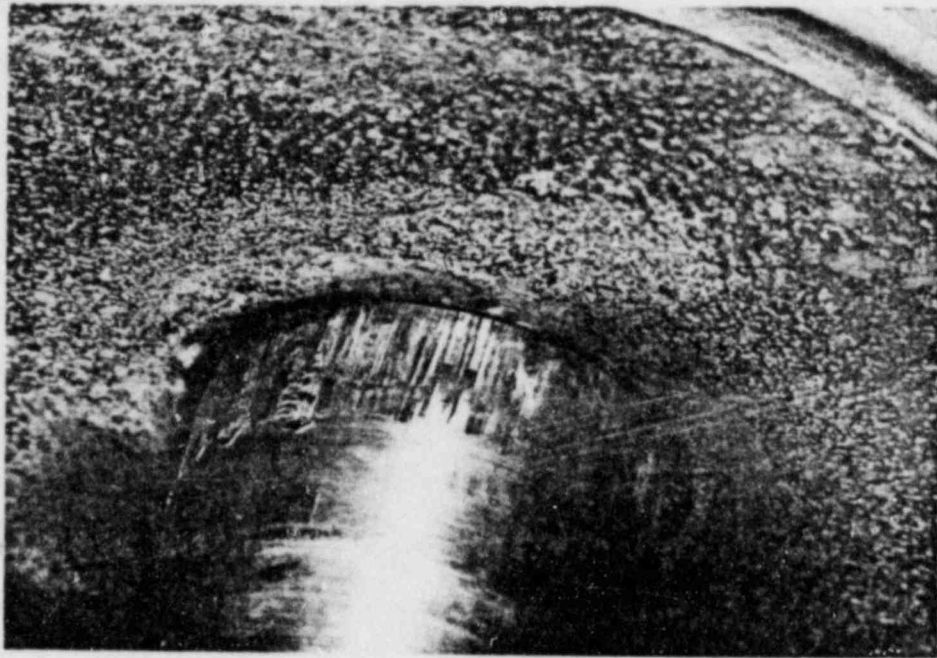
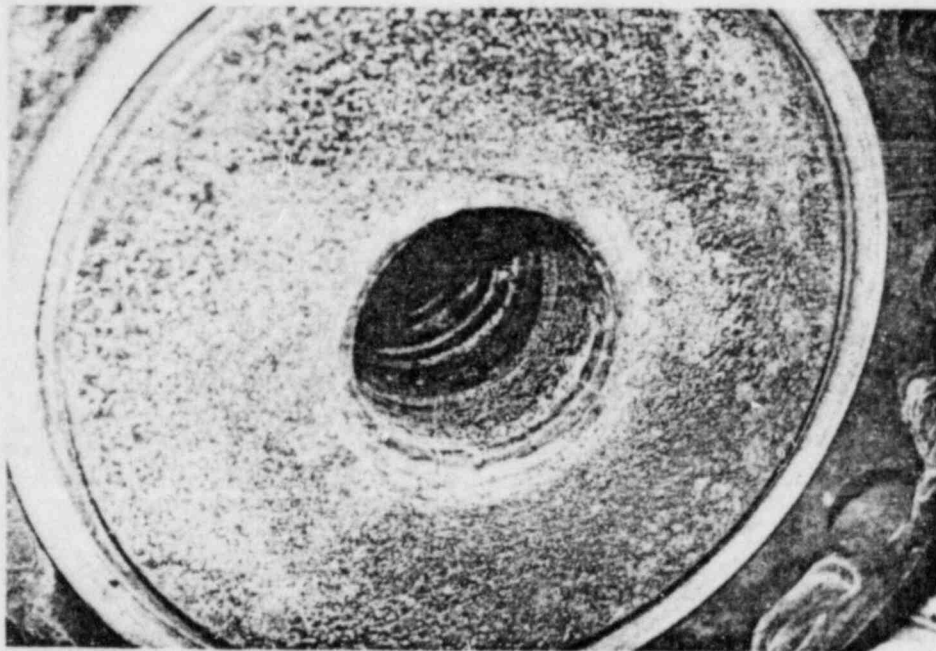
- a. The disc nut was unscrewed from the disc and separated from the stem. There was no apparent damage to the threads or shaft.
- b. The split ring retainer was separated from the assembly. One-half of the retainer was found just downstream of the D004 pressure reducing orifice and the other half was found in the condensate storage tank. The orifice was heavily marked by impact and bowed concave toward the downstream side.
- c. The stem was badly galled due to the motor pulling the stem into the backseat, Figure 9.
- d. The back seat in bonnet is badly cracked as a result of the stem being pulled into the back seat, Figure 10.

FIGURE 10. UPPER PHOTO SHOWS STEM PARTIALLY PULLED INTO BACK SEAT. LOWER PHOTO SHOWS CRACKED STELLITE RESULTING FROM PULLING STEM INTO BACK SEAT (FOIL VALVE)

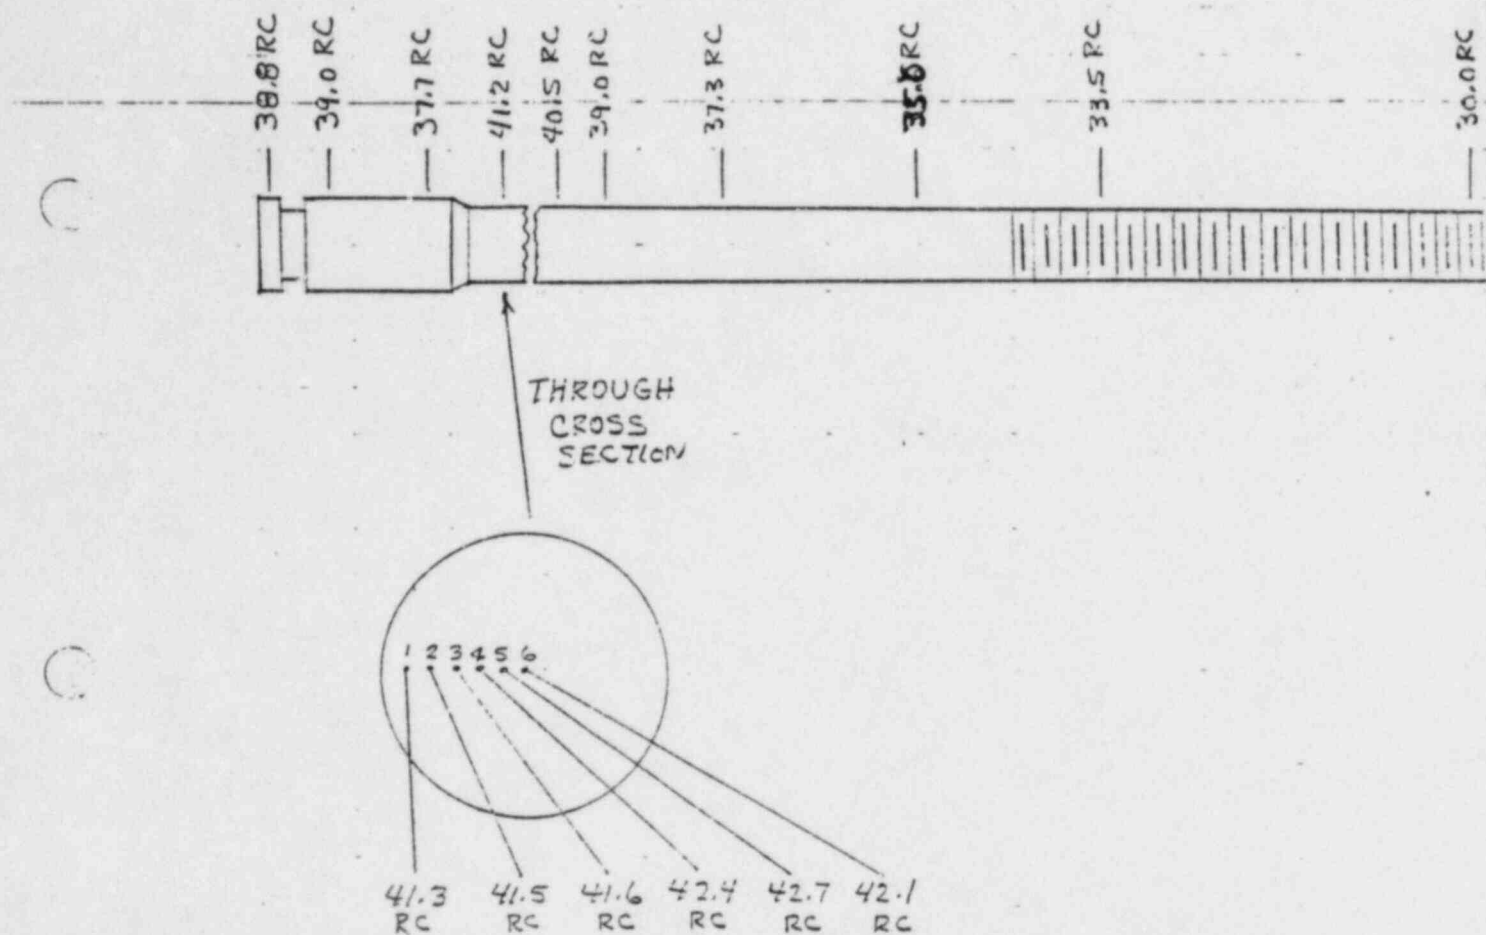
FIGURE 11. HARDNESS MEASUREMENTS ON F010 SHAFT SHOWING HARDNESS GRADIENTS. ALL HARDNESS MEASUREMENTS TAKEN WITH EQUOTIP TESTER AND CONVERTED TO RC

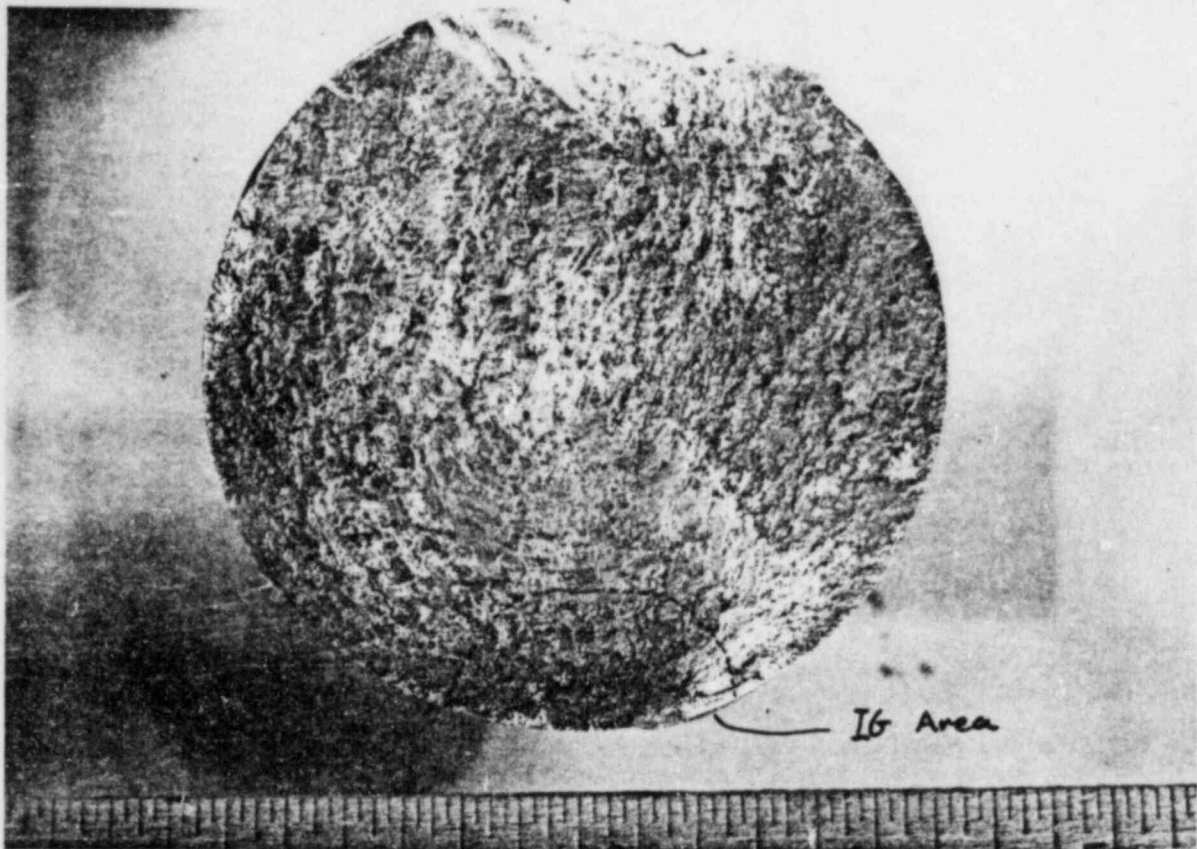
The main fracture severing the valve stem was initiated intergranularly (IG) and then rapidly propagated by brittle fracture, Figure 12 through 14. Longitudinal cracks were also found emanating from the main fracture which were intergranular. There were also other cracks in the stem located at the bottom radius of the groove housing the split ring retainer, Figure 16 and 17. There are several notable attributes of this stem fracture and these cracks as follows:

Both fracture faces from the lower stub piece as well as the upper shaft were examined by scanning electron microscope (SEM). Both pieces were quite badly hammered but the upper one was in better shape and the origin of the crack was identified, Figure 12. A band of intergranular fracture was found approximately 30° in length and 1/2 inch in depth in from the circumference of the shaft. The balance of the fracture was cleavage indicating a rapid fracture, Figures 13 and 14.

FIGURE 12. MACRO PHOTO OF CRACK FACE SHOWING POINT OF ORIGIN OF INTERGRANULAR CRACKING

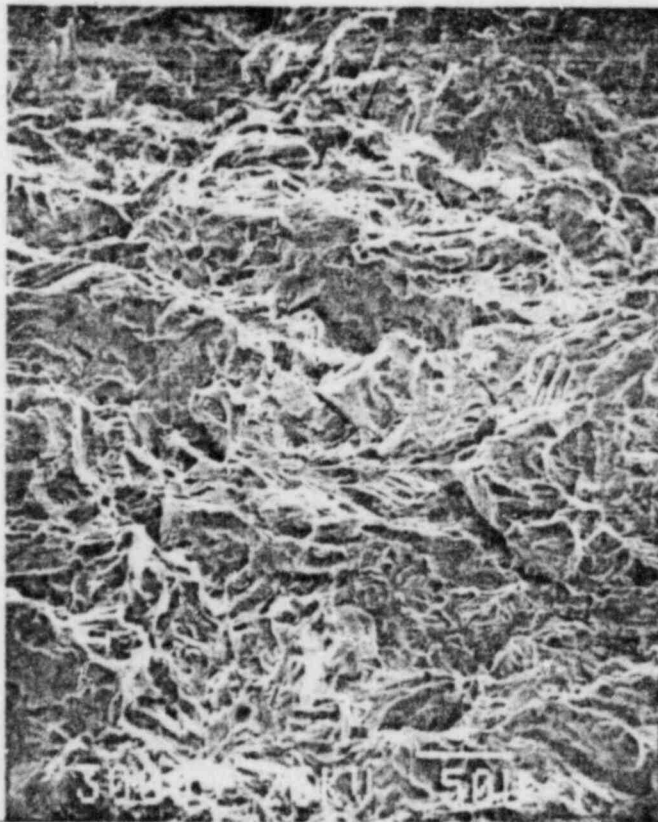
FIGURE 13. SEM PHOTO SHOWING CLEAVAGE FRACTURE TYPICAL OF AREA OUTSIDE IG AREA

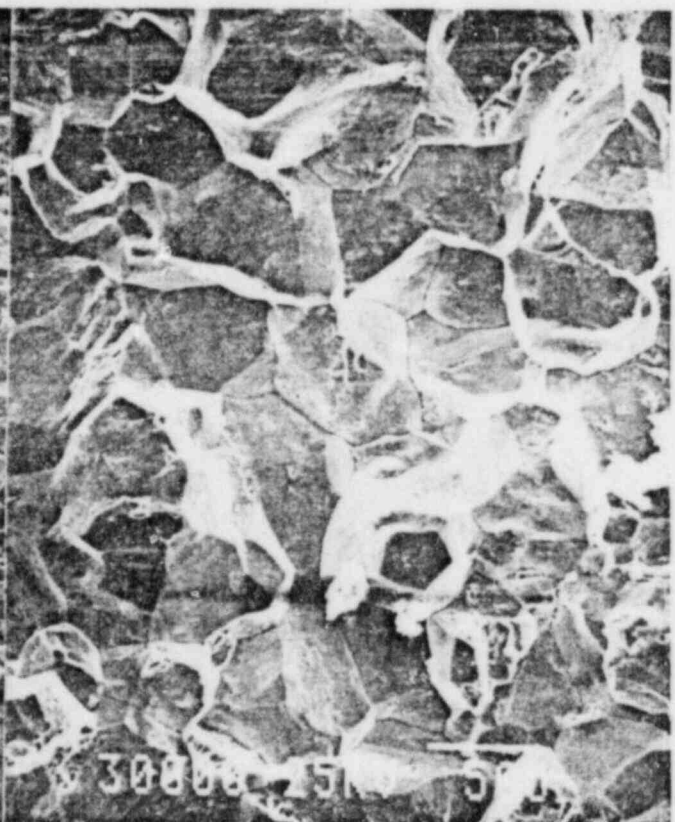
FIGURE 14. SEM PHOTO SHOWING TYPICAL FRACTURE IN IG AREA

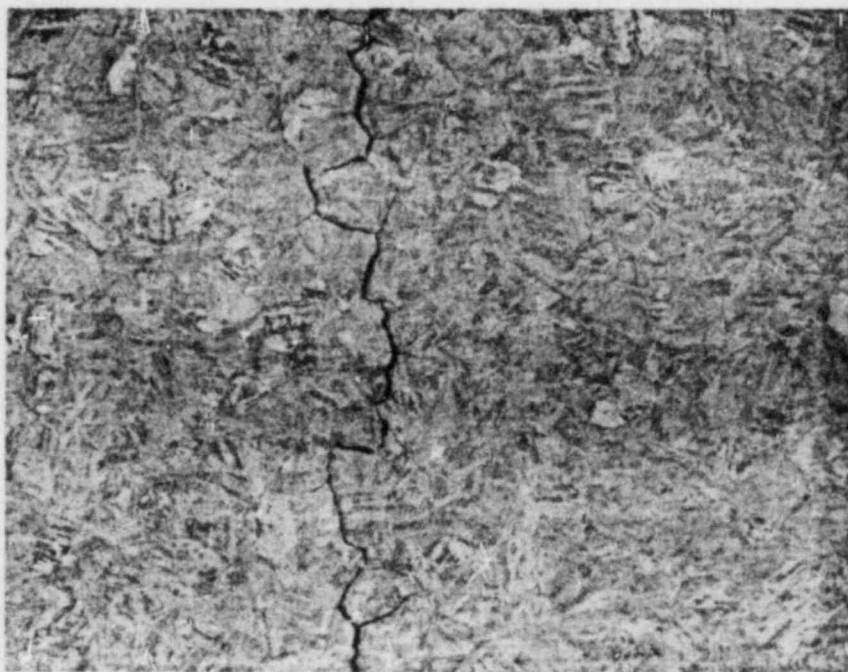
There were several short longitudinal cracks extending from the main fracture the longest of which was approximately 3/8 inch long. This crack was broken open and examined by SEM and it was found to be completely intergranular. Figure 15 shows metallography of one of the longitudinal cracks.

FIGURE 15. METALLOGRAPHY OF LONGITUDINAL CRACK COMING FROM MAIN FRACTURE. 100X, ETCHANT VILELLA'S REAGENT

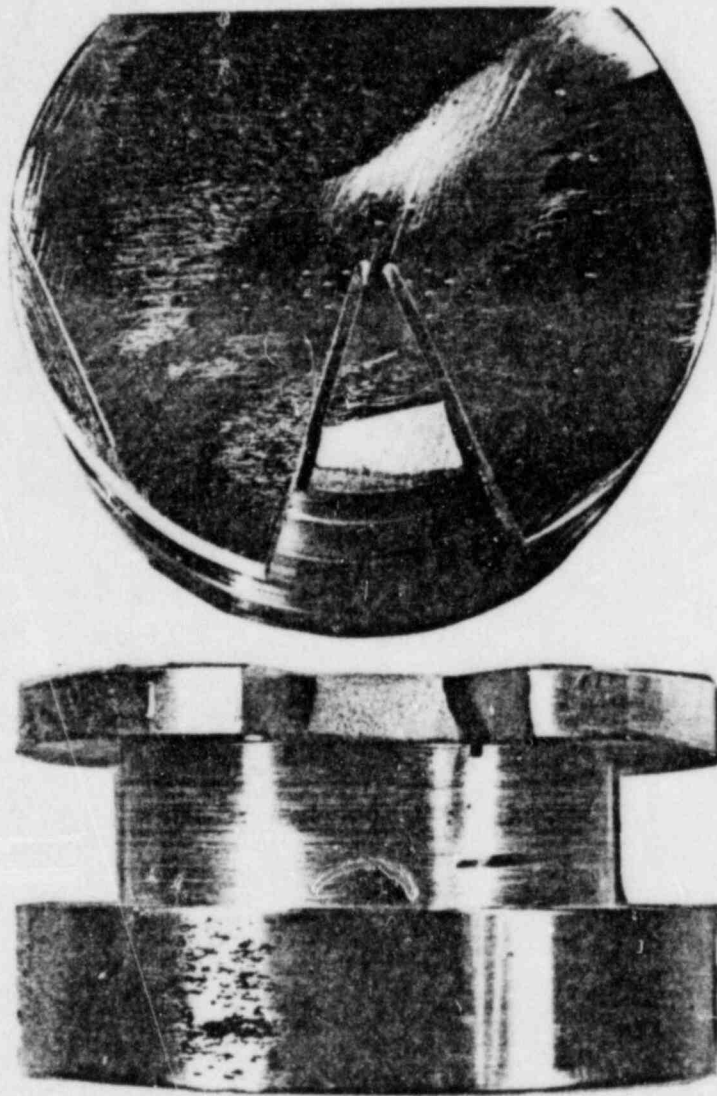
FIGURE 16. LOWER PORTION OF VALVE STEM WITH SECTION  
BROKEN AWAY SHOWING IG CRACK

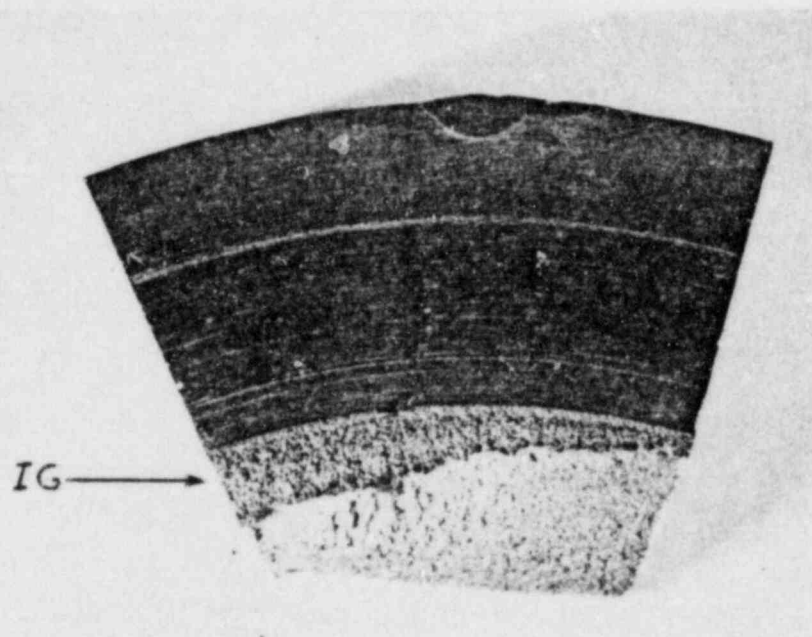
FIGURE 17. MACRO OF IG CRACK IN LOWER PORTION OF VALVE STEM, 3.4X
