SUBJECT: Calvert Cliffs Nuclear Power Plant  
Unit 2; Docket No. 50-318  
Report of Steam Generator Tube Plugging

ATTACHMENT: (1) Tubes Plugged #21/#22 Steam Generator  
(2) Tube Support Location Drawing

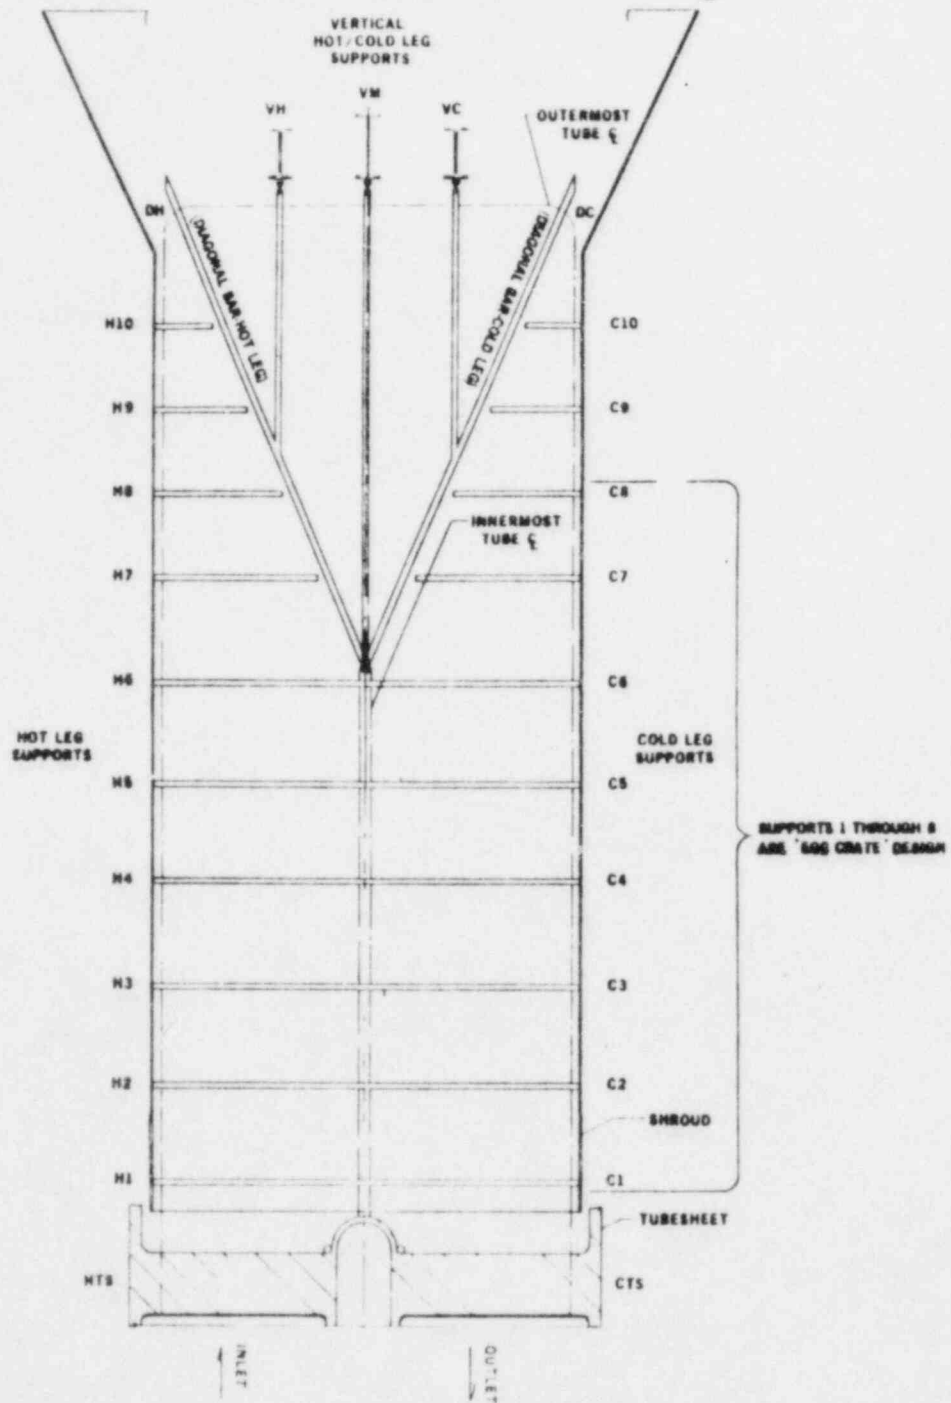
**Figure 1.1**  
**Steam Generator Drawing**

\*Reference Attachment (2) for support locations.

\* Reference Attachment (2) for support locations.
