## NONCONFORMANCE REPORT (NCR)

Wolf Creek 7158

15N12865F

TO: WENDELL FROST  
FROM: PAUL B. HALE  
DATE: DEC. 27, 1983  
SUBJECT: WOLF CREEK GENERATING STATION: QUALITY CONCERNS.

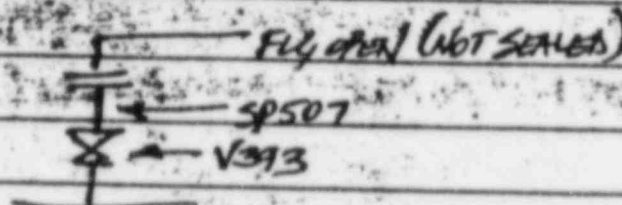
SURVEILLANCE REPORT NO. 104

DESCRIPTION OF DISCREPANCIES FOUND FLANGE CONNECTING TO SP507 NOT SEALED (OPEN TO CONTAMINANTS).

procedure violation  
write NCR  
Ref WP VII 201  
(RECAP REACH NIGHT)

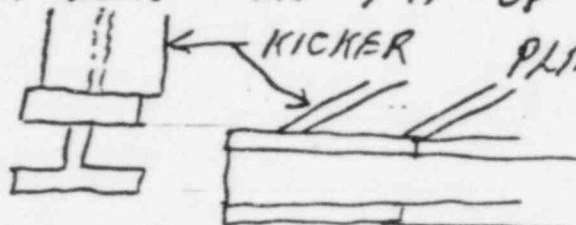
WOULD A  $\frac{1}{16}$ " OVERHANG ON A TV HANGER  
BE ACCEPTABLE ON FIT-UP OR FINAL INSPECTION  
PLEASE GIVE GUIDE LINES

Recommended maximum lateral deviations between  
centerline of web and centerline of flange of build up "Wor's"  
members at contact surface shall be  $\frac{1}{4}$  in. max. The fillet  
weld shall be full length of the contact surfaces.

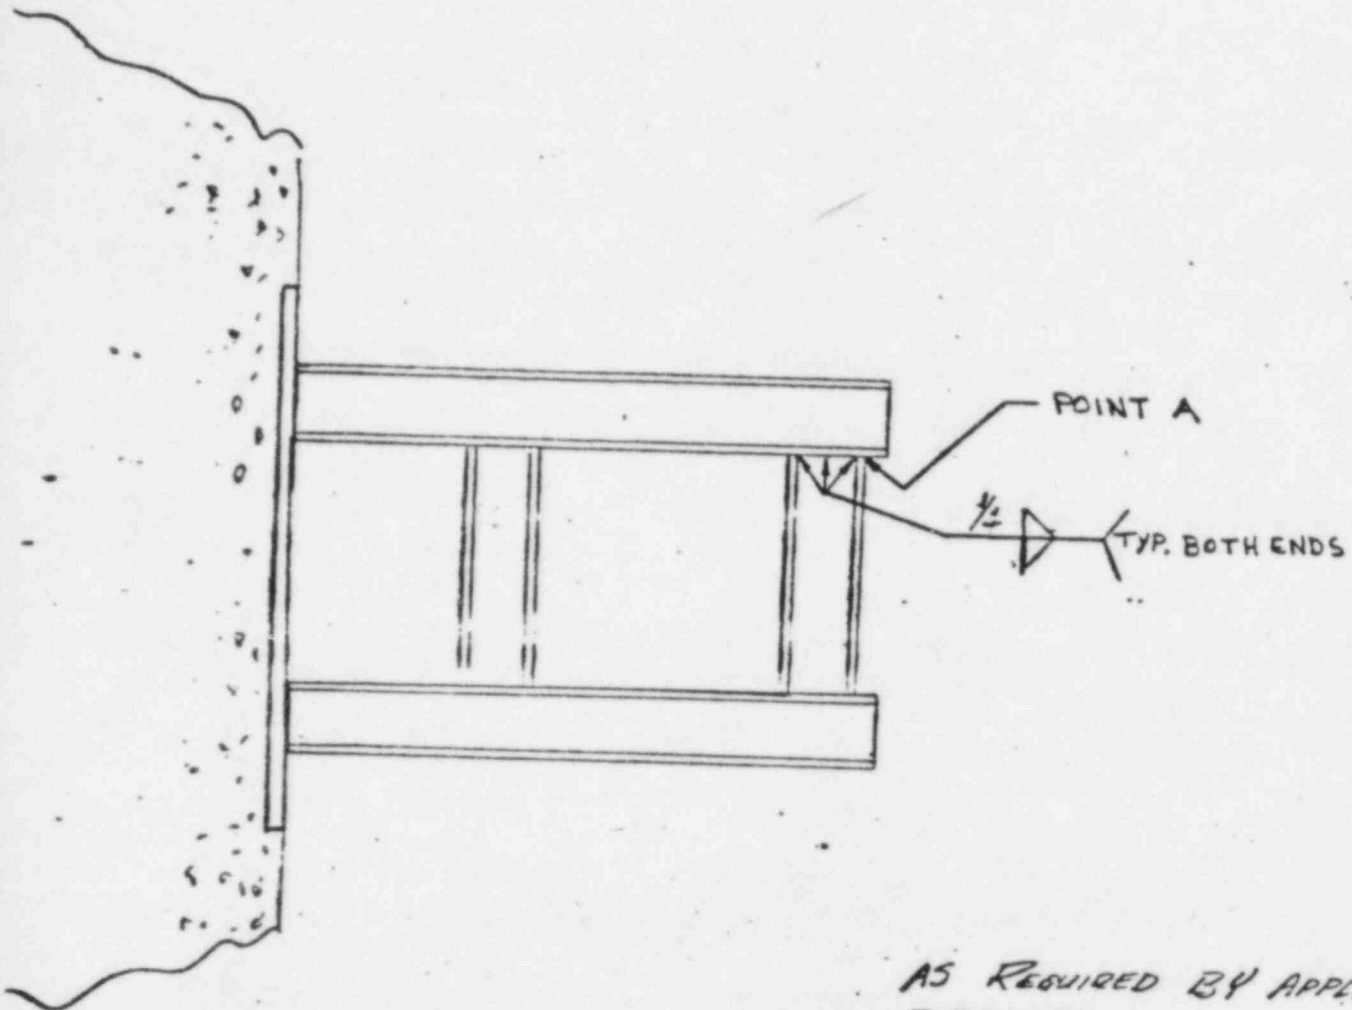
Governing drawings require a  $\frac{1}{2}$  inch fillet weld on the web and inside flanges of the vertical member to the outside flange of the horizontal member. (See attachment). Upon reinspection of this weld, a gap was noted at point A of  $\frac{1}{8}$  inch, which according to the assigned weld procedure (N-1-1-A-6A), should have increased the fillet size to  $\frac{3}{8}$  inch. The weld as applied is  $\frac{1}{2}$  inch.

AS REQUIRED BY APPLICABLE  
DRAWING.

$\frac{1}{8}$  INCH GAP AT POINT A.

I would recommend that CWP-504 be revised as soon as is practical to identify this type occurrence and the above solution to the problem.

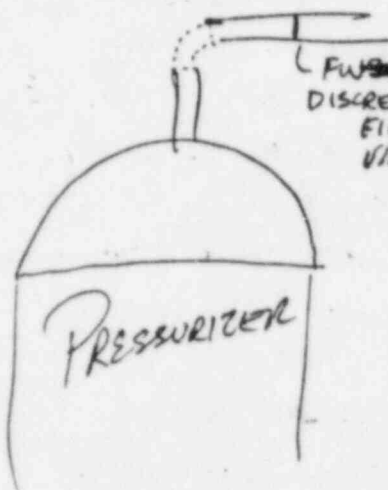
15N14769PW

I WAS CALLED TO DO A CLEANLINESS INSPECTION (INTERNAL AND EXTERNAL) IN THE PRESSURIZER ROOM. UPON LOOKING INSIDE HORIZONTAL RUN OF PIPE, THE VISUAL DEFECT WAS NOTED.

FW-512  
DISCREPANT WELD: EXC. PENETRATION UNCONSUMED FILLER, MELTHROUGH, BORNTHROUGH. DEFECT VISUALLY.
