NORTHEAST UTILITIES

October 7, 1985

Docket No. 50-423
F0865A

Millstone Nuclear Power Station, Unit No. 3
Reporting of Potential Significant Deficiencies
In Accordance with 10CFR 50.55(e):
Diesel Generator Brush Rigging Failure (SD-88)

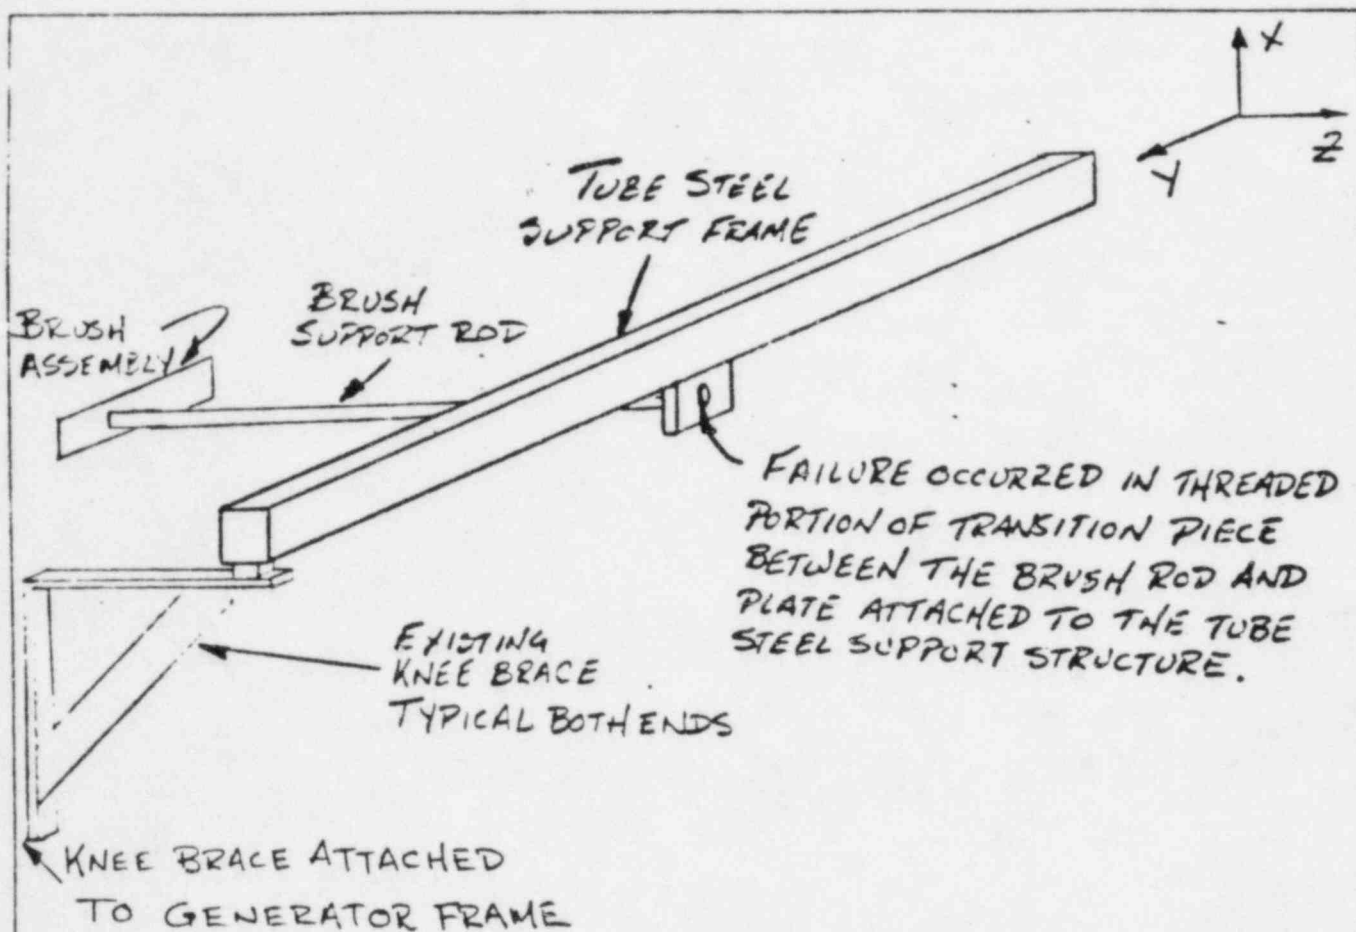
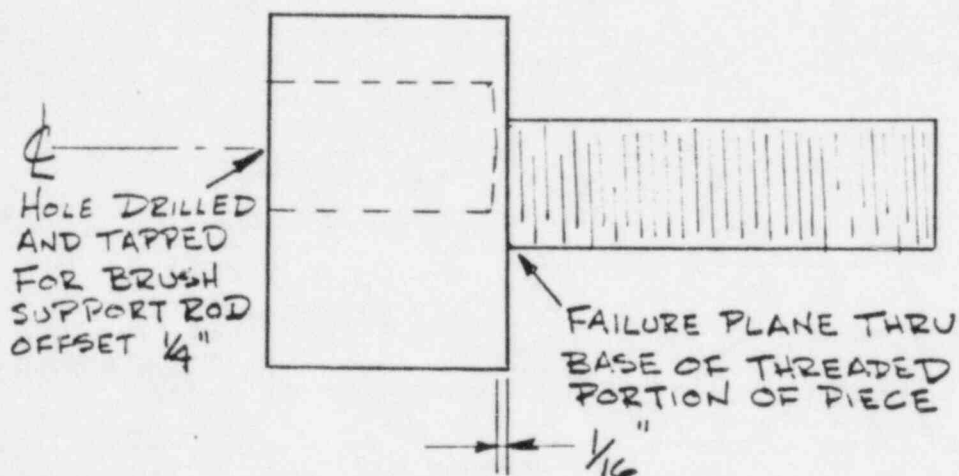
FIGURE 1 (SD-88)

In a September 5, 1985 telephone conversation between your Mr. T. Rebelowski and our Mr. P. J. Quinlan, Northeast Nuclear Energy Company (NNECO) reported a potential significant deficiency in the construction of Millstone Unit No. 3 in accordance with 10CFR 50.55(e). The potential significant deficiency involved the failure of the brush rigging on the "B" diesel generator during startup testing. The failure occurred on the transition piece which connects the brush support to the structure connected to the generator frame (see Figure 1).

An engineering evaluation determined that the failure was due to a design/fabrication error which allowed the hole for the brush rod to be drilled too deep leaving only 1/16 inch of material between the bottom of the hole and the opposing face of the piece. The lack of reinforcement material resulted in a high stress concentration which caused a fatigue failure in the transition piece when exposed to low vibration levels. Although vibration data was not available for the assembly before failure, vibration levels on the "A" diesel generator and the "B" diesel generator using an identical replacement part were relatively low such that a failure would not be expected if the piece had adequate reinforcement material between the bottom of the hole and the opposing face.

If this failure had occurred when the diesel generator was performing its intended safety function, an unacceptable plant condition may have developed. Therefore, we consider this to be a significant deficiency in the final construction of Millstone Unit No. 3 in accordance with 10CFR 50.55(e).

Subsequent to this evaluation, a one piece support rod was designed and installed on both diesels. The new design eliminates the stress concentration effect and utilizes a high strength carbon steel material with favorable ductility characteristics.
