UNITED STATES  
NUCLEAR REGULATORY COMMISSION  
WASHINGTON, D. C. 20555

SUBJECT: FINAL CASE STUDY REPORT - OVERPRESSURIZATION OF EMERGENCY  
CORE COOLING SYSTEMS IN BOILING WATER REACTORS

A generic review and evaluation of operational events involving actual and potential overpressurization of emergency core cooling systems in boiling water reactors has been conducted. Eight events, each entailing the failure of a testable isolation check valve on the injection line of an emergency core cooling system, were identified and evaluated. Five of the eight events involved an additional failure of the second and final isolation barrier--the inadvertent opening of a normally closed motor-operated injection valve. Four of these five events occurred during power operation, thus leading to an actual overpressurization of an emergency core cooling system. Each of these operational events is considered a precursor to an interfacing loss-of-coolant accident between the reactor coolant system and an emergency core cooling system. Such an accident would involve the sudden discharge of reactor coolant at operating pressure and temperature outside the primary containment and would also likely disa

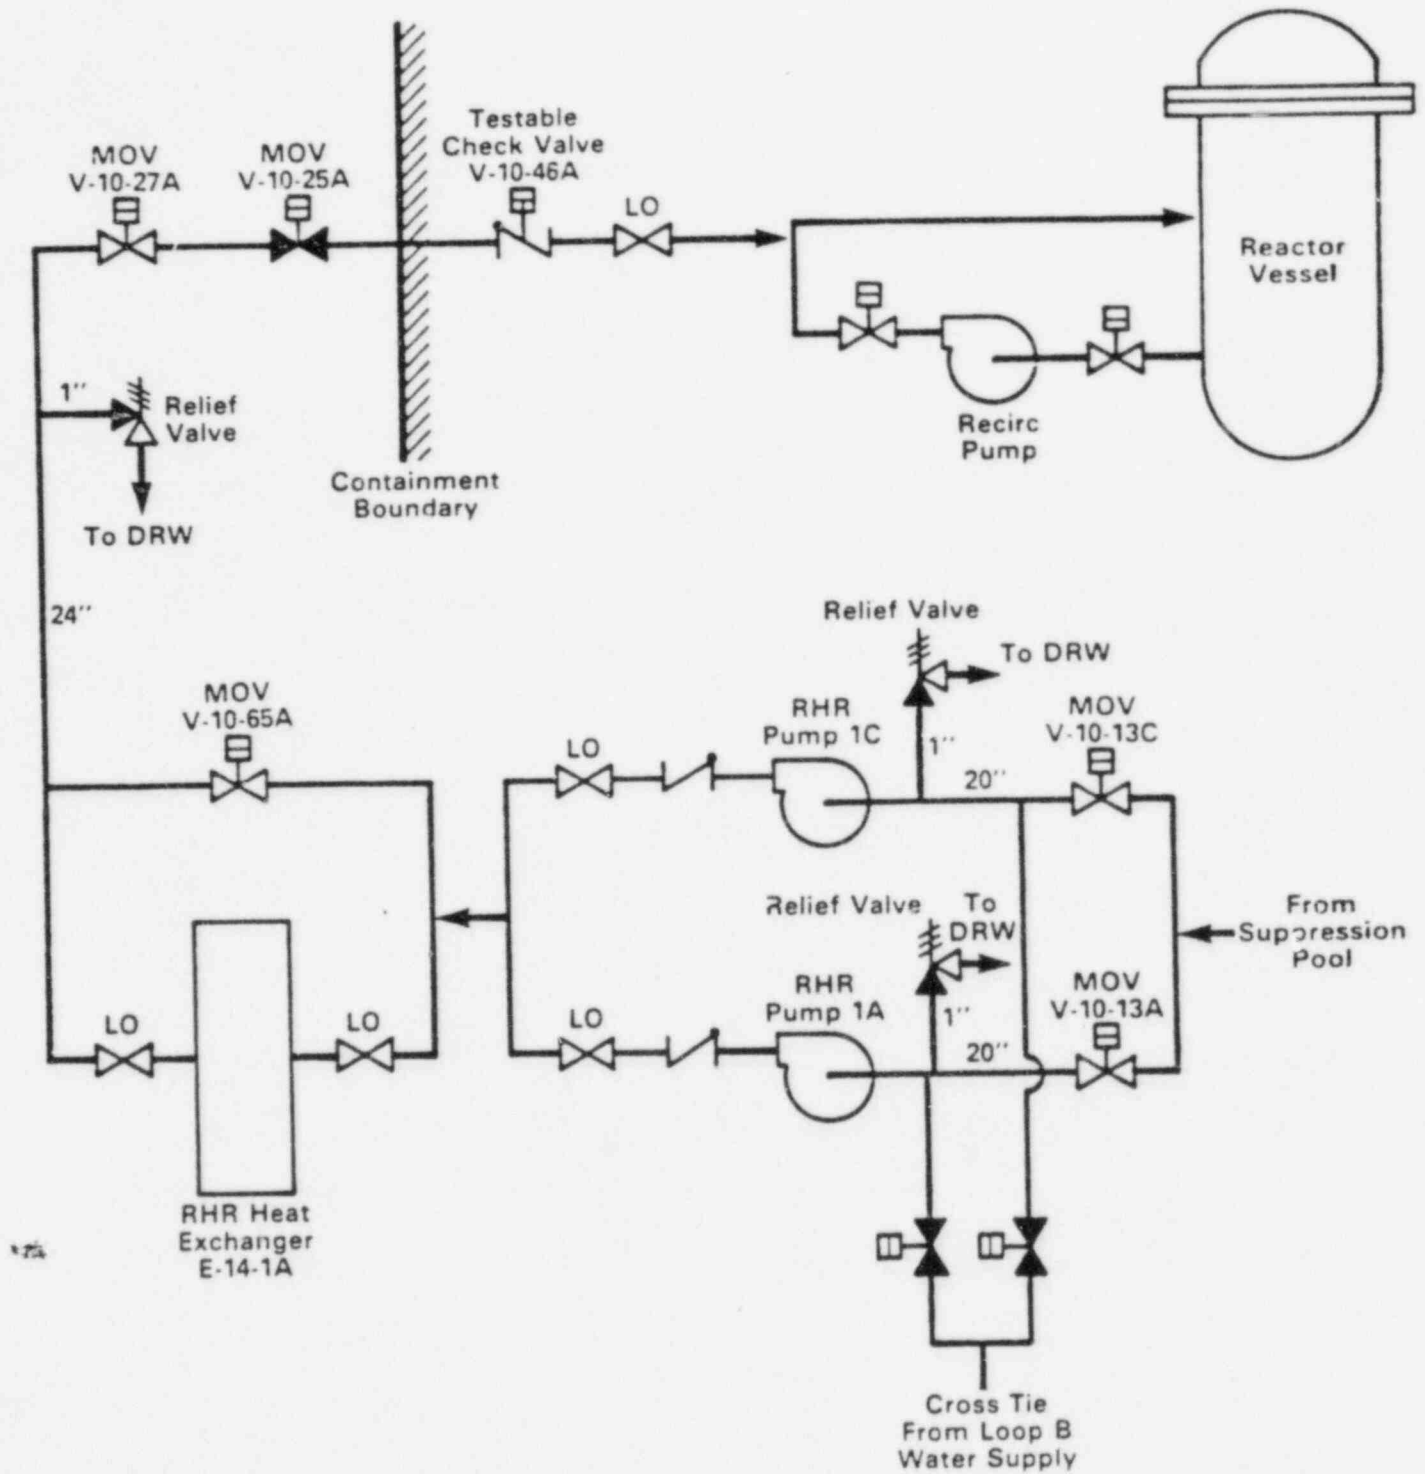
Figure 2 Simplified Flow Diagram for Division A of LPCI/RHR at Vermont Yankee

On December 12, 1975, with the plant at 99% power, monthly operability surveillance testing was being conducted on Loop "A" LPCI injection valve V-10-25A (see Fig. 2). Initially, injection valve V-10-25A failed to respond to an open signal from its remote control switch. To determine if the motor-operated valve failure was caused by excessive differential pressure across the valve disk or a specific mechanical or electrical malfunction, plant personnel first manually cracked open V-10-25A. Then the valve was successfully cycled fully open and closed. During this time, and unknown to the plant personnel, testable isolation check valve V-10-46A downstream of the injection valve was not seating properly, and the supposedly closed motor-operated valve (V-10-27A) upstream of the injection valve was partially open. With a partially open flow path between the RCS and RHR system unknowingly established, RCS water at operating pressure and temperature flowed into the low-pressure LPCI Loop "A" system piping, pressurizing it in excess of its design pressure. High pressure in the line caused a mixture of steam and water to be discharged from each of the three RHR system relief valves and the RHR heat exchanger tube sheet-to-shell flange area. The gasket in the tube sheet-to-shell flange area began leaking as a result of the elevated pressure conditions.

The exact cause for the testable isolation check valve not seating properly was not reported at the time of the event in 1975. The upstream injection valve (V-10-27A) had been closed from the control room prior to opening V-10-25A as part of the surveillance test sequence, but had failed to fully shut. The partial opening of the motor-operated valve also was not known by plant personnel at the time of the event due to a false closed position indication. The exact causes for the faulty position indication also were not reported at the time of the event. Following successful pressure and operability testing of the subsystems involved in the overpressurization event, the subsystems were declared operable.

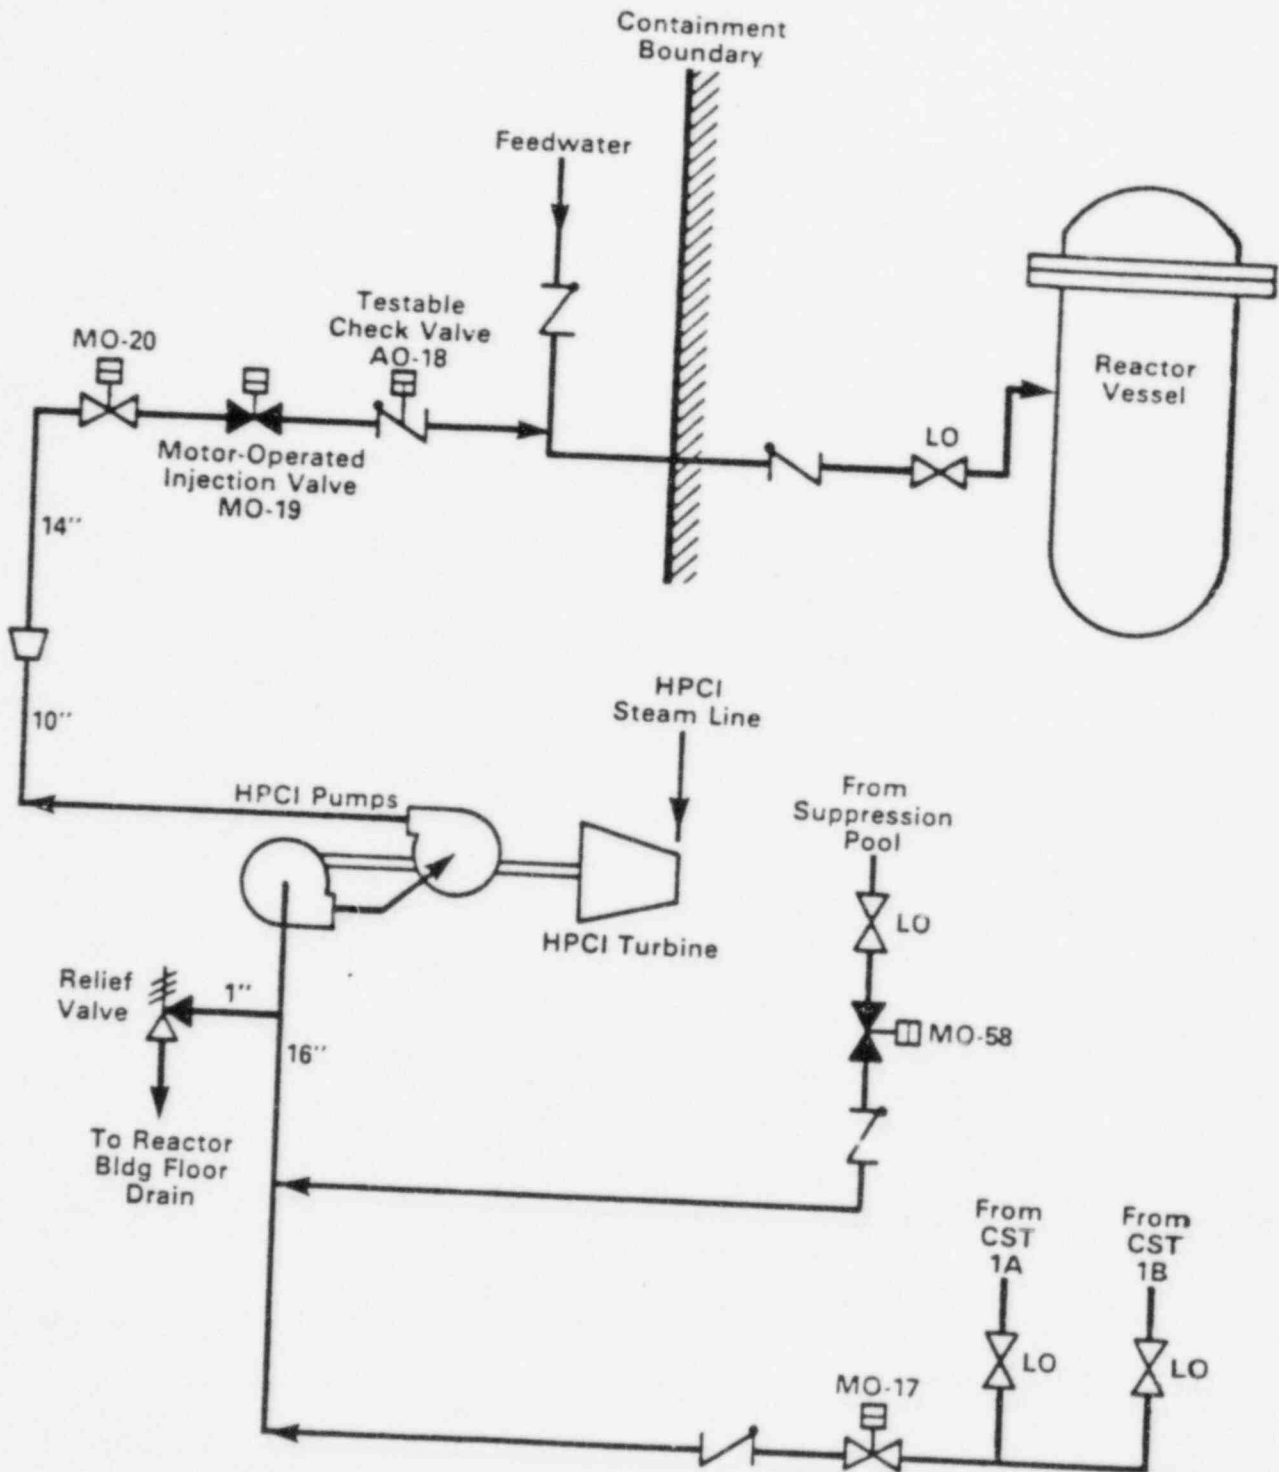
Figure 3 Simplified Flow Diagram for the High Pressure Coolant Injection System at Cooper

The licensee determined that the HPCI testable check valve (AO-18), downstream of the injection valve, had been stuck open during the test allowing feedwater to backflow into the system when the injection valve was cycled open. The testable isolation check valve was disassembled following shutdown of the reactor about two weeks later and, was found to be blocked open by a 14-1/2-inch long sample probe which had wedged under the edge of the valve disk. This prevented the check valve from fully closing. It was determined that the broken probe had come from a sample point on a 24-inch feedwater line upstream of the HPCI injection line junction. The length of time that the check valve had been stuck open was not determined.

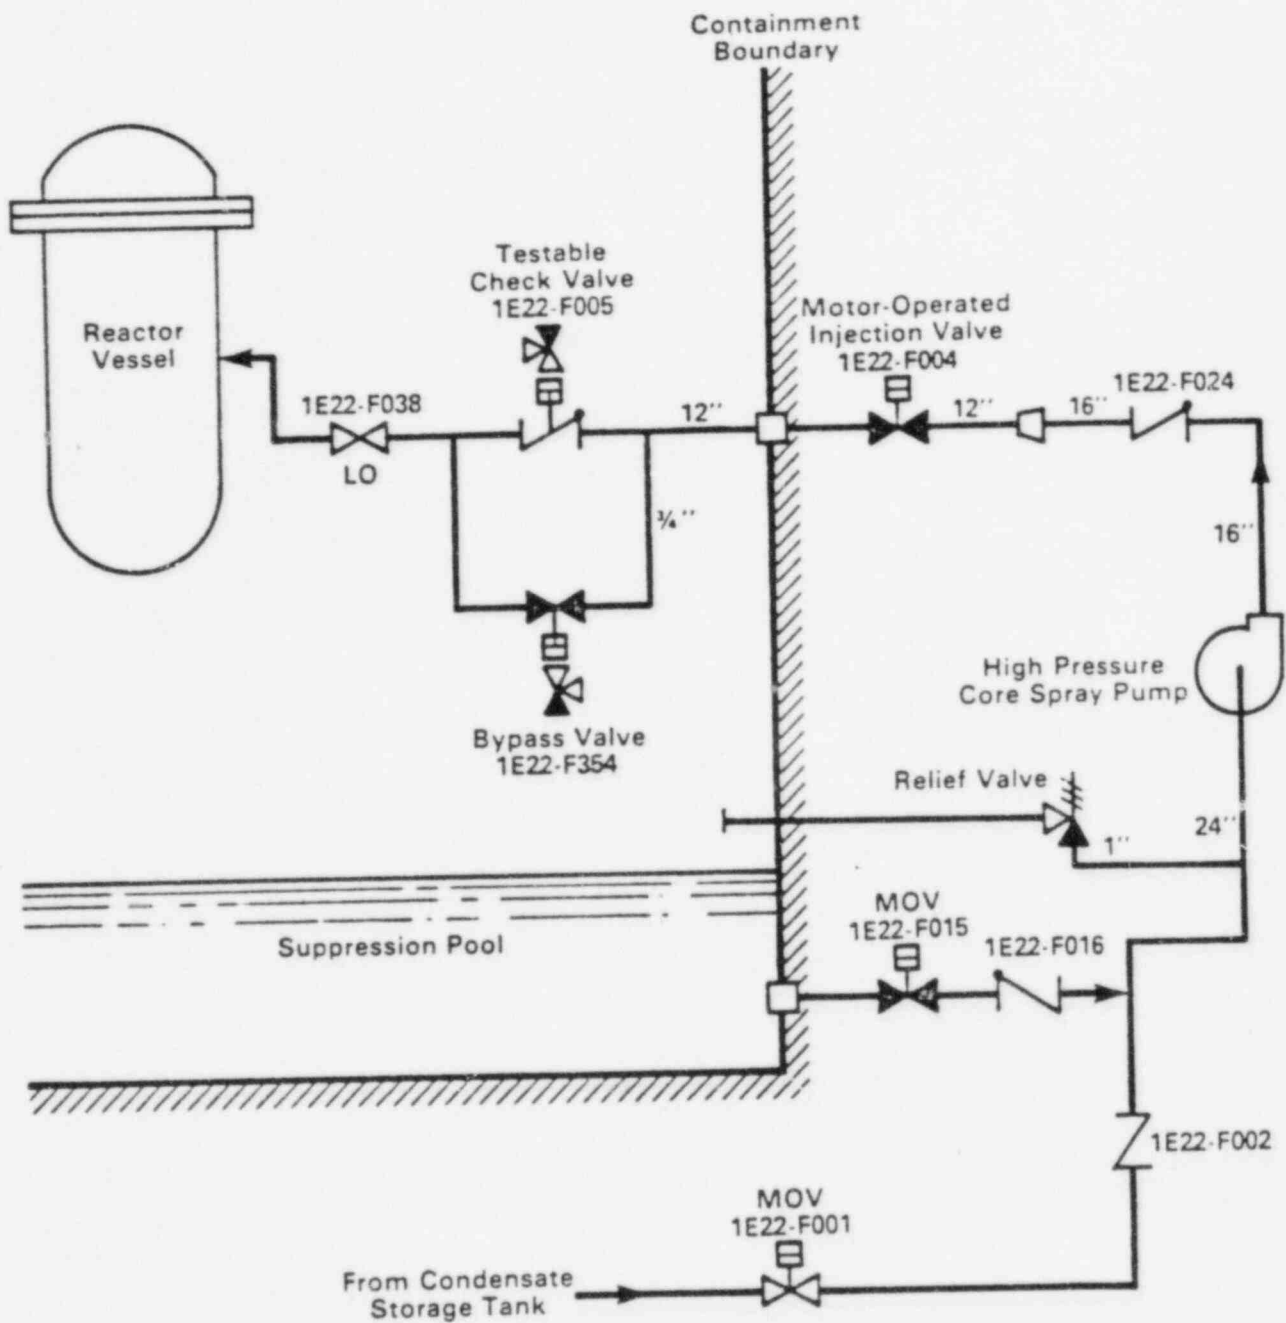
Figure 4 Simplified Flow Diagram for the High Pressure Core Spray System at LaSalle-1

On October 5, 1982, with the plant operating at 20% power, quarterly surveillance testing on the high pressure core spray system (HPCS) was being conducted. The testable isolation check valve 1E22-F005 and its associated bypass valve 1E22-F354 failed to indicate completely closed after they were opened for the test (see Fig. 4). Both the testable isolation check valve and its bypass valve are situated on the HPCS injection line inside primary containment. The HPCS system was declared inoperable. The motor-operated HPCS injection valve was closed and deactivated.

During the surveillance test, the check valve bypass valve 1E22-F354 was first opened to equalize the pressure on both sides of the testable check valve disk. The testable check valve was then tested open by operating a remote handswitch. This handswitch energized the actuator solenoid valve to allow instrument air to be supplied to one side of the piston cylinder of the valve's air operator, causing the piston cylinder to move a rack and gear assembly against spring tension. The rack and gear assembly movement rotated the actuator rod which lifted the valve disk off its seat. When the handswitch was returned to its

closed position, the solenoid valve was deenergized, cutting off instrument air to the piston cylinder. This should have allowed the spring (tension) to return the rack and gear assembly to its normal position. This, in turn, should have rotated the actuator rod back to its original position, allowing the valve disk to reclose by its own weight and differential pressure. However, the disk did not completely reseal.

The failure of testable check valve 1E22-F005 to reclose was investigated by the licensee. It was determined that the failure was caused by: (1) dried lubricant on the actuator piston cylinder, (2) insufficient preload on the actuator spring assembly, and (3) the stuck open testable check valve bypass valve 1E22-F354. Together, these problems prevented the piston cylinder of the check valve air operator from returning to its fully retracted position.

On June 17, 1983, with the plant at 48% power and quarterly surveillance testing of the HPCS system in progress, HPCS testable isolation check valve 1E22-F005 and its associated bypass valve 1E22-F354 failed to indicate closed after being tested open. The HPCS system was declared inoperable and was isolated by deactivating the normally closed motor-operated HPCS injection valve 1E22-F004.

The licensee determined that the failure of the testable isolation check valve to reclose was caused by: (1) a stuck open bypass valve 1E22-F354, which prevented a pressure differential from developing across the valve disk of the testable check valve; and (2) possible thermal binding of the check valve disk. With respect to the latter cause, the licensee indicated that the Anchor Darling check valve and bypass valve have a tendency if tested hot to remain partially open after being cycled. The failure of the bypass valve to reclose was traced to insufficient return spring tension in the bypass valve. While shutting down the plant, both the bypass valve and the testable check valve closed without any assistance as reactor pressure and temperature decreased. Following an analysis of the event, the licensee submitted a request to the NRC to conduct surveillance testing of testable check valve 1E22-F005 only during cold shutdown.

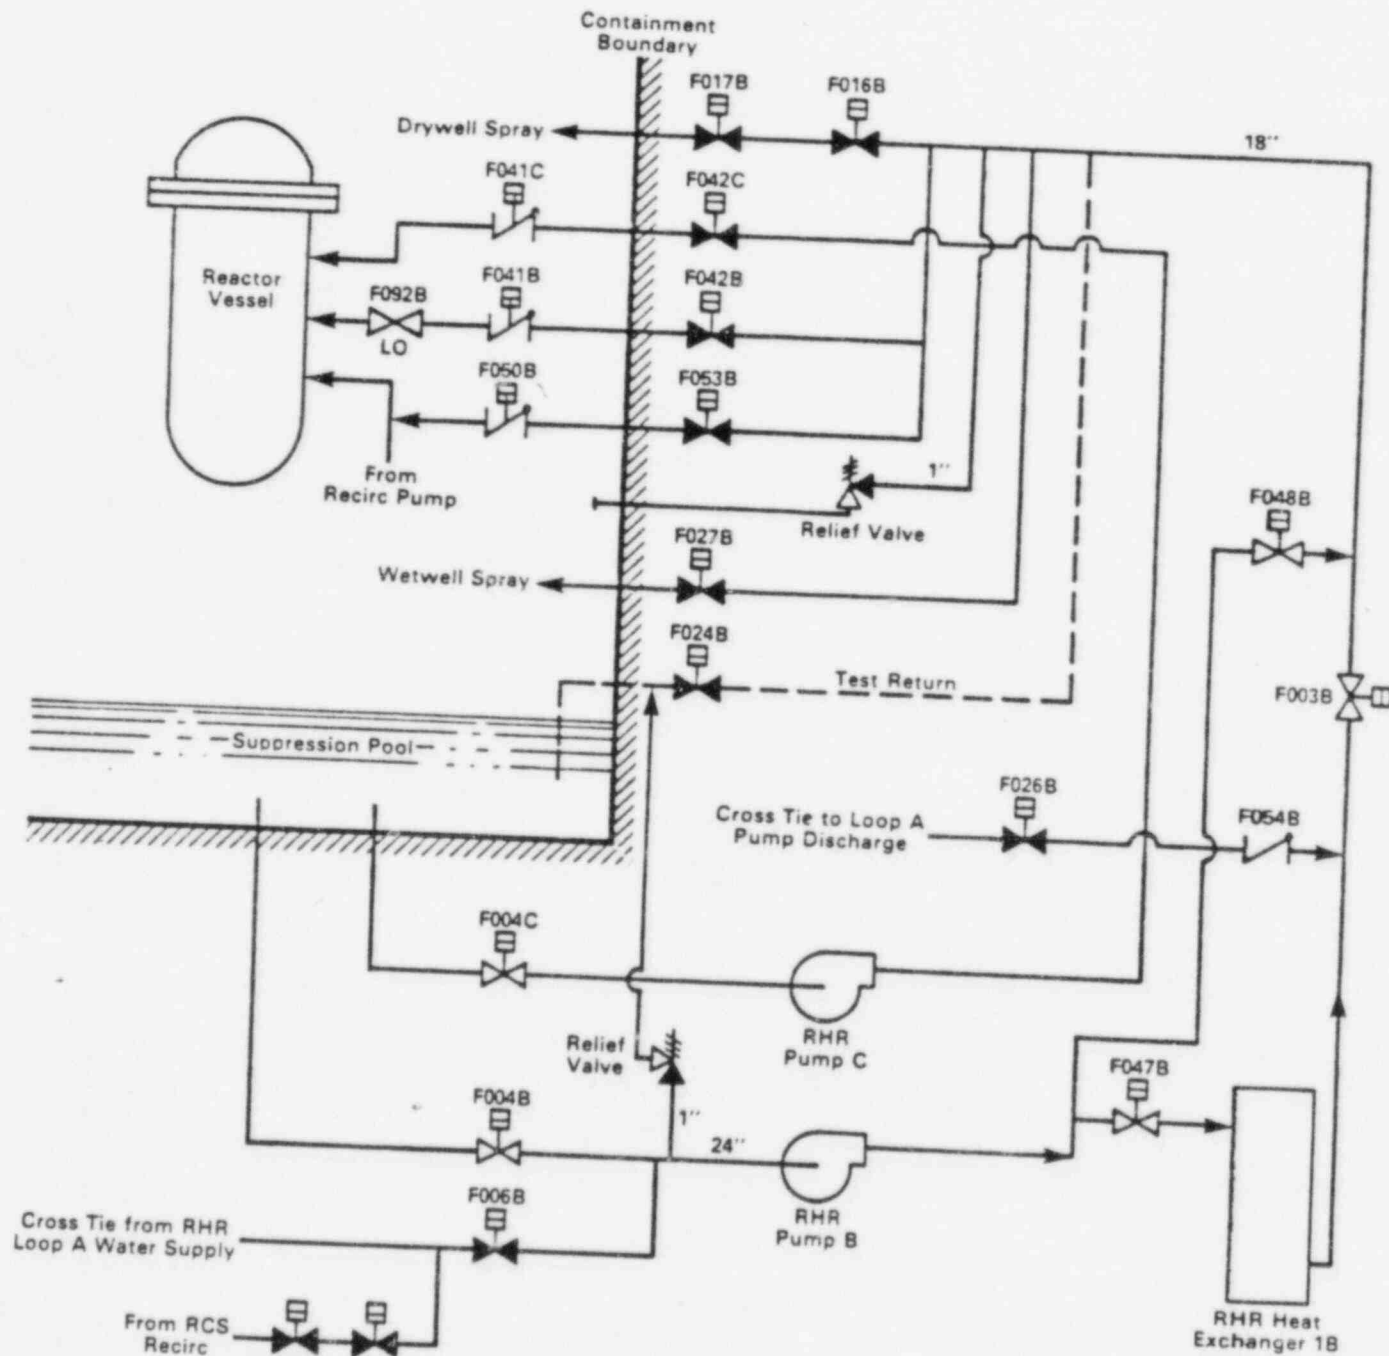
Figure 5 Simplified Flow Diagram for Loops B and C of LPCI/RHR at LaSalle-1

On September 14, 1983, the plant staff was in the process of performing a routine RHR system relay logic surveillance test while the plant was in cold shutdown. At the time of the test, the "B" RHR loop was lined up with both drywell spray valves 1E12-F016B and 1E12-F017B open, the suppression pool spray valve 1E12-F027B open, the test return to the suppression pool valve 1E12-F024B open, the manual valve 1E12-F092B on the LPCI loop "B" inadvertently open, and the "C" RHR loop injection valve 1E12-F042C open (see Fig. 5). Unaware that the LPCI loop "B" testable isolation check valve 1E12-F041B was also stuck open, the plant staff opened (as required by the test precheck) the "B" RHR loop injection valve 1E12-F042B. When the injection valve was opened, a rapid decrease in reactor vessel water level was observed. Water level dropped quickly from +50 inches to 0 inches, causing a Group VI primary containment isolation at +12.5 inches. Automatic containment isolation is not required to be operable while the plant is in shutdown or refueling mode. The operator quickly secured the valve line-up, stopping the water level decrease. Most of

the water lost from the reactor vessel went to the suppression pool, while some went to the drywell.

The cause of the draindown was determined to be the stuck open testable isolation check valve 1E12-F041B and the inadvertently open manual isolation valve 1E12-F092B on the loop "B" LPCI injection line. Thus, when the injection valve was opened during the test, an open flow path between the reactor vessel and the suppression pool and drywell was established which allowed backflow of reactor water into the drywell and wetwell. The isolation check valve also provides the first isolation barrier between the high-pressure RCS and the low-pressure RHR system when the plant is operating at power.

The manual valve 1E12-F092B should have been closed but was inadvertently left open due to a temporary procedure change implemented prior to the logic surveillance test. The testable isolation check valve was stuck open due to two causes. First, it was held open by its attached air operator as a result of a misalignment of the interfacing gears between the check valve and the air operator. The misalignment resulted from maintenance errors on the air operator that were made earlier in the outage. During the maintenance, a score mark on the spline shaft of the check valve was used instead of a "timing" mark for aligning the gears. The gear misalignment resulted in the air operator holding the check valve disk in the open position and inhibiting disk movement in the closed direction during the draindown. Additionally, the packing gland on the check valve shaft was found to be too tight, inhibiting free movement of the valve disk. Finally, the valve position indications were reversed following the maintenance, which led the operator to believe that the check valve was closed when in fact it was open.

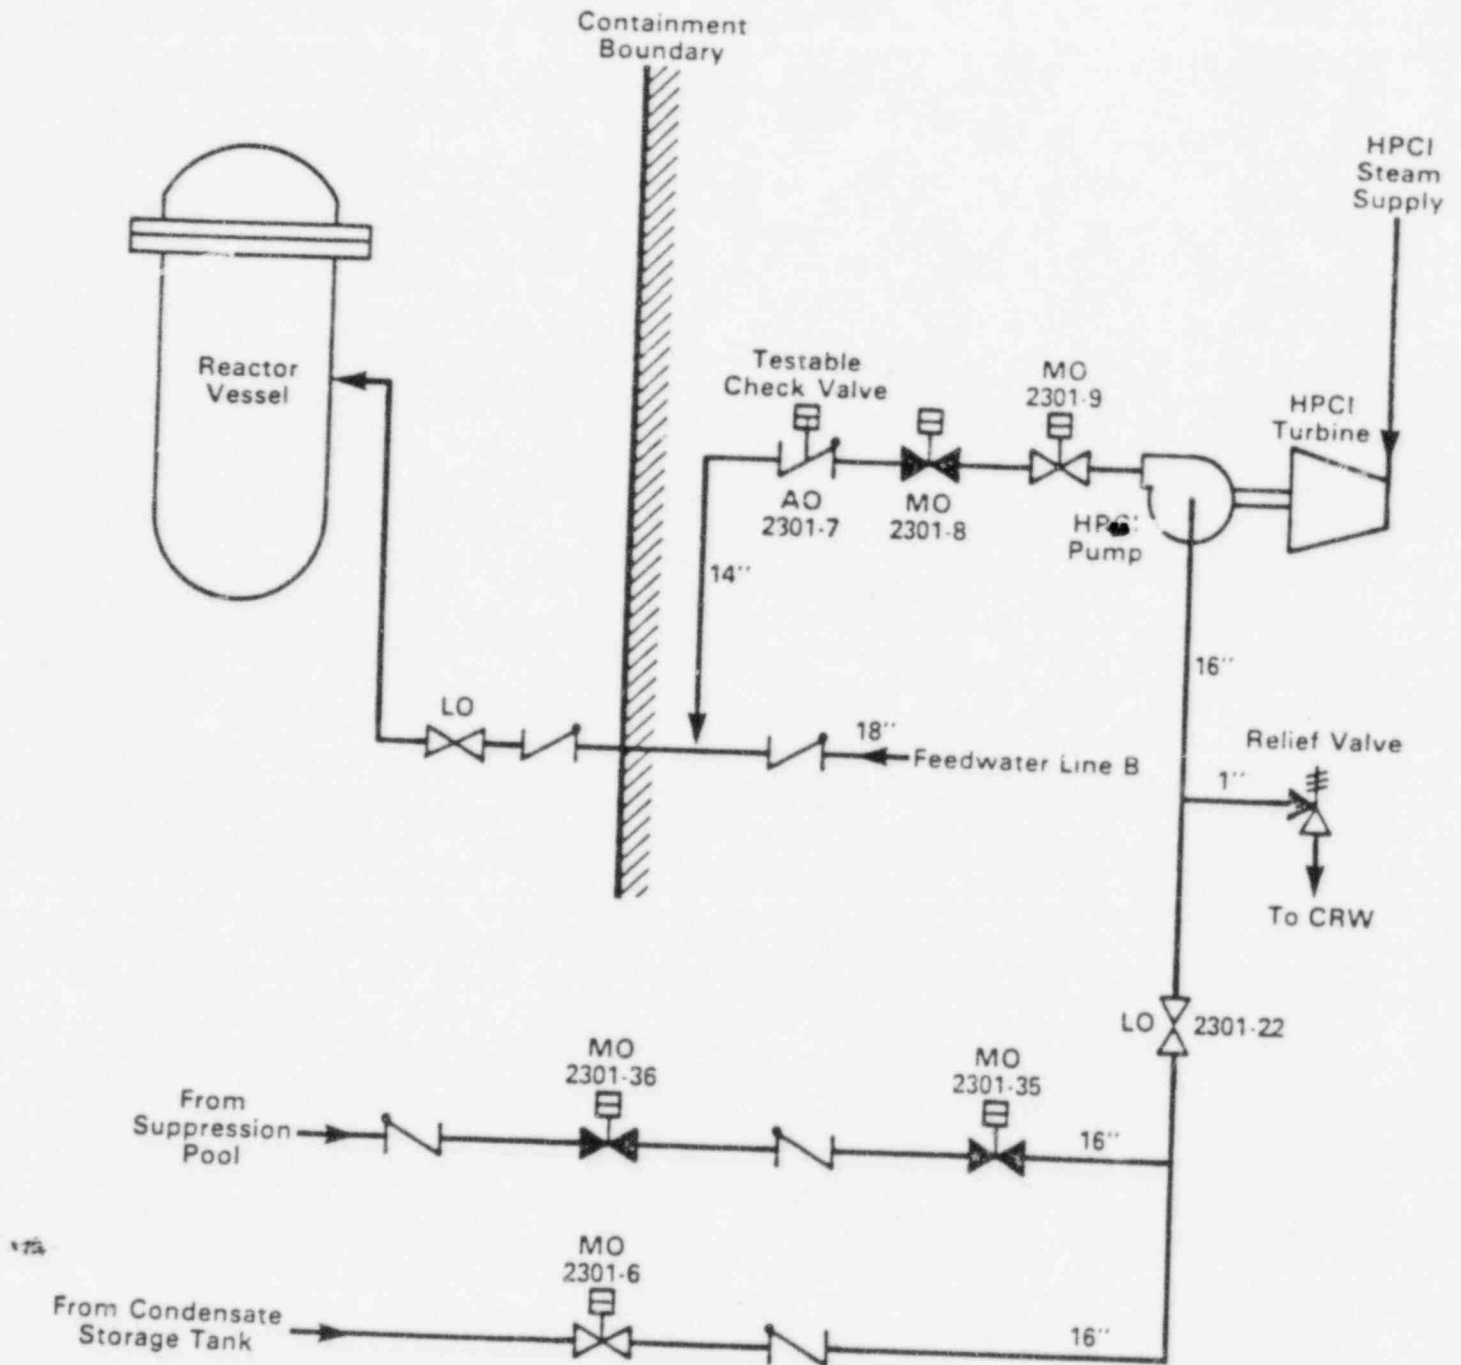
Figure 6 Simplified Flow Diagram for the High Pressure Coolant Injection System at Pilgrim

On September 29, 1983, during HPCI system logic testing while the plant was at 98% power, the low-pressure suction piping of the HPCI system was overpressurized to near operating reactor pressure. The event occurred when two HPCI pump discharge motor-operated valves, MO 2301-8 and MO 2301-9, were simultaneously opened as a result of personnel errors (see Fig. 6). The errors occurred because more than one surveillance test was being conducted at the same time, and test prerequisites and initial test conditions were not ensured for all steps in the test procedures. Since the testable isolation check valve (AO 2301-7) downstream of the discharge valves was partially stuck open at the time, the overpressurization occurred when the pump discharge valves were opened. The overpressurization of the suction piping (which is designed for 150 psi) ruptured the gland seal condenser gasket on the HPCI turbine. This in turn caused a mixture of water and steam to spray from the condenser onto a limit switch. The water spray resulted in a 250 V dc battery ground and a large amount of water on the HPCI room floor. Smoke detector alarms also were set off by vapor from the heated paint on the low-pressure piping. An HPCI high suction pressure alarm and lube oil high temperature alarm were also actuated during the event.

The exact cause for the testable check valve being partially open was not determined. There was some evidence that a rusted linkage between the valve stem and the attached air operator had contributed to the valve being partially open. In the short term, the licensee repaired the linkage and returned the valve to its correct position. The licensee decided to replace the check valve

with a new design as a long term solution. To prevent a recurrence of the personnel errors, instructions for verbal communications were to be implemented at the plant.

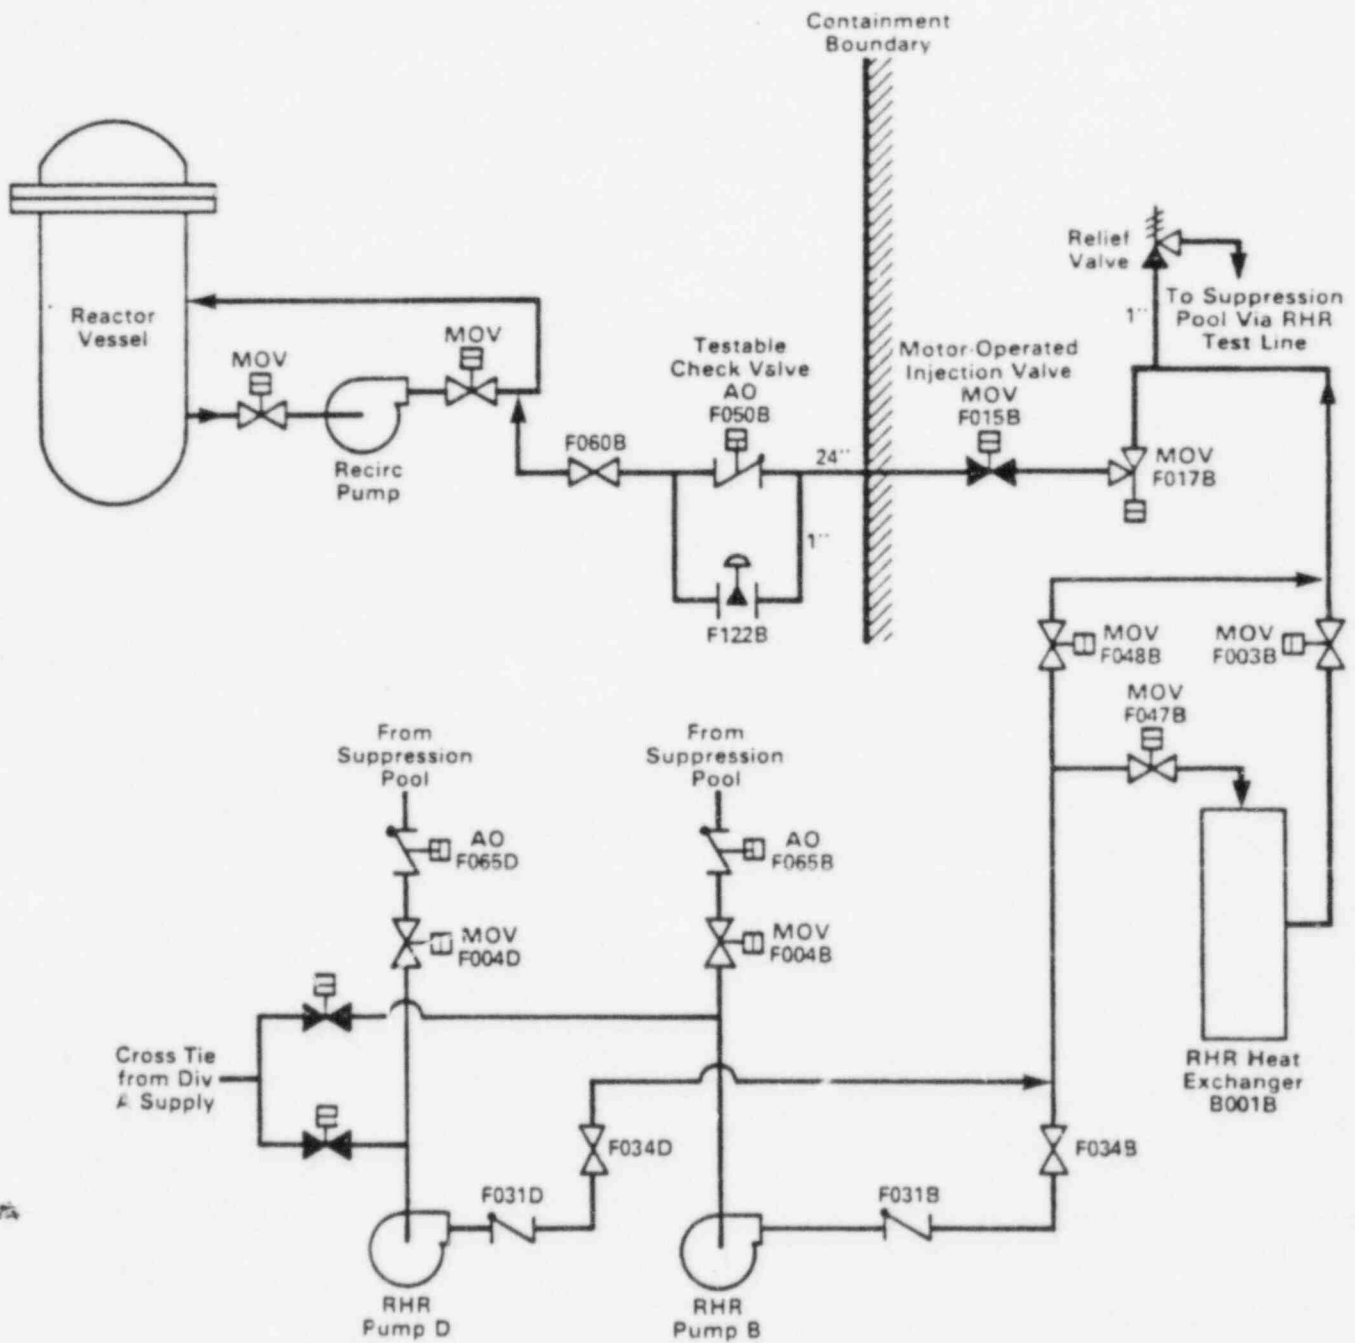
Figure 7 Simplified Flow Diagram for Division B of LPCI/RHR at Hatch-2

On October 28, 1983, with the plant in cold shutdown, the testable isolation check valve F050B on the 24-inch "B" LPCI injection line of the RHR system was found open and could not be closed (see Fig. 7). It was determined that the valve was being held open by its attached air operator. The licensee's investigation revealed that the air supply lines to the air operator had been connected backwards during a prior maintenance on the valve performed on June 7, 1983. The resultant pneumatic pressure reversal caused the air operator to hold the check valve open even though the check valve was not being tested. The mispositioned check valve was not detected for a four-month period, during which the plant operated at close to full power. The failure to detect the mispositioned valve was attributed to a second error involving the reversal of the electrical leads for the valve position indicator following the June 7, 1983 maintenance. This had apparently been done by plant personnel in the belief that the valve was actually closed. Inadequate post-maintenance testing also contributed to the error not being detected.

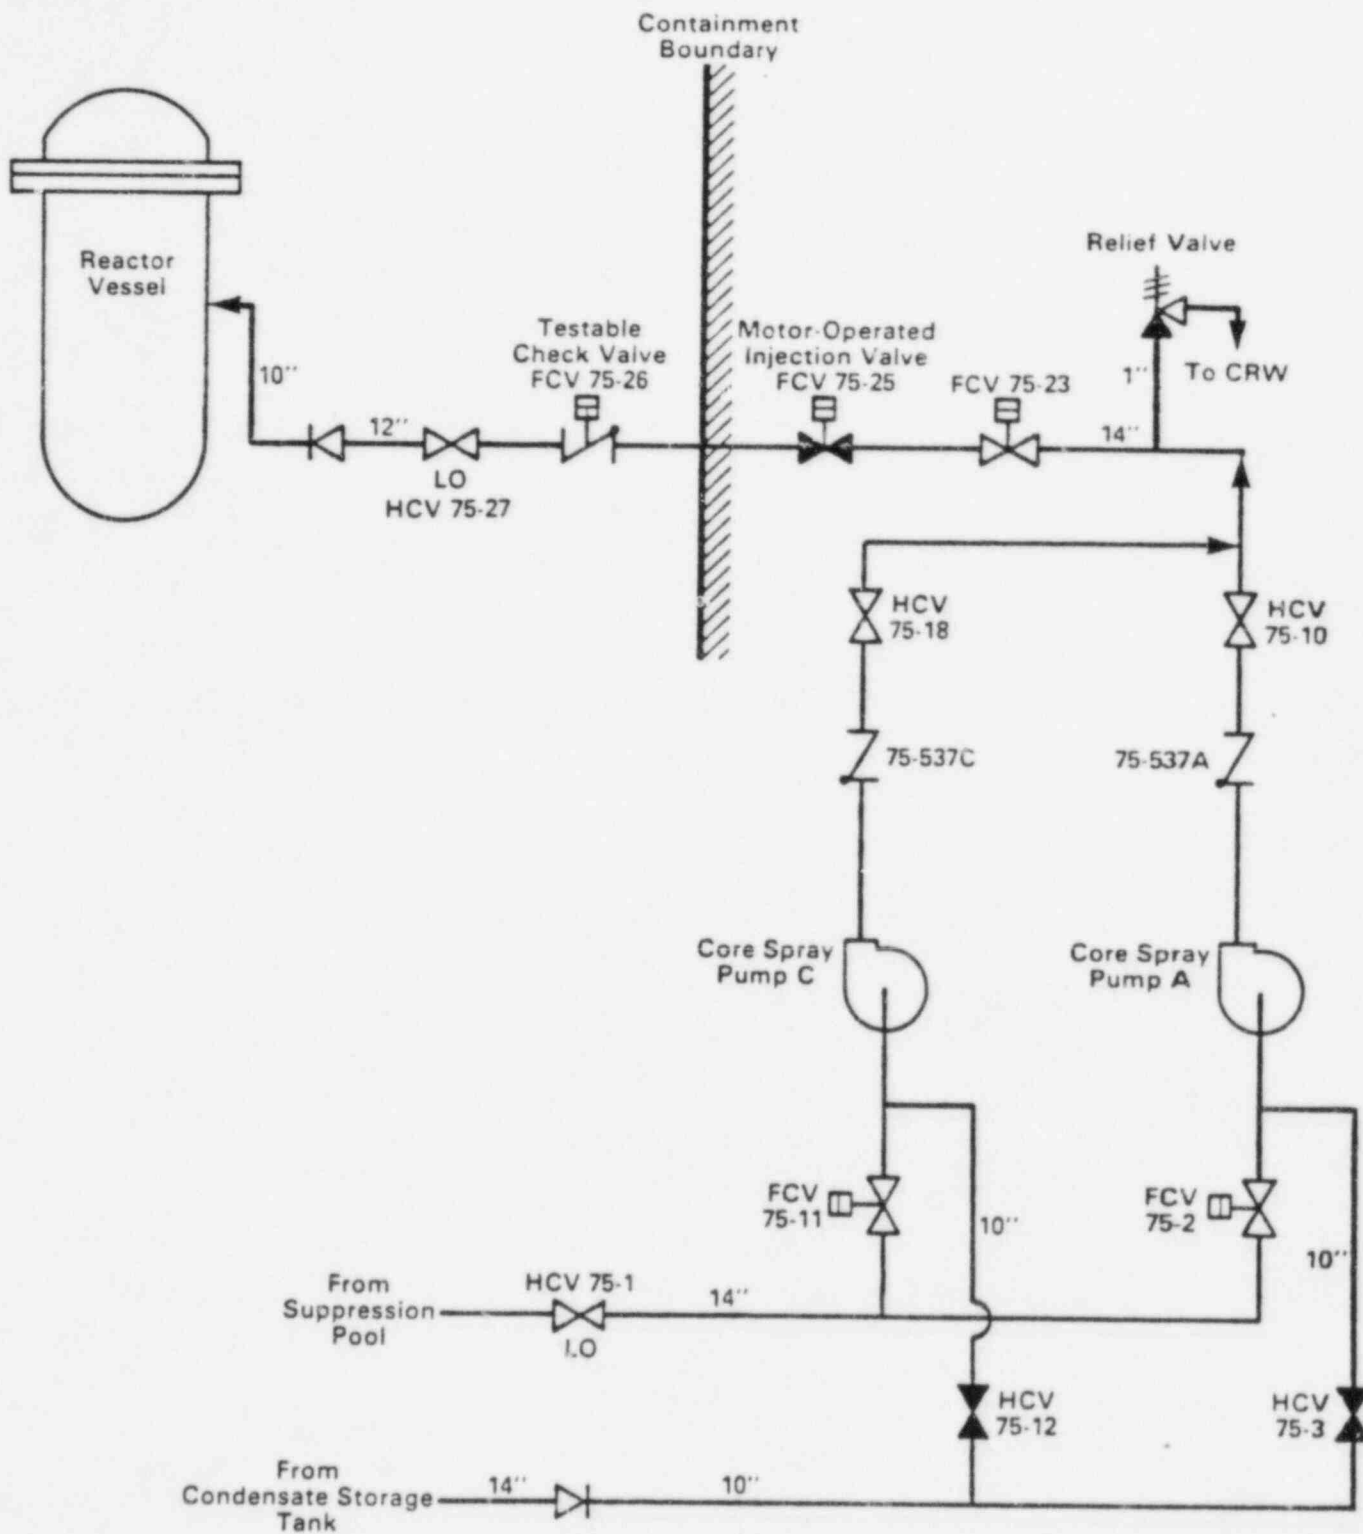
Figure 8 Simplified Flow Diagram for Core Spray System I at Browns Ferry-1

On August 14, 1984, while at 100% power and during the performance of a six-month surveillance test of the core spray system logic, the normally closed motor-operated injection valve (FCV 75-25) on core spray system I was inadvertently opened. When the valve opened, reactor coolant at operating pressure and temperature backflowed into the low-pressure core spray system, pressurizing the system piping close to full reactor pressure. The backflow also heated portions of the system piping to about 400°F. Paint on sections of piping was damaged by heat which also actuated a smoke detector. Steam from the relief valve on the core spray system, which opened to relieve the overpressurization, discharged into an open drain line. Steam escaping from the drain line was spotted by a roving fire patrol who initiated a fire alarm. A mixture of hot water and steam sprayed from the seals of pump "A" of core spray system I. Thirteen workers were contaminated by the sprayed water/steam mixture while responding to the fire alarm. The overpressurization, which lasted about 13 minutes, was terminated when plant personnel reclosed the

injection valve. A simplified flow diagram of the plant's core spray system I at the plant is given in Figure 8.

An investigation by the licensee following the event determined that the normally closed testable isolation check valve (FCV 75-26), downstream of the injection valve, had also been open during the event. With the check valve open, a flow path between the high-pressure RCS and the low-pressure core spray system piping was created when the injection valve was inadvertently opened. The cause for the open testable check valve was traced to a pneumatic pressure reversal in the air actuator. The reversal was caused by an earlier maintenance error in installing a plunger with reversed air ports in the air actuator pilot solenoid valve. A review of plant maintenance records indicated that the valve likely had been held open since December 1983. The valve misposition was not detected for the ensuing eight-month period because of a second error committed during the same maintenance. The valve position indications were altered following the maintenance such that the valve misposition was not evident.

A review was also conducted to determine the cause for the inadvertent opening of the injection valve during the surveillance test. The test procedures specified that the valve motor operator circuit breaker be opened prior to the test so that the valve would have no motive power and would remain closed during the logic test. It was determined, however, that the licensed operator assigned to perform this step had failed to open the breaker. He had mistaken a "power on" light to mean that the breaker was open. Thus, when the test signal was applied during the logic test, the injection valve opened.
