TUGCO ENGINEERING DIVISION	INSTRUCTION	REVISION	ISSUE DATE	PAGE
FOR INFORMATION ONLY CONTROLLED COPY NO.	CP-EI-4.0-51	1	4-6-84	1 of 5
CONTROL OF PROTECTIVE COATINGS FIELD VERIFICATION ACTIVITIES		PREPARED BY <u><i>Mark Wells</i></u> APPROVED BY <u><i>L. M. [Signature]</i></u>

Texas Utilities Services, Inc.
Comanche Peak Steam Electric Station
1980-82 2300 MW Installation
Brown & Root, Inc. Job 35-1195

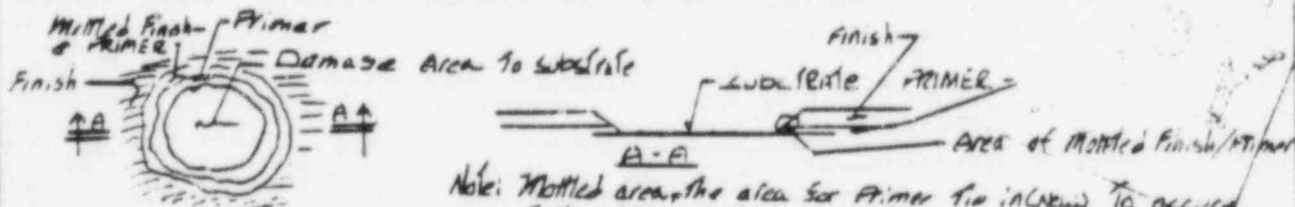
QUESTION: Cited paragraphs addresses repairs of scratches and damaged areas, repair of top coat or CZ II major defects and coating interface. When performing spots repair that require abrasion feathering of 305 and CZ II, is it permissible to apply CZ II directly over Phenoline 305? If so, is there a maximum distance that may be coated with CZ II for this tie in. CCP 30 states "feather" back a sufficient distance to insure a smooth blend with existing coating. Please clarify.

Note: Mottled area - the area for primer tie in needs to occur. If new primer extends over finish coat the applied primer should be sanded back to the mottled area prior to final application for proper application method. This method is for areas which are damaged to 5th or 6th substrate which were previously finish coated or seal coated.

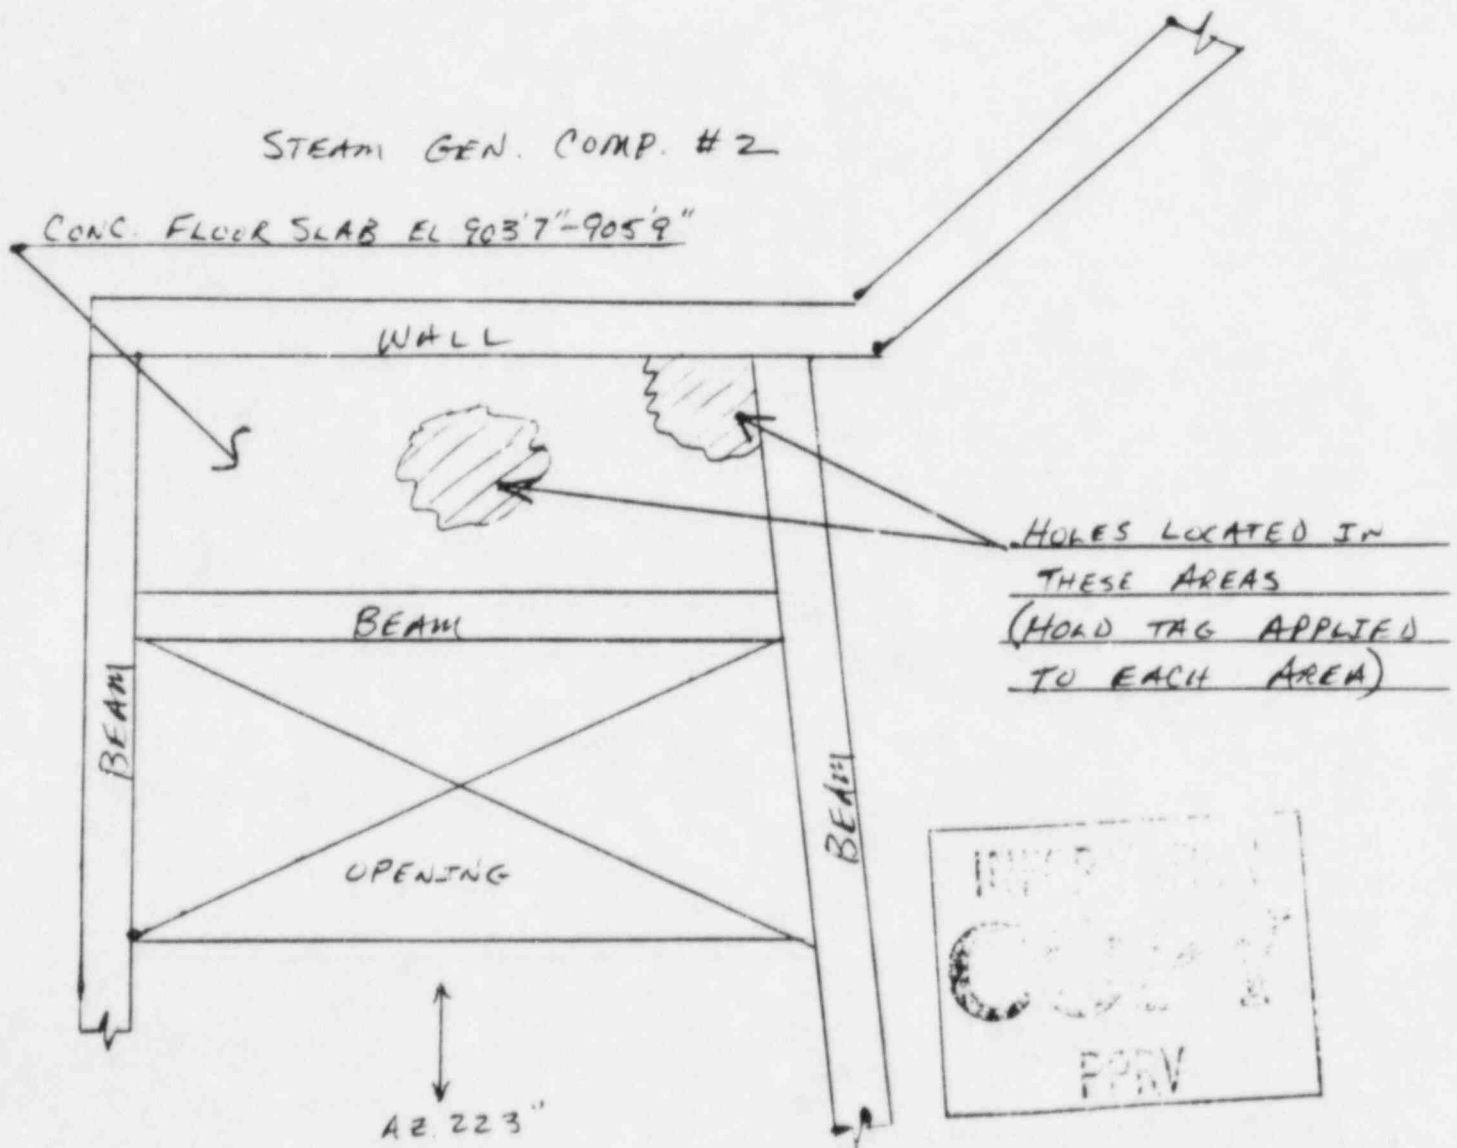
SHEET 2 OF 2

APPROXIMATELY 20 HOLES IN CONCRETE CEILING AT EL. 903'7" WERE FILLED WITH AN UNIDENTIFIED MATERIAL WHICH APPEARS TO BE A SILICONE OR RUBBER TYPE SEALANT. THE HOLES RECEIVED CONCRETE COATINGS IN VIOLATION OF BELOW REFERENCED PROCEDURE. CONDITION WAS DISCOVERED BECAUSE SEALANT MATERIAL HAS EXPANDED UNDER HOT CONDITIONS CAUSING COATINGS TO FAIL. SEVERAL HOLES HAD SEALANT MATERIAL "BLEEDING" THROUGH CRACKS IN COATINGS. SEE SHEET 2 FOR LOCATION OF AREA.
(HOLD TAG APPLIED)

PLAN VIEW EL. 905'9"
(HOLES ARE LOCATED BELOW FLOOR
SLAB AT EL. 903'7")

Remove the caulking material from the affected holes and patch in accordance with CEI-20. Repair damaged coatings in accordance with specification 2323-AS-31 and applicable site procedures.
