VERMONT YANKEE NUCLEAR POWER CORPORATION

February 27, 1997
BVY 97-32

Subject: Reportable Occurrence No. LER 97-01, Rev. 01

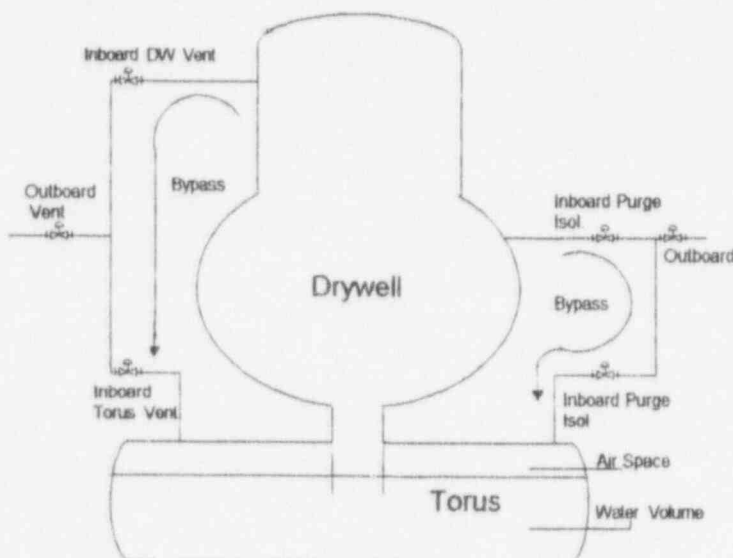
FIGURE I

On 02/07/97 during a cause analysis investigation for an unrelated issue, while operating at 100% power, VY discovered the potential for a postulated electrical failure to affect primary containment (EIS=NH) integrity. It was postulated that a single electrical failure which disables the torus and drywell vent and purge (EIS=VB) inboard isolation valves (EIS=ISV) could allow an open flow path from the drywell to the torus air space partially bypassing the primary containment heat sink.

VY Containment isolation logic (EIS=JE) design ensures that a single component failure cannot prevent automatic closure of the potential containment leakage pathways. For the containment vent and purge lines the design ensures that either the outboard isolation or the two inboard isolations will close given any postulated single failure. However the cited electrical failure could allow two 18 inch bypass lines connecting the drywell to the torus air space to remain open, thus partially bypassing the water and reducing the condensation of the steam. The bypass can occur via the air purge inboard isolation valves and through the drywell and torus inboard vent valves as the same control logic provides isolation of both flow paths.
