LICENSEE EVENT REPORT (LER)

FACILITY NAME (1) Calvert Cliffs, Unit 1										DOCKET NUMBER (2) 0 5 0 0 0 3 1 7				PAGE (3) 1 OF 03						
TITLE (4) Control Room Ventilation Damper Failure																				
EVENT DATE (5)			LER NUMBER (6)				REPORT DATE (7)			OTHER FACILITIES INVOLVED (8)										
MONTH	DAY	YEAR	YEAR	SEQUENTIAL NUMBER	REVISION NUMBER	MONTH	DAY	YEAR	FACILITY NAMES				DOCKET NUMBER(S)							
1	1	2	0	8	5	8	5	0	1	4	0	0	1	2	2	0	8	5	Calvert Cliffs, Unit 2	0 5 0 0 0 3 1 8
OPERATING MODE (9)			THIS REPORT IS SUBMITTED PURSUANT TO THE REQUIREMENTS OF 10 CFR 5: (Check one or more of the following) (11)																	
1			20.402(b)				20.408(a)				50.73(a)(2)(iv)				73.71(b)					
POWER LEVEL (10)			20.408(a)(1)(i)				50.36(a)(1)				50.73(a)(2)(v)				73.71(c)					
1 0 0			20.408(a)(1)(ii)				50.36(a)(2)				50.73(a)(2)(vi)				OTHER (Specify in Abstract below and in Text, NRC Form 386A)

At 1425 on November 20, 1985, one isolation damper in each of two Control Room Heating, Ventilation and Air Conditioning (HVAC) inlet ducts was discovered inoperable. Continued operation with these dampers inoperable and a second set of isolation dampers open was a condition prohibited by T

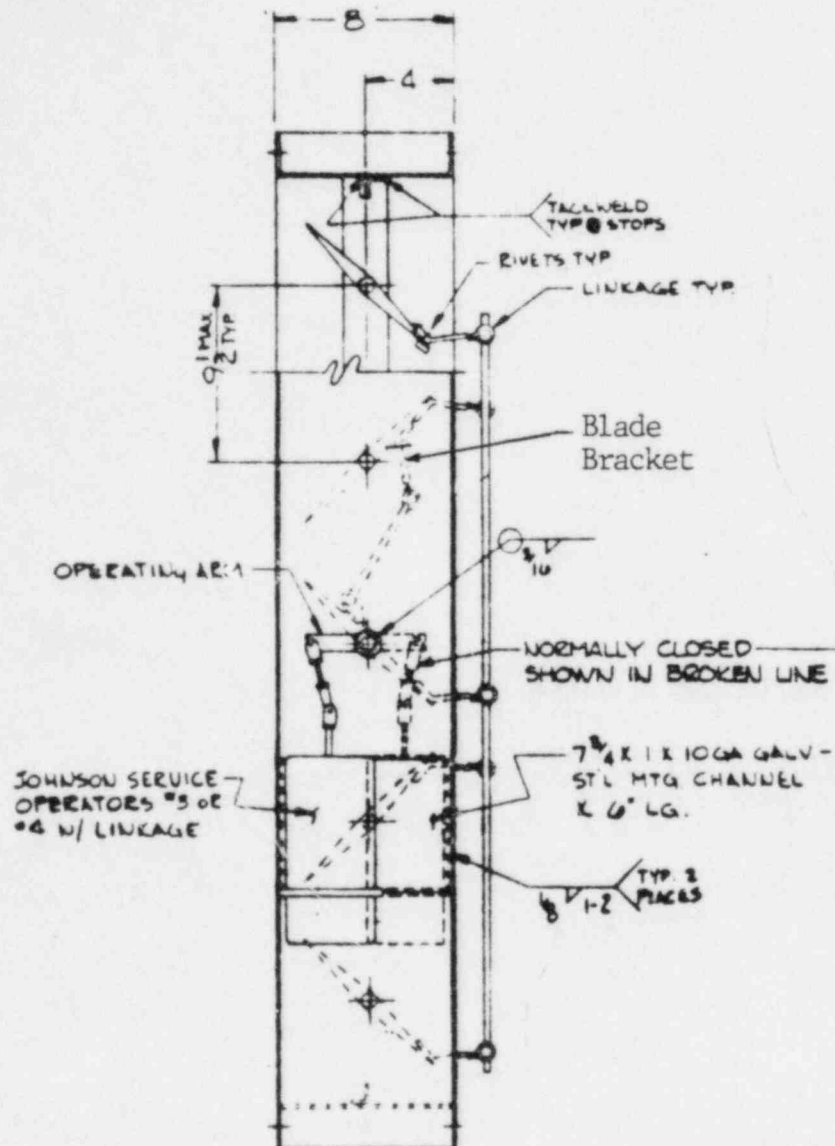
ATTACHMENT 1

The immediate cause of failure of both dampers was broken blade brackets (see Attachment 1). This prevented a closing force from being transmitted to three of six blades in the damper; an opposed-blade, louvered type.

The root cause of failure of both dampers was improper adjustment of the linkages which connect alternating damper blades (see Attachment 1). This adjustment appears to have been set during damper installation, although whether or not the adjustment had been changed during future operation could not be determined. The improper adjustment caused binding between adjacent damper blades which placed undue stress on the two blade brackets, causing them to break. The blade brackets were replaced and the linkages adjusted. Both louvered dampers were returned to an operable status by 1950 on November 27, 1985.

Opposed Blade Damper

1. The surveillance procedure used to verify closure of isolation dampers in the Control Room HVAC System on a high radiation signal has been changed to include verification of louvered damper closure at least once per 18 months.
2. An inspection of other dampers of the same or similar model as those that failed was conducted and no broken brackets were found.
3. An evaluation of the isolation capability of the louvered type dampers will be conducted.
