Edwin I. Hatch Nuclear Plant

Edwin I. Hatch Nuclear Plant - Unit 2
Licensee Event Report
High Pressure Coolant Injection System Inoperable
Following Unplanned Engineered Safety Feature Actuation

Enclosure: LER 50-366/1997-001

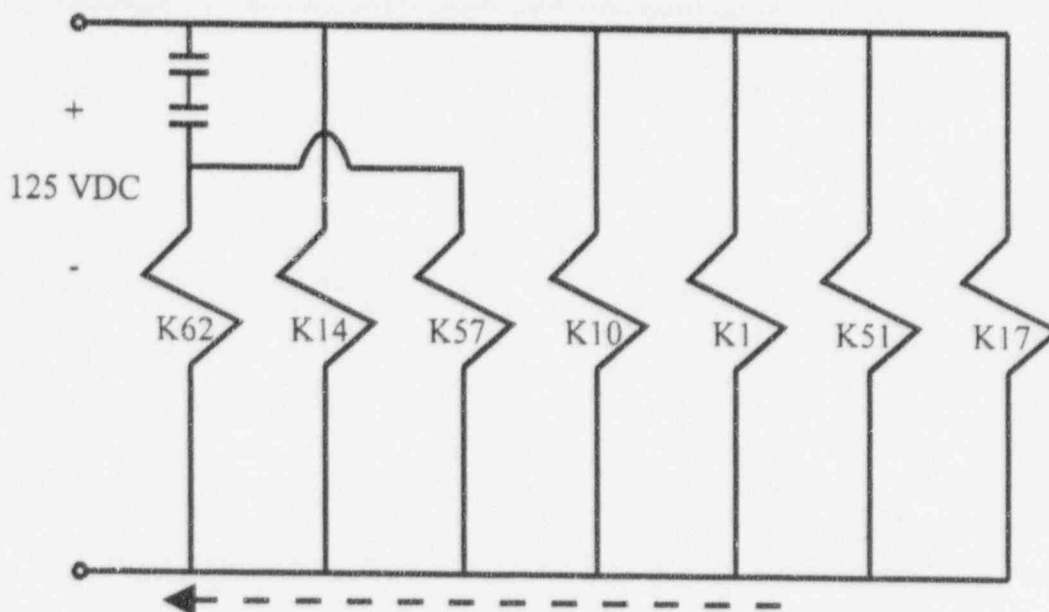
Relay 2E41-K14 is located in the HPCI initiation control logic as shown in Figure 1. When the leads were lifted from the relay, this interrupted the neutral circuit for the entire logic system. This had two results. First, it re-routed the neutral current path through two relays, 2E41-K57 and 2E41-K62, as shown in Figure 2 (next page). Relay 2E41-K57 controls isolation of PCIS valve 2E41-F111. The currents flowing through the remaining, normally-energized relays in the circuit were sufficient to energize 2E41-K57. When it energized, this sent an isolation signal to PCIS valve 2E41-F111, which then closed per design.

Figure 1, Simplified Circuit in Normal Configuration, with Neutral Circuit Intact.
Dashed Line Indicates Neutral Current Flow.

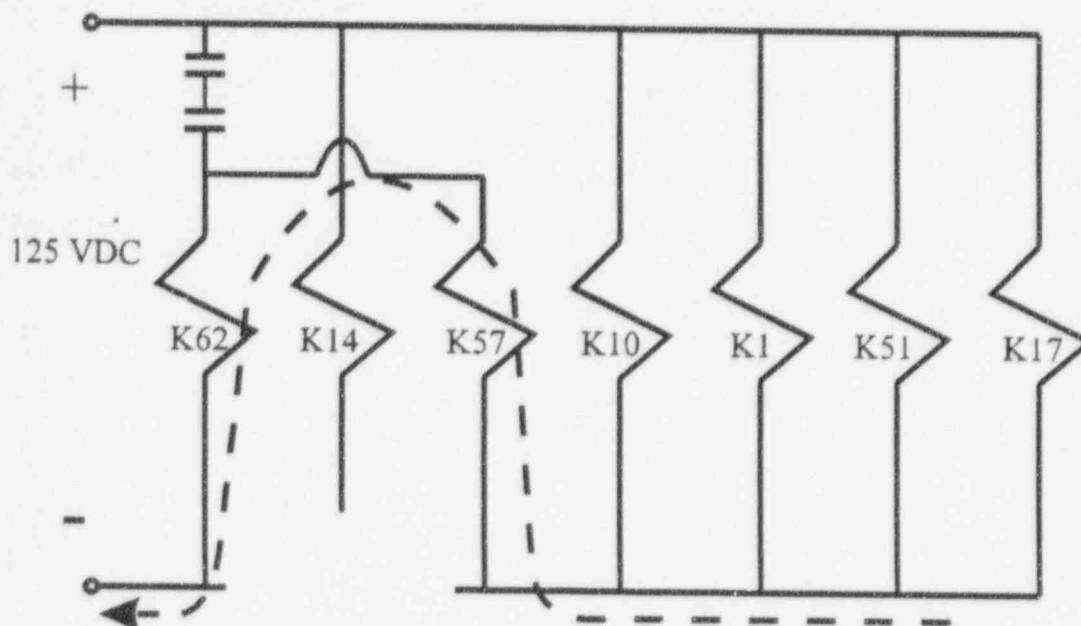
The second effect was that the HPCI initiation logic system was rendered inoperable. In the configuration shown in Figure 2, the voltage drop across relays 2E41-K62 and 2E41-K57 was enough to prevent any other relays in the logic system from actuating. This would have prevented an automatic initiation of the HPCI system. Therefore, the HPCI system was inoperable as soon as the leads were lifted from the relay.

Figure 2, Simplified Circuit Showing Alternate Path Created with Neutral Connection Interrupted.
Dashed Line Indicates Neutral Current Flow.

The annunciators observed by control room personnel showed that some, but not all, of the parallel relays in Figure 2 (K10, K1, K51, and K17) dropped out as a result of lifting the wire. This occurred because the voltage appearing across them was reduced to a level in which the response of General Electric type HGA, 125-volt DC relays becomes unpredictable.

Extrapolations based on the bench-tested configuration indicate that with the neutral circuit interrupted, the voltage drop across the four parallel relays would be below 15 volts. This was later confirmed by a documented study produced by the plant's Architect/Engineer. Since these are DC

1. The wires were reconnected to relay 2E41-K14 and PCIS valve 2E41-F111 was opened, restoring the HPCI system to operable status. This action is complete.
2. Approval of procedure 57CP-CAL-051-2S has been rescinded by the Maintenance Department Manager so that it cannot be performed until it has been corrected.
