**Florida
Power**
CORPORATION
Crystal River Unit 3
Docket No. 50-302

Subject: Licensee Event Report (LER) 97-S01-00

TITLE (4) Maintenance Activities in Circulating Water System Result in Protected Area Breach

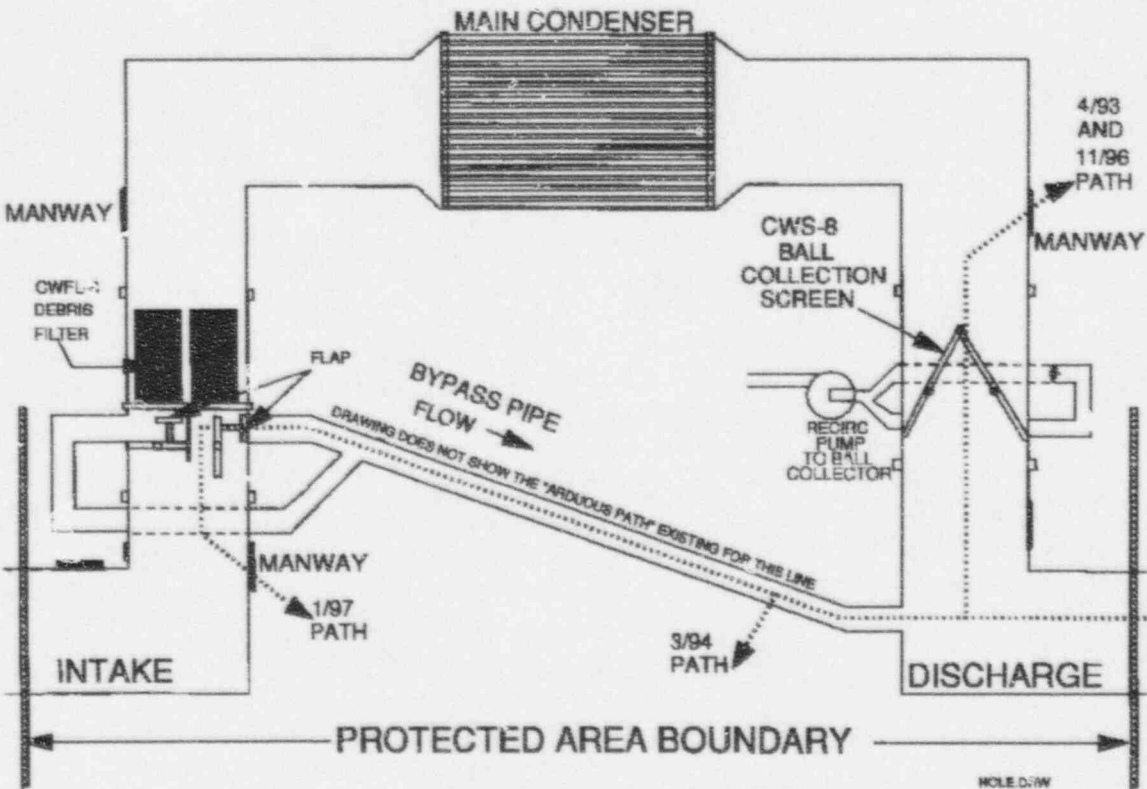
Figure 1

The Circulating Water System [KE](CW) provides seawater to the Main Condenser [SG,COND] to condense steam from the Low Pressure Turbines [TA,TRB] and Main Feed Pump [SJ,P] turbine exhausts. It also provides sea water to the Secondary Services Closed Cycle Cooling Water (SC) Heat Exchangers [KB,HX]. The Amertap System provides intermittent cleaning and removal of deposits in the Main Condenser tubes by recirculating sponge rubber balls. Seawater is drawn from the intake canal at the intake structure. Four Circulating Water Pumps [KE,P] move the water through individual underground conduits to the inlet water boxes. The main flow is through the condenser tubes to the Outlet Waterbox. At the Outlet Waterbox, main flow is mixed with the outlet from the respective SC Heat Exchanger and passes through Amertap ball retention screens before entering the underground conduits. The bypass line flaps control water flow in the CW debris filter bypass lines. The conduits direct the water to the outfall at the discharge canal. The (CW) debris filter bypass line flaps serve as a security barrier that had not been previously identified as a protective barrier until this event occurred.

No safety systems were affected or threatened by this event; however, the removal of the Circulating Water System debris filter bypass line flap exposed a possible penetration path into the protected area.

A contributing cause of this event was the fact that a similar event in 1994 involving the same access path, did not sufficiently diagnose the path for Protected Area vulnerability. The 1994 event and corrective actions were limited to removal of a section of the bypass line piping and did not identify the affect of removal of the bypass flaps.

The waterbox manways will be secured with Security-controlled locking mechanisms.

FPC Engineering will develop a Security Barrier Component List (SBCL) based on the 96 square inch opening criteria associated with protected and vital area barriers as established by the CR-3 Physical Security Plan. This SBCL will be integrated into the planning and work controls process for maintenance activities.
