FORM 1 LER SCSS DATA 00-00-85
 BUCKET YEAR LER NUMBER REVISION DCS NUMBER NSIC EVENT DATE
 250 1981 001 0 8102060421 163459 01/01/81

DOCKET: 250 TURKEY POINT 3 TYPE: PWR
 REGION: 2 NSSC: WE
 ARCHITECTURAL ENGINEER: TECH
 FACILITY OPERATOR: FLORIDA POWER & LIGHT CO.
 SYMBOL: IPL

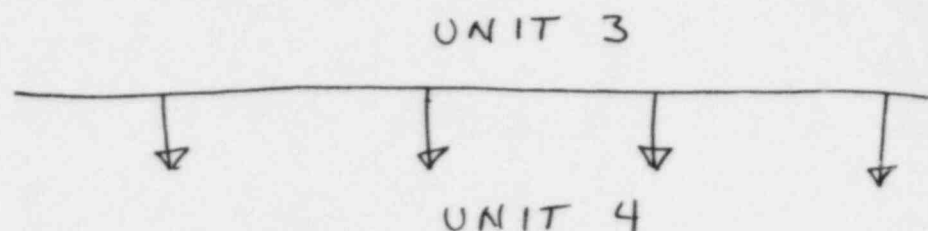
DURING STARTUP, FOR A PERIOD OF ABOUT 4 HOURS, THE CONDENSATE STORAGE TANK (CST) CONTAINED LESS THAN THE 185,000 GALLONS REQUIRED BY TS. THE CST INVENTORY DURING THIS INTERVAL WAS NOT REDUCED BELOW APPROXIMATELY 180,000 GALLONS. REFERENCE SIMILAR OCCURRENCE LER 250-80-2. THERE WERE NO EQUIPMENT FUNCTIONAL PROBLEMS ASSOCIATED WITH

LESS THAN
REQ'D VOLUME
IN CST.

THIS EVENT. INCREASED WATER DEMAND DURING LOW POWER PHYSICS TESTING EXCEEDED WATER TREATMENT PLANT OUTPUT AND RESULTED IN CST LEVEL DECREASING TO LESS THAN THE TS LIMIT. PLANT CHANGES AND MODIFICATIONS CURRENTLY SCHEDULED WILL REDUCE THE POTENTIAL EXPOSURE TO EVENTS OF THIS TYPE.
